**18501 Mississauga Road, Town of Caledon,
Municipality of Peel, Ontario**

Cultural Heritage Documentation Report

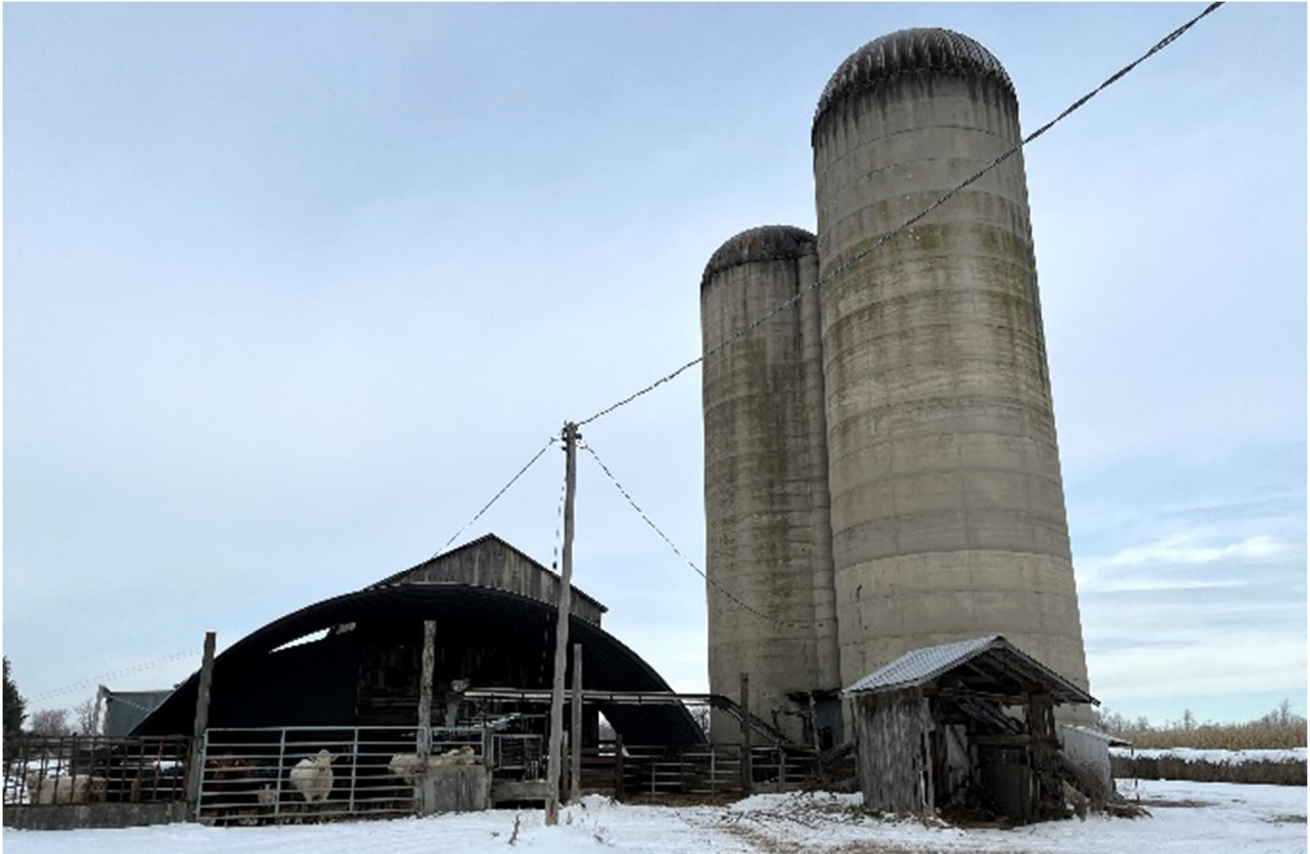
Plate 15: South elevation of Barn No. 1 (barn outlined in red, Quonset addition outlined in yellow)

Barn No. 1 is a Central Ontario Barn that dates to the late 19th century. The original section of the barn has a rectangular plan, gable roof, and stone foundations (Plate 15 to Plate 18). A Quonset is attached to the south elevation of the barn and an addition with a shed roof is attached to the west elevation. The original barn is clad in vertical wood plank siding and has a gable roof clad in metal sheets (Plate 19 and Plate 20). The barn has rubble stone foundations with wood frame window openings and holes where I-beams have been added for structural support (Plate 21 to Plate 24). A small wood door is located on the east elevation (Plate 25). The original section of the barn measures approximately 16 m by 17 m and is 258 m² (Figure 3).

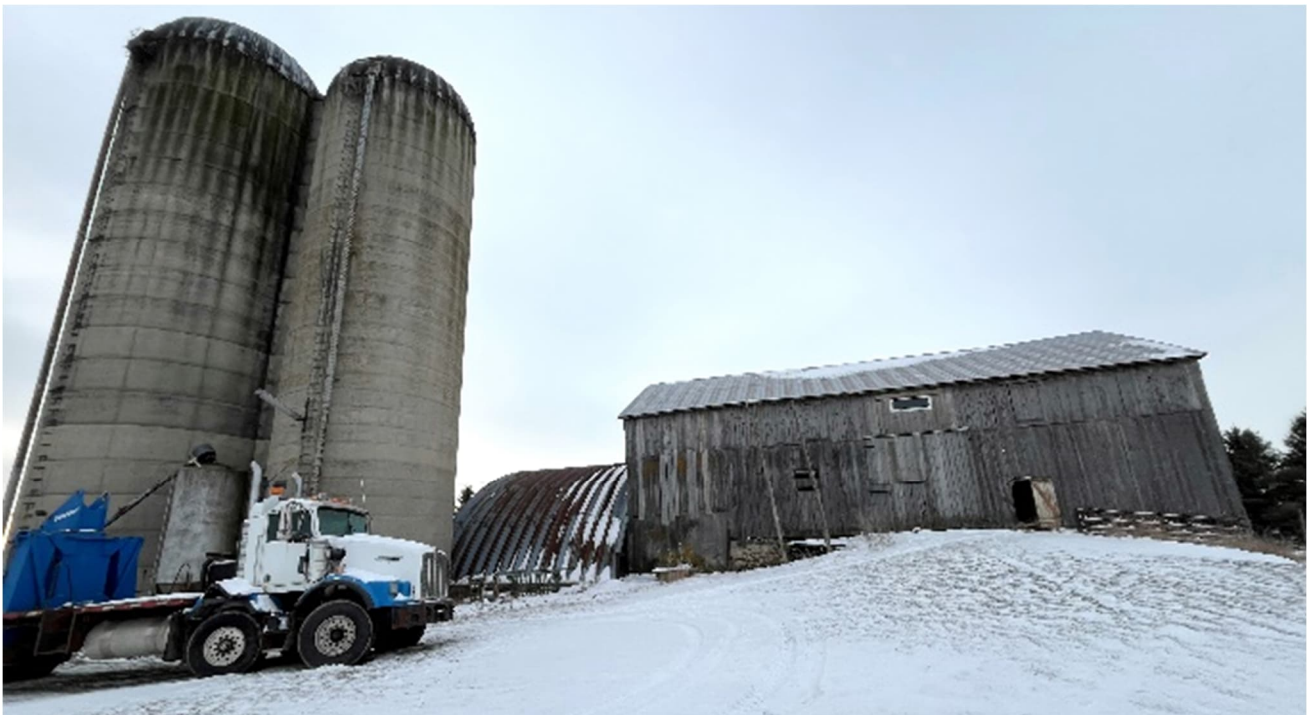
Plate 16: East elevation of Barn No. 1 (barn outlined in red, Quonset outlined in yellow)

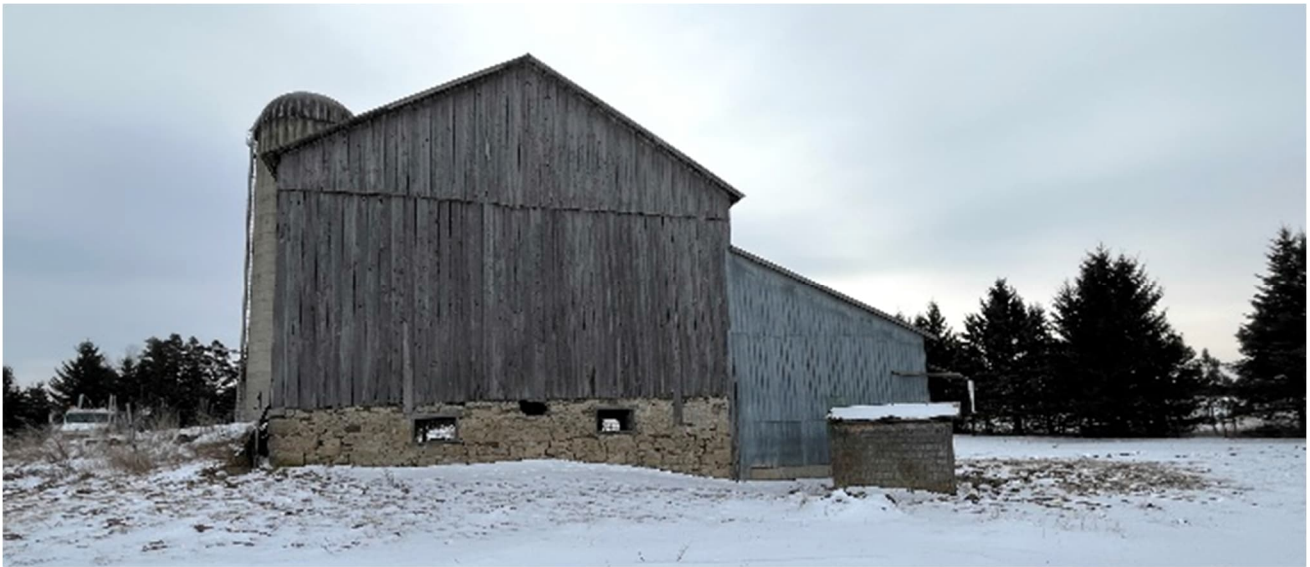
Plate 17: North elevation of Barn No. 1 (barn outlined in red, south addition outlined in green)

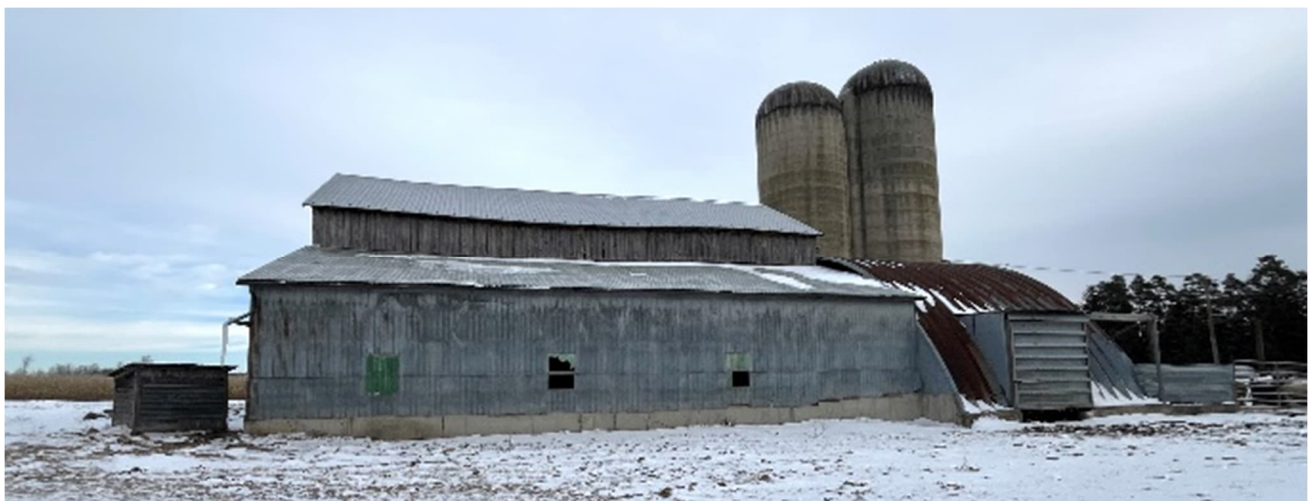
Plate 18: West elevation of Barn No. 1 (original barn outlined in red, west addition outlined in green, Quonset outlined in yellow)

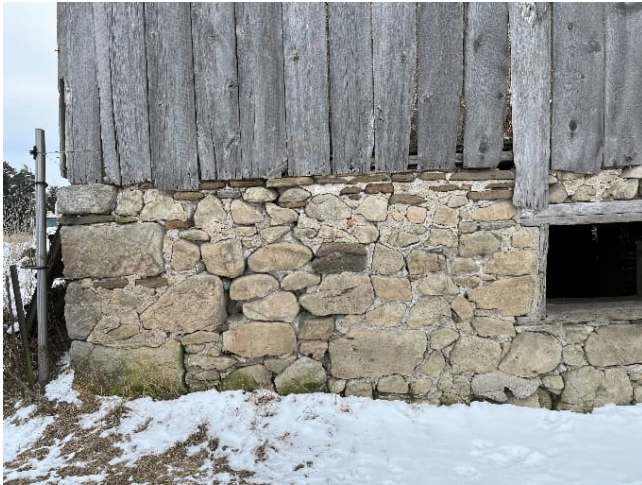
Plate 21: Fieldstone foundation on the northwest elevation

Item	Location	Condition	Salvage Opportunity
Fieldstone	Barn No. 1 foundation	Good	The fieldstones appear to be in good condition and present an opportunity to be salvaged and used for other purposes as an alternative to being deposited as landfill.
Timber	Structural timbers in Barn No. 1 and Barn No. 2	Good	A visual inspection of the structural timbers determined some splitting but had occurred but overall, they are in good condition. The timbers should be inspected during removal but overall present a good opportunity for salvaging. Those found to be in good condition can be retained and used for other purposes as an alternative to being deposited as landfill.
Wood Plank	Exterior cladding of Barn No. 1 and Barn No. 2	Good	A visual inspection of the wood plank determined that, despite sections of significant weathering, they are overall in good condition. The wood plank should be inspected during removal but overall present a good opportunity for salvaging. Those found to be in good condition can be retained and used for other purposes as an alternative to being deposited as landfill.

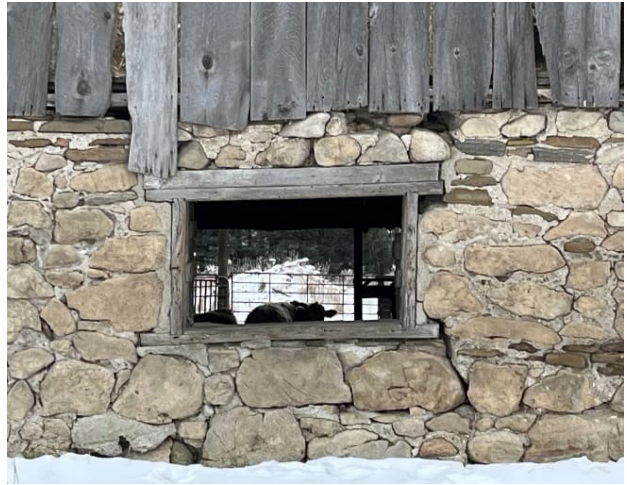
Plate 22: Wood-framed window opening on the northwest elevation

Cut Wood	Window frames, sills, and lintels of Barn No. 1 and Barn No. 2	Good	A visual inspection of the wood window elements determined that, despite sections of significant weathering, they are overall in good condition. The wood should be inspected during removal but overall present a good opportunity for salvaging. Those found to be in good condition can be retained and used for other purposes as an alternative to being deposited as landfill.
Windows	Foundation of Barn No. 2	Fair	The windows in the foundation of Barn No. 2 appear to be significantly weathered but appear to be in fair condition for their age. They are 20th century wood frame fixed windows and offer opportunity for salvaging. They should be retained and used for other purposes as an alternative to being deposited as landfill.
Concrete Foundation	Barn No. 2 foundation	Good	The concrete does not have heritage value and the effort required to remove the concrete while preserving it structurally is not commensurate to the heritage value that would be retained. As such, the concrete should not be salvaged.

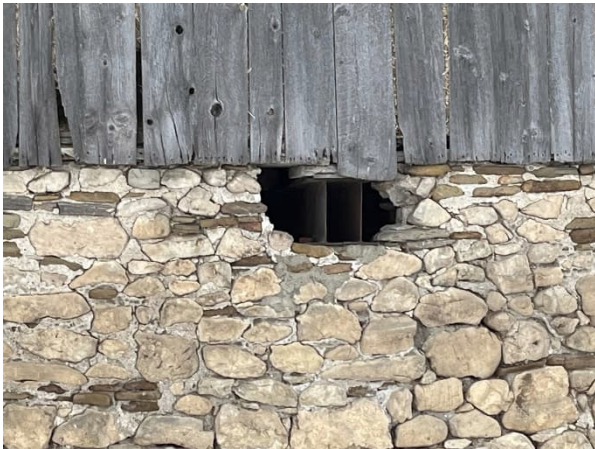
Plate 23: Hole in the foundation where a metal I-beam has been installed

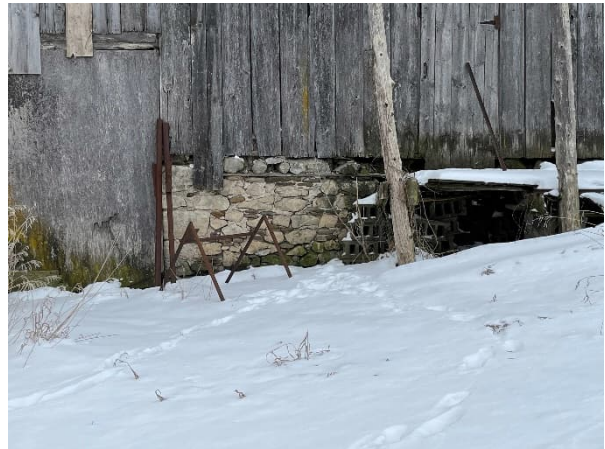
Plate 24: Fieldstone foundation seen on the northeast elevation

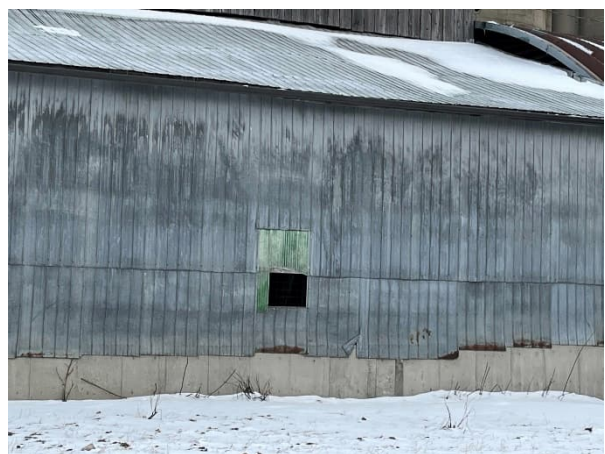
Plate 26: Southwest addition fiberglass windows

The west elevation of Barn No. 1 has a corrugated metal-clad addition with shed roof that stands on a cast-in-place concrete foundation (Plate 26). Along the metal-clad addition are three fiberglass windows. Near the rear of the addition there is small shed with shed roof (Plate 27).

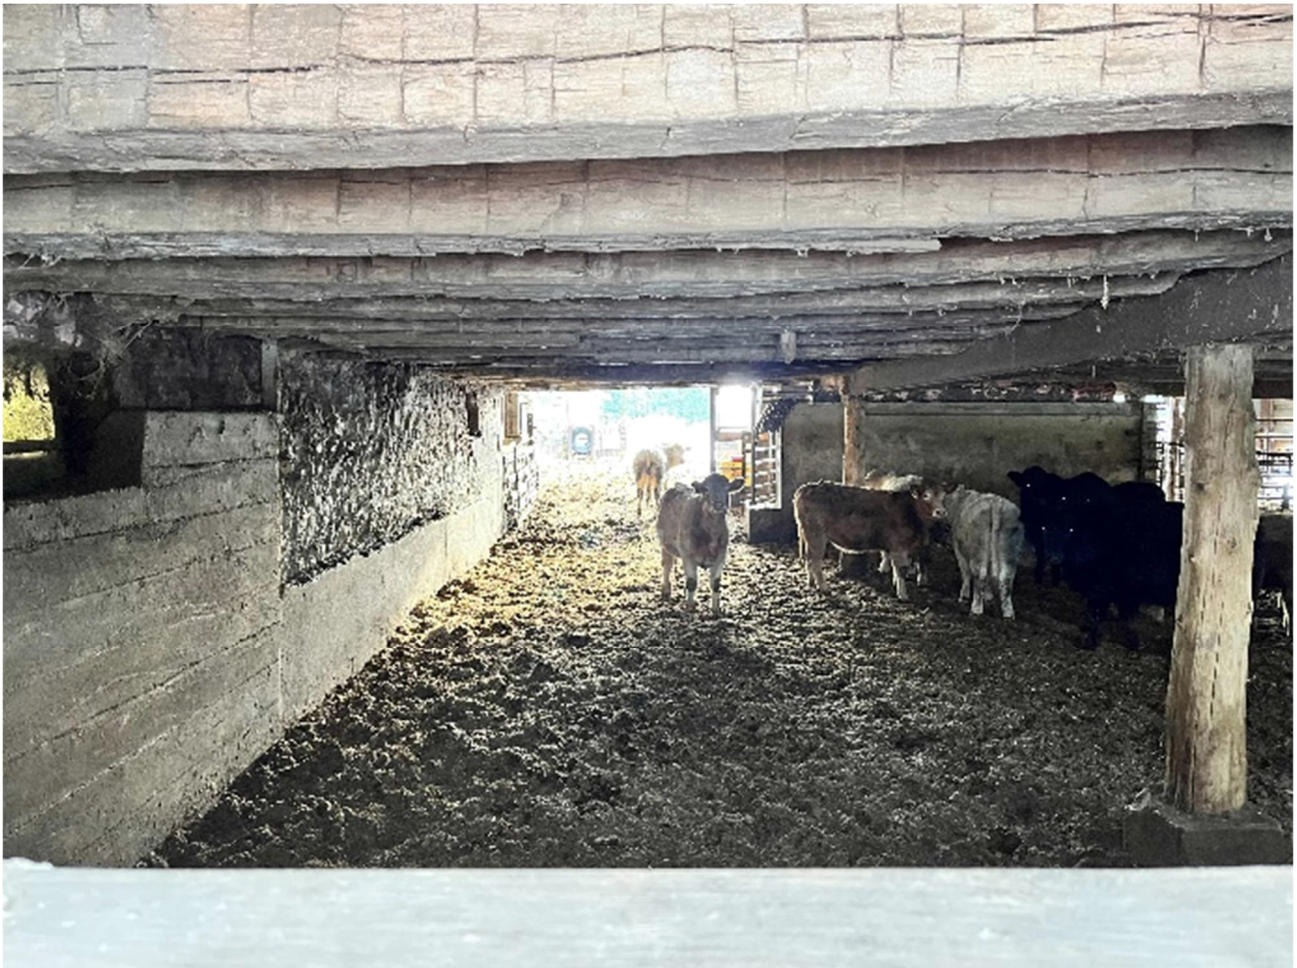
Plate 36: Lower level of the barn showing the hand-hewn beams and log posts

Based on available views of the barn interior, the lower-level of Barn No. 1 houses livestock. The barn is supported by hand-hewn beams supported by posts left in the round (Plate 29). The upper level of the barn is used for storing hay and farm equipment. The upper level has a large open floor and three smaller storage rooms accessed by a central walkway (Plate 30 to Plate 34). It also has a set of metal stairs leading to the lower level (Plate 35) and a ladder on the left side of the entrance that leads to the mow for hay storage (Plate 36).

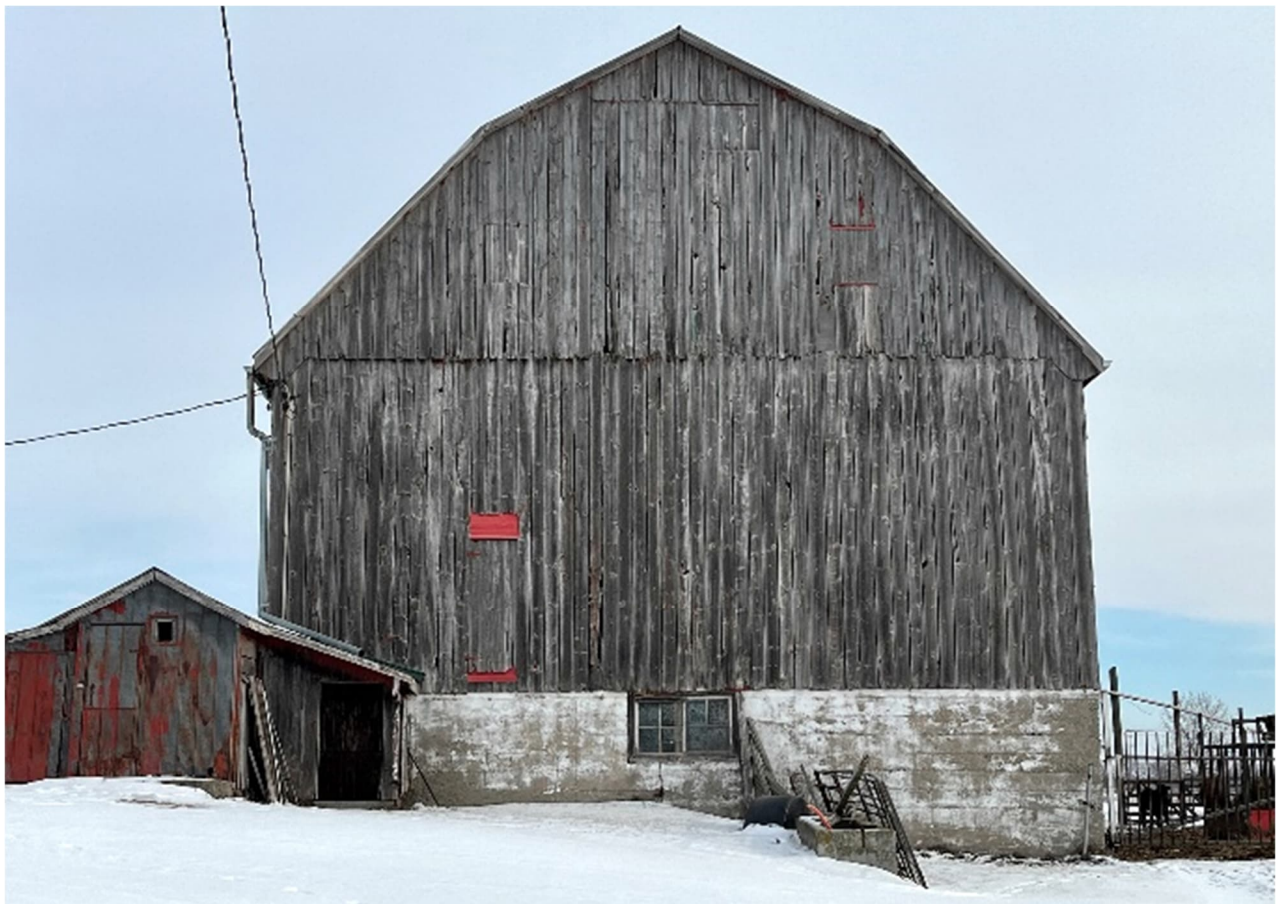
Plate 38: West elevation of Barn No. 2

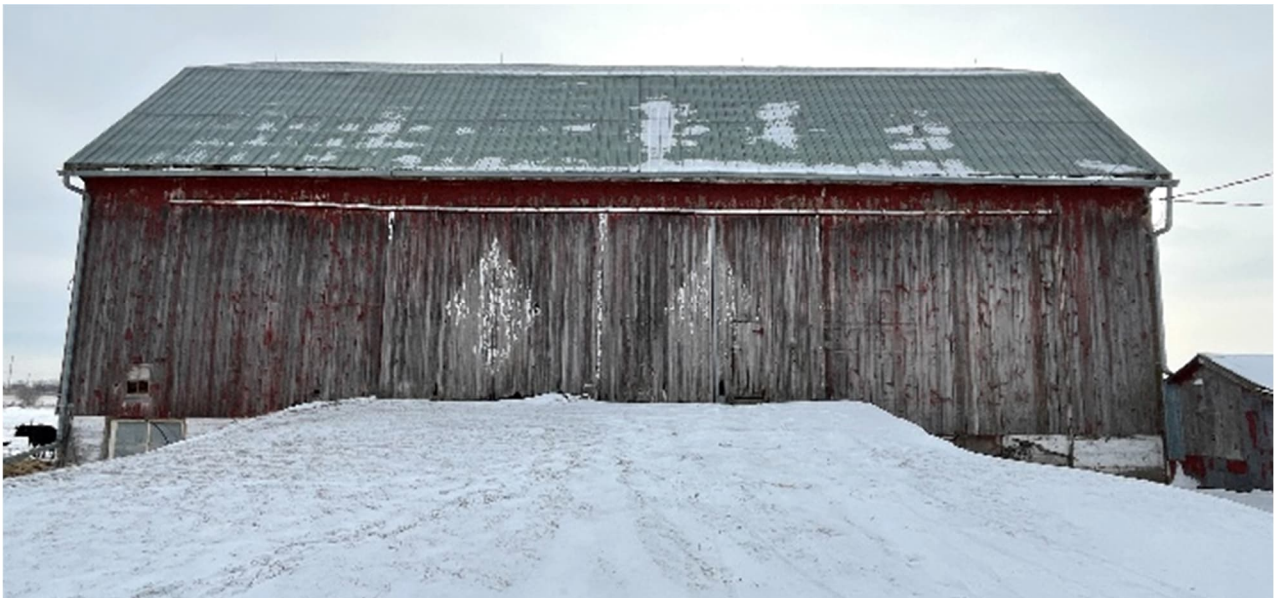
Plate 39: North elevation of Barn No. 2

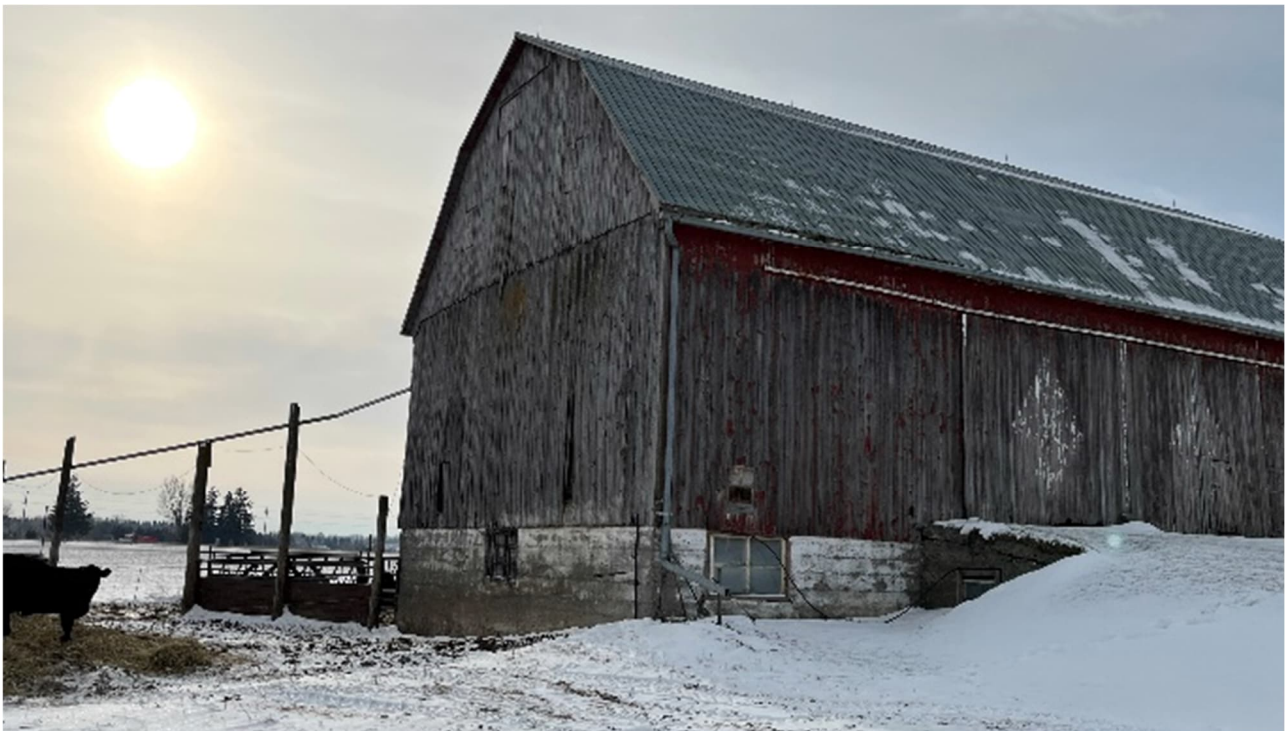
Plate 40: East elevation of Barn No. 2

The east elevation has a single pane window centrally located within the concrete foundation (Plate 49). This elevation is obscured by the livestock enclosure.

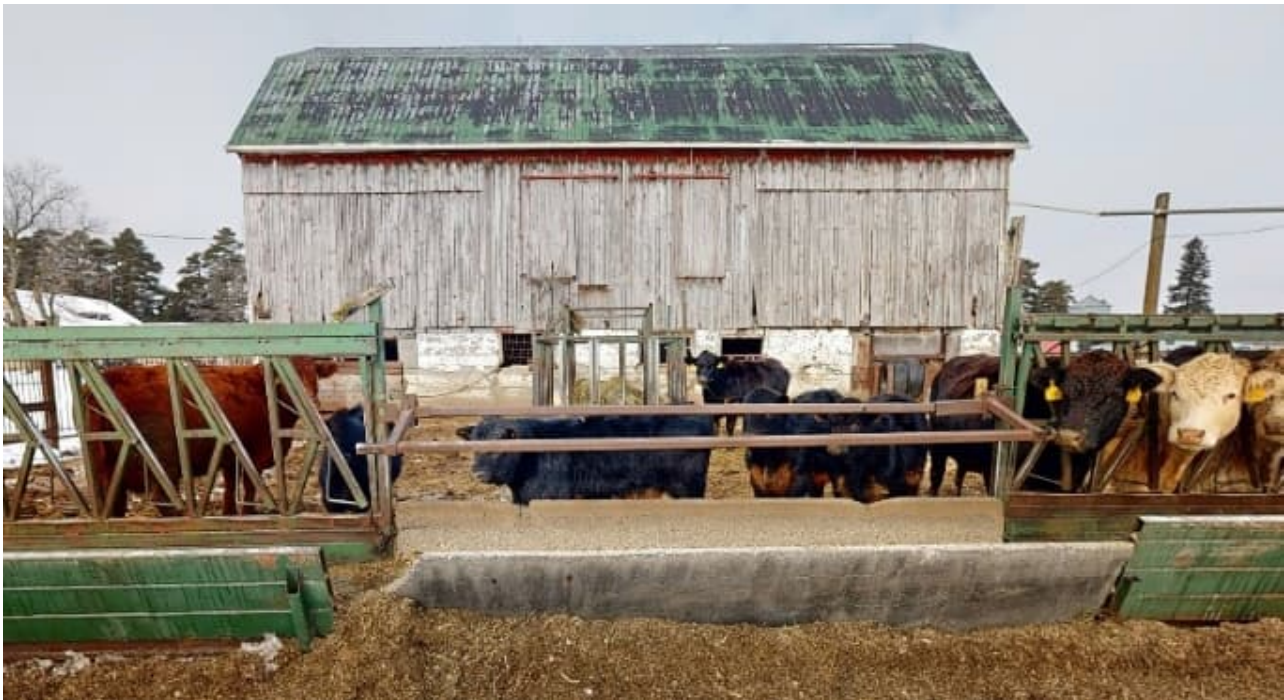
Plate 41: South elevation of Barn No 2

The south elevation has three windows along the foundation with two blind entries on either side (Plate 48 and Plate 50). This elevation is enclosed with a wire fence around the livestock feeders (Plate 51).

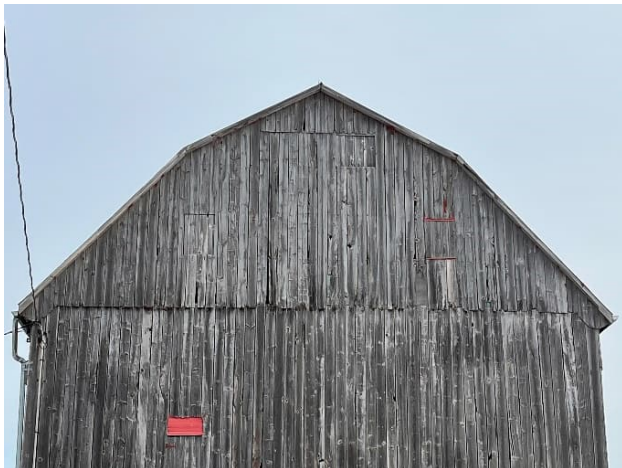
Plate 42: Gambrel roof of Barn No. 2

Barn No. 2 is a Central Ontario Barn that dates to the 20th century that is located in the core of the farm complex to the east of the farm house (Plate 37). The barn has a rectangular plan, gambrel roof, and cast-in-place concrete foundation (Plate 38 to Plate 43). The barn is clad in vertical wood plank siding and a metal-clad roof. The wood plank siding is painted red, which is weathered and faded, and the metal roof is painted green and weathered.

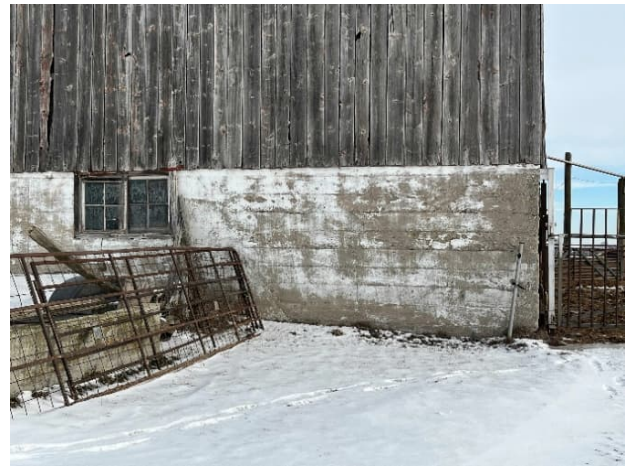
Plate 43: Cast-in-place concrete foundation and vertical wood plank siding

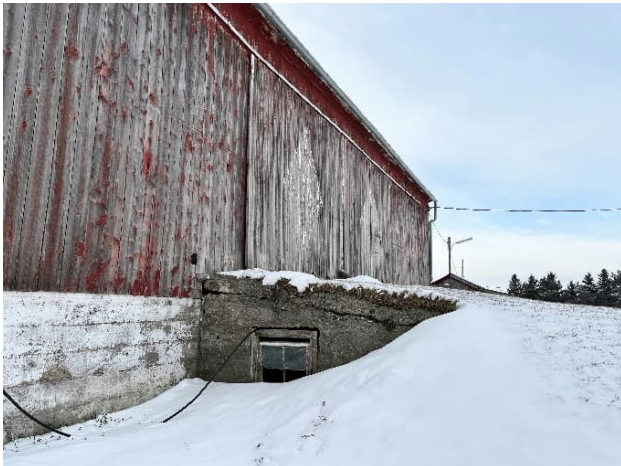
Plate 46: Gangway leading to the main entrance with window in the wing wall

The north elevation has a gangway (ramp) leading to two large sliding barn doors painted with large white diamonds (Plate 46). The ramp is supported by concrete wingwalls, the north of which has a fixed sash window with wood sill, frame, and muntins (Plate 47). There are two windows on the east side of the north elevation that are within the barn's concrete foundation (Plate 48).

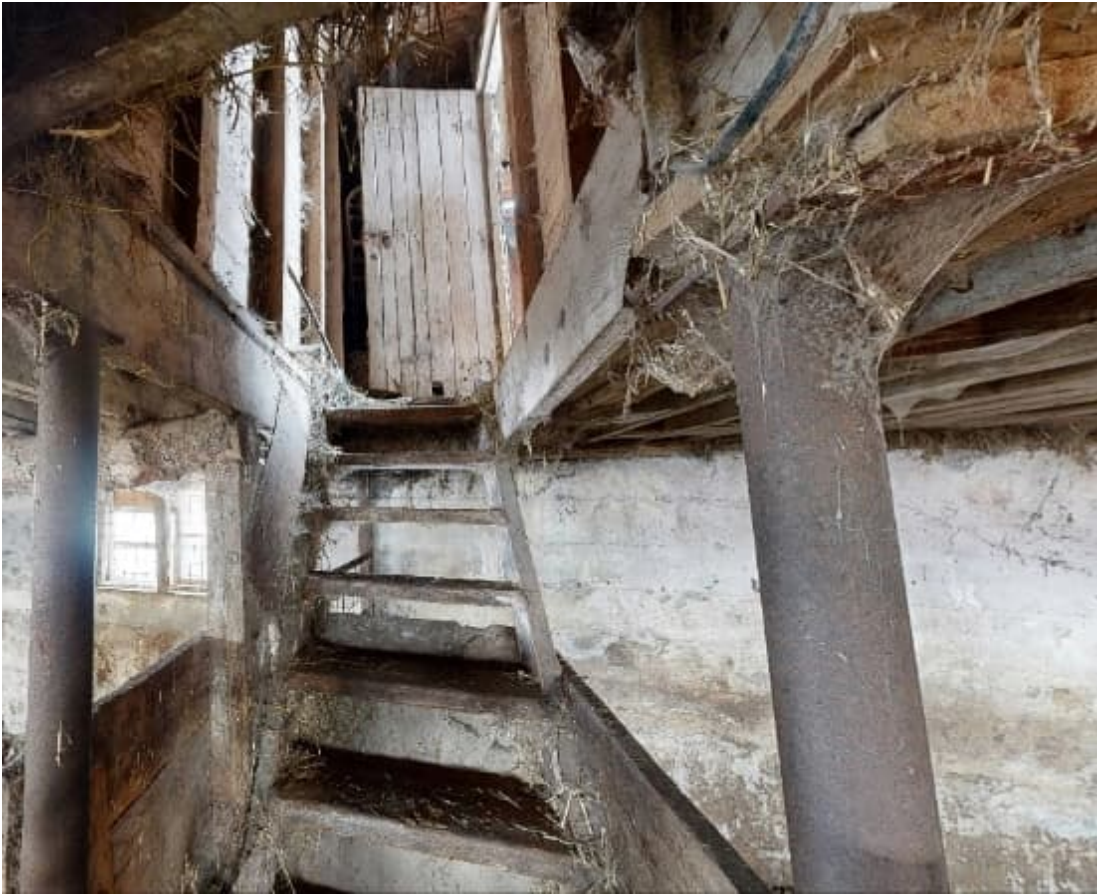
Plate 55: Stairs between upper and lower levels of Barn No. 2
