REPORT

**18667 Mississauga Road, Town of Caledon,
Municipality of Peel, Ontario**

Cultural Heritage Documentation Report

CA-GLD-19129150

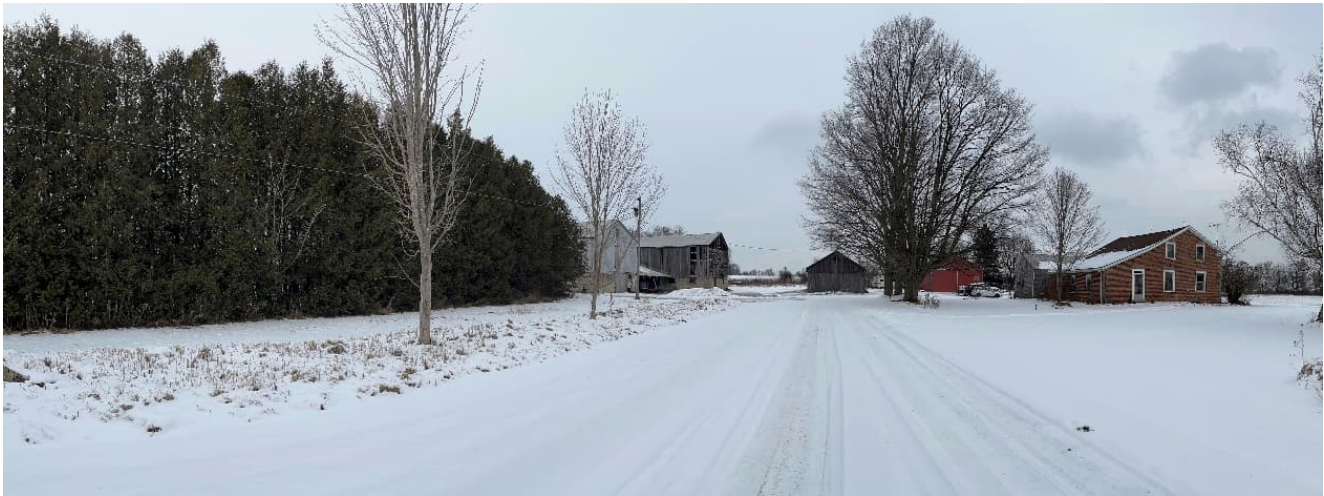
Plate 8: Overview of built environment in the Study Area

The approximately 98-acre Study Area features the farmhouse and additions, H-shaped barn complex, a drive shed, a steel-clad shed, a creek and artificial pond, a driveway lined with trees and fieldstone walls, and cultivated fields (Plate 8; Figure 2).

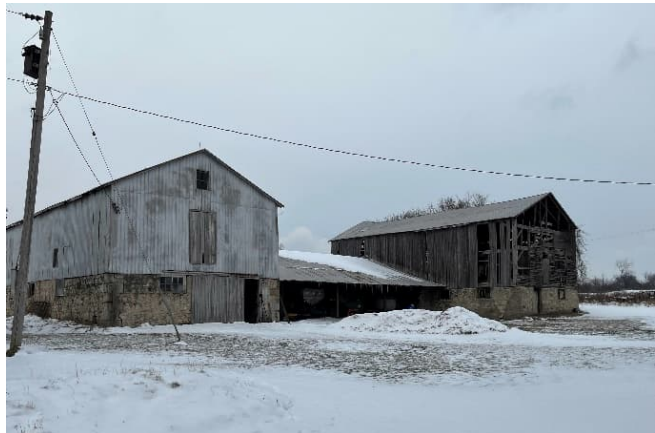
Plate 10: View from the driveway towards the main barn complex

The farmhouse and outbuilding complex is accessed from Mississauga Road by a long and straight gravel driveway lined with mature trees that also extend along the north side of the road right-of-way (ROW). Dry-laid fieldstone walls border the south portion of the driveway as well as along the north side of the road ROW (*Plate 9*). Circulation routes link the building complex with the surrounding agricultural fields and a stream traverses the Study Area (*Plate 10*).

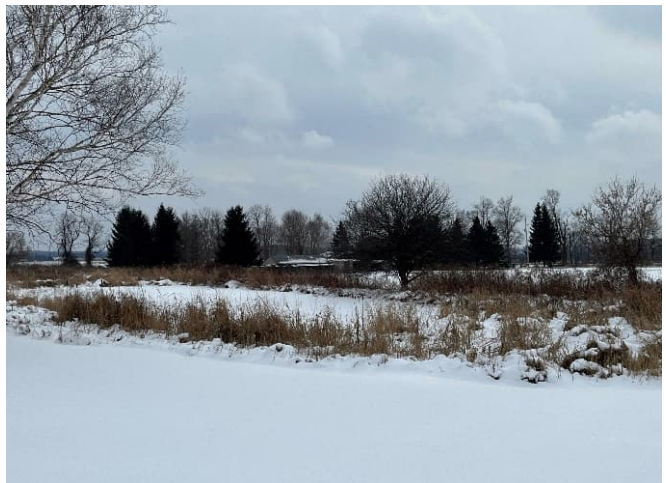
Plate 14: Artificial pond in front of the farmhouse

Piles of fieldstone mark the edges of the Study Area's agricultural fields, while wire fencing lines the boundary between the Study Area and the Mississauga Road ROW. At the west corner of the Study Area is an approximately 4.9-hectare wooded section and an artificial pond is south of the farmhouse (*Plate 11*).

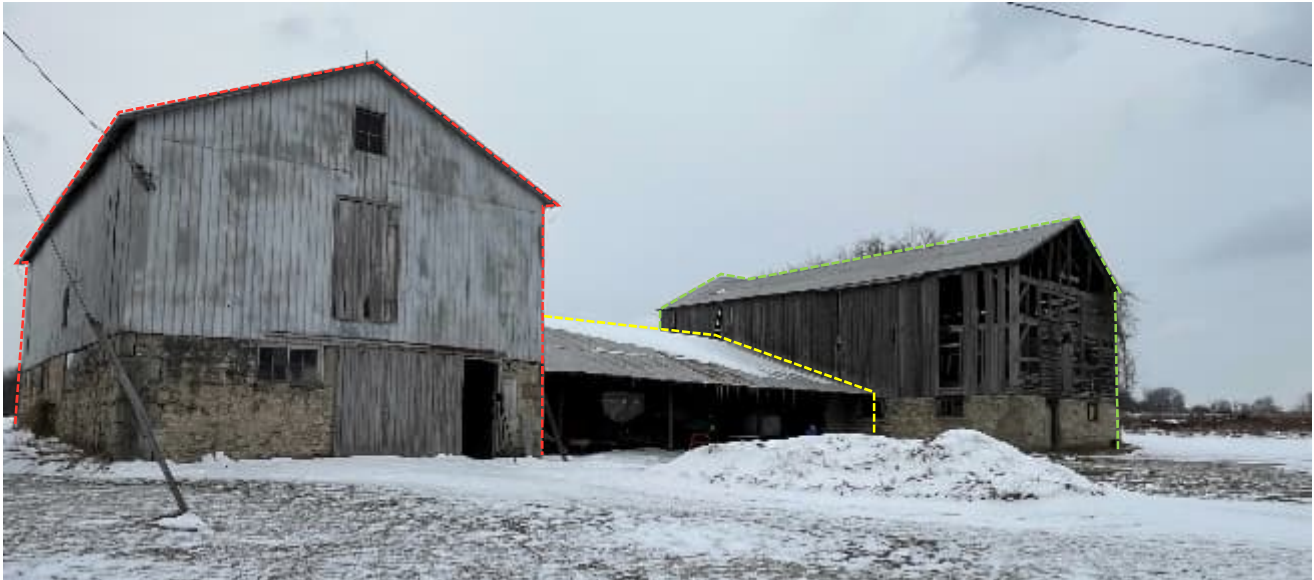
The barn complex northwest of the farmhouse comprises two large barns (South Barn and North Barn) linked by a drive shed (Connecting Shed), forming an H-shaped footprint (Plate 15 and Plate 16; Figure 3 and Figure 4).

Plate 15: South and east elevations of the H-shaped barn complex (South Barn outlined in red, drive shed outlined in yellow, North Barn outlined in green)

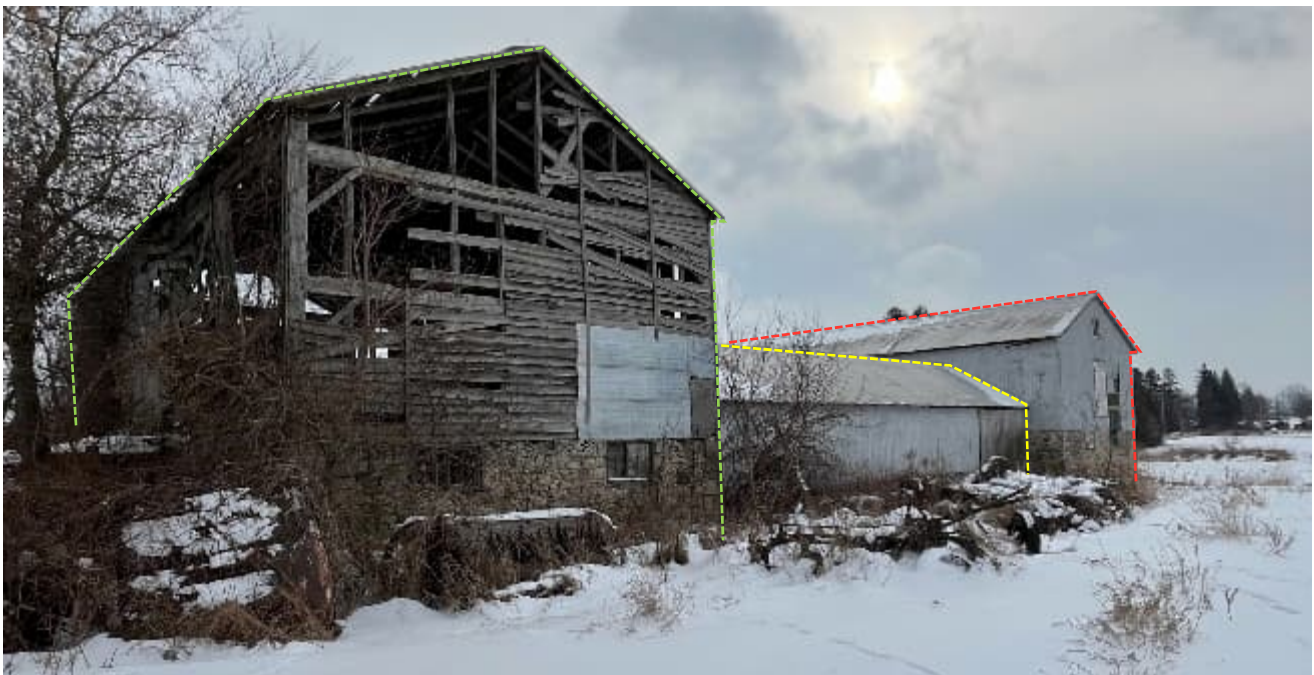
Plate 16: North and west elevations of the H-shaped barn complex (North Barn outlined in green, drive shed outlined in yellow, South Barn outlined in red)

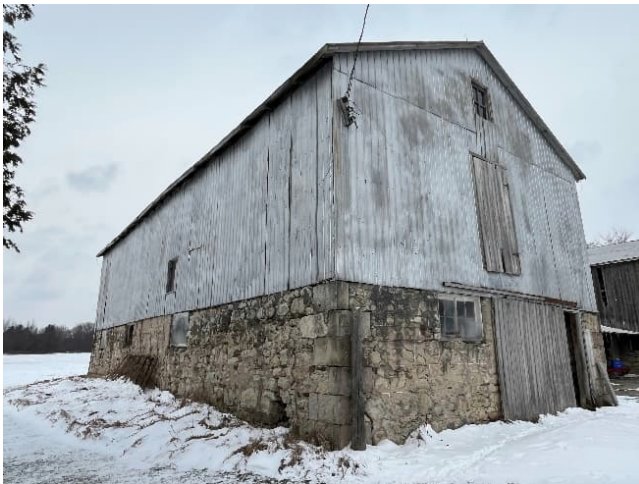
The South Barn has a parged fieldstone foundation with cut-stone quoins at the ground level, and is timber framed with aluminum cladding and a front gable roof at the second level (Plate 17 to Plate 21). The South Barn has a rectangular plan and measures 7.62 m x 18.04 m.

Plate 17: The South Barn

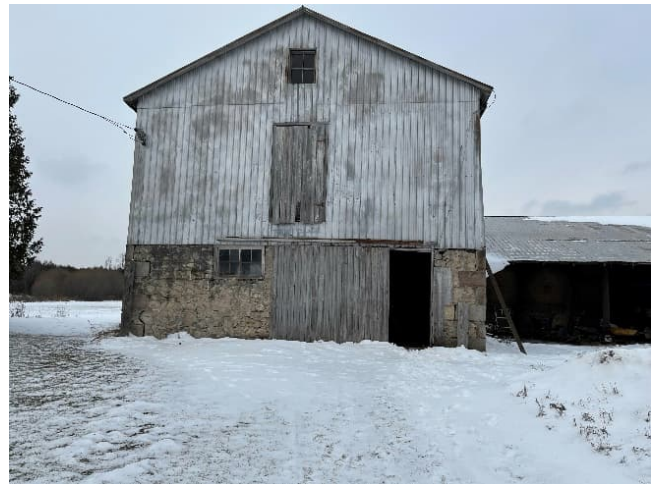
On the east elevation is a window and offset sliding wood plank door (Plate 18) at the foundation, a tall wood plank door centred at the second level, and a square, four-paned window at the gable.

Plate 18: East elevation of the South Barn

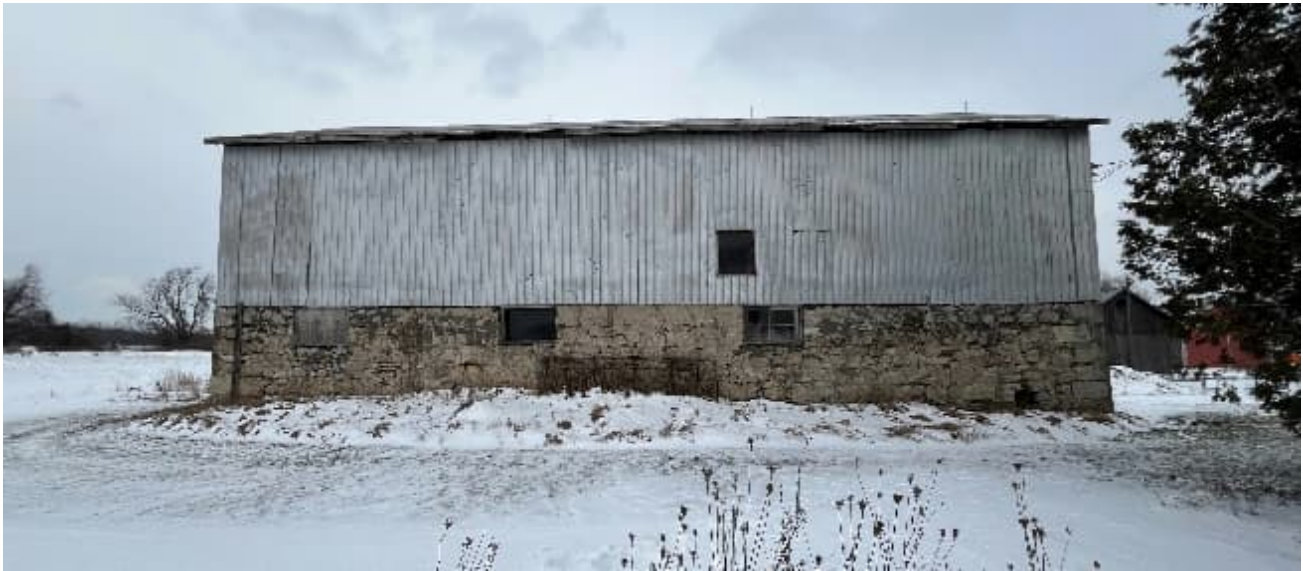
The south elevation foundation has lost much of its ashlar parging (Plate 19 and Plate 20) and has three, asymmetrically placed, wide windows on the foundation: one with four panes, one with a single pane (Plate 22), and one that is blind (Plate 23). Another window with a single pane is offset at the second level (Plate 21).

Plate 19: South elevation of the South Barn

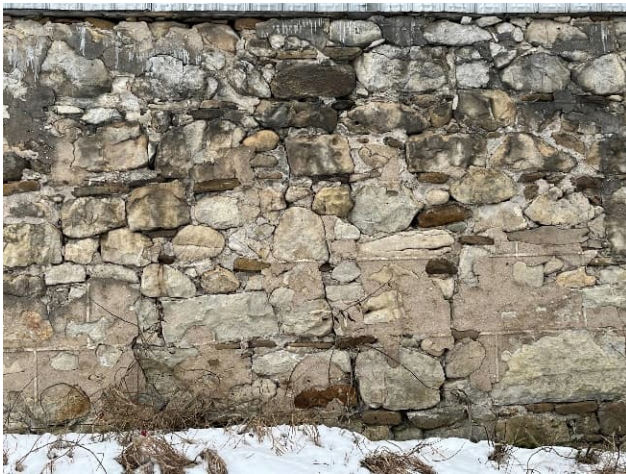
Plate 20: Partially parged fieldstone foundations

Item	Location	Condition	Salvage Opportunity
Fieldstone	South Barn and North Barn foundation as well as fieldstone walls lining the driveway and Mississauga Road	Good	The fieldstones appear to be in good condition and present an opportunity to be salvaged and used for other purposes as an alternative to being deposited as landfill.
Cut Stone Quoins	South Barn foundation	Good	The cut stone quoins in the south barn foundation appear to be in good condition and present an opportunity to be salvaged and used for other purposes as an alternative to being deposited as landfill.
Timber	Structural timbers in South Barn, Connecting Shed, North Barn, and Drive Shed	Good	A visual inspection of the structural timbers determined some splitting has occurred but overall, the timbers are in good condition. The timbers should be inspected during removal but overall present a good opportunity for salvaging. Those found to be in good condition can be retained and used for other purposes as an alternative to being deposited as landfill.

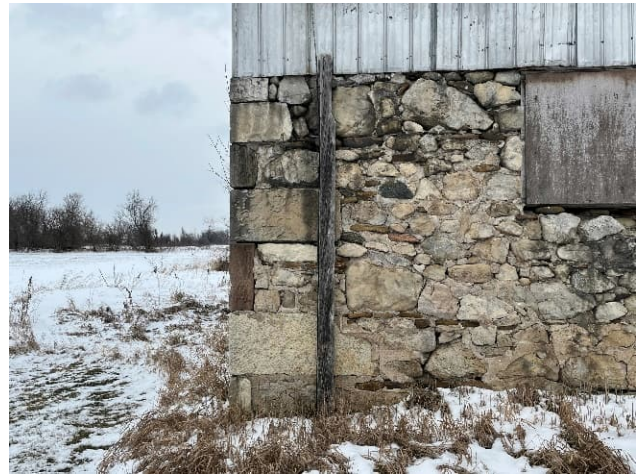
Plate 21: Cut stone quoining

- Fieldstone in South Barn and North Barn as well as along driveway and Mississauga Road
- Cut Stone Quoins in South Barn foundation
- Structural timbers in South Barn, North Barn, Connecting Shed, and Drive Shed
- Wood plank cladding on North Barn and Drive Shed
- Cut wood on South Barn, North Barn, and Drive Shed

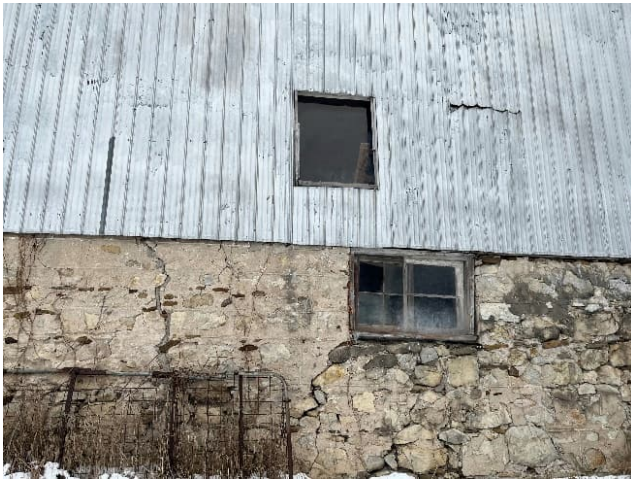
Plate 22: Windows of the south elevation

Item	Location	Condition	Salvage Opportunity
Windows	North Barn, South Barn, and Drive Shed	Poor	The majority of windows appear to be in poor condition with significant rotting in the wood frames and broken or missing glass. The windows do not present a viable salvage opportunity.

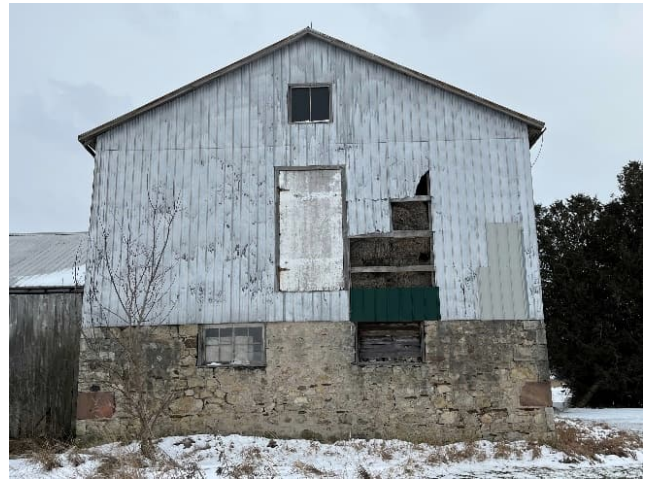
Plate 25: West elevation of the South Barn

The west elevation has two symmetrically placed and wide windows at the foundation, one with four-over-four panes and the other blind (Plate 24 and Plate 25). A door is centrally located at the second level and adjacent to it is an exposed section of framing. A two-pane window is centred at the gable (Plate 26).

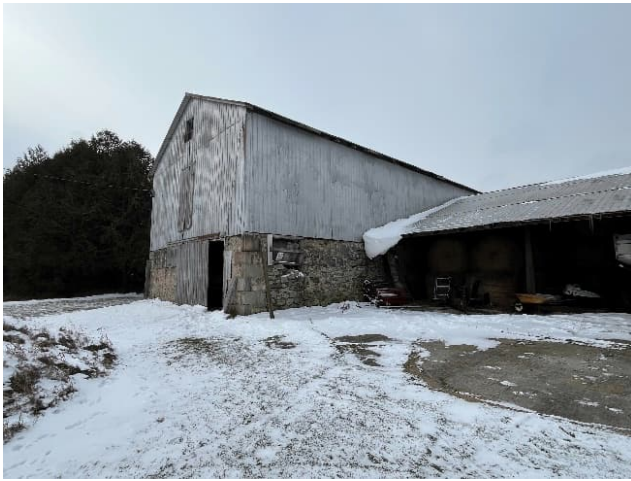
Plate 28: Oblique view of South Barn

The north elevation of the South Barn is partially obscured by the Connecting Shed (Plate 27). There is a blind window on the east side of this elevation, near the corner (Plate 28), and a blind entryway at the centre of the elevation underneath the Connecting Shed.

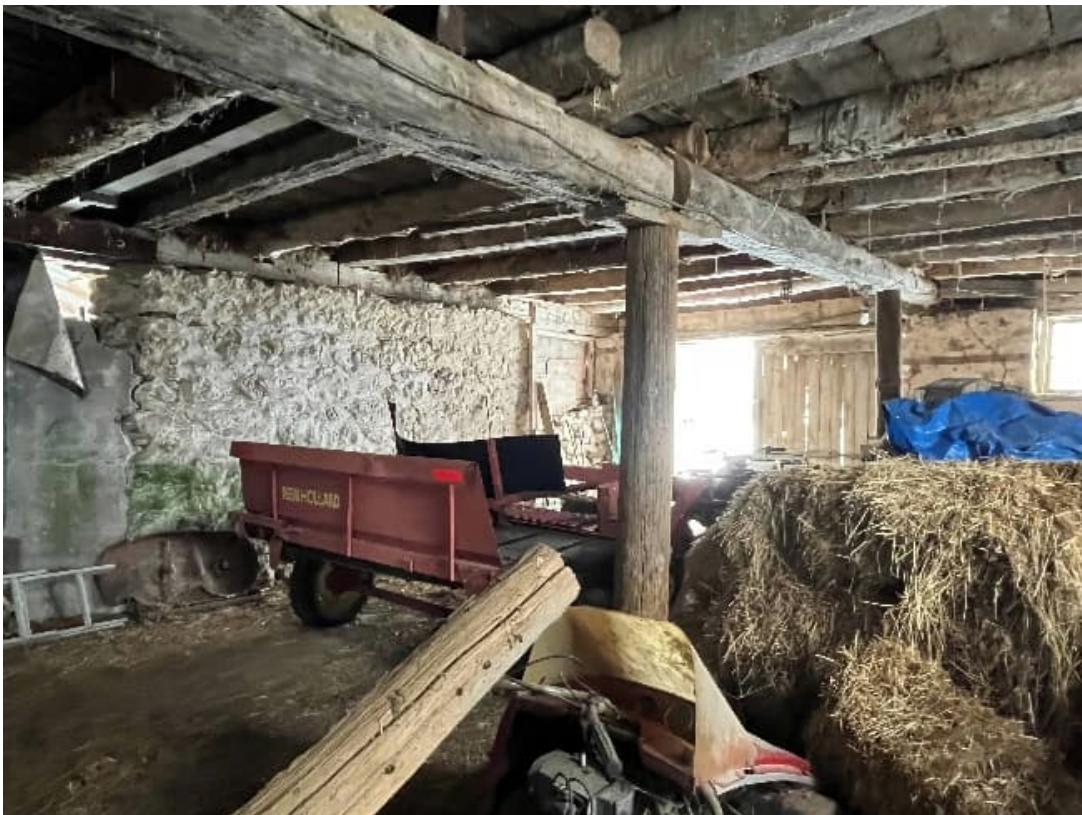
Inside the South Barn is an open area at the lower level used to store farm equipment and an open area in the upper level for hay storage (Plate 30). The timber framing in the lower floor ceiling comprises a hand-squared sill with redundant mortises (indicating it to be salvaged from another structure), central log beam running longitudinally and supported by log posts, and joists that are a mix of hand-squared (also with redundant mortises) and log (Plate 32, Plate 33 and Plate 34). On the south side of the interior is an opening with wooden ladder leading to the second level (Plate 33).

Plate 30: Lower level interior

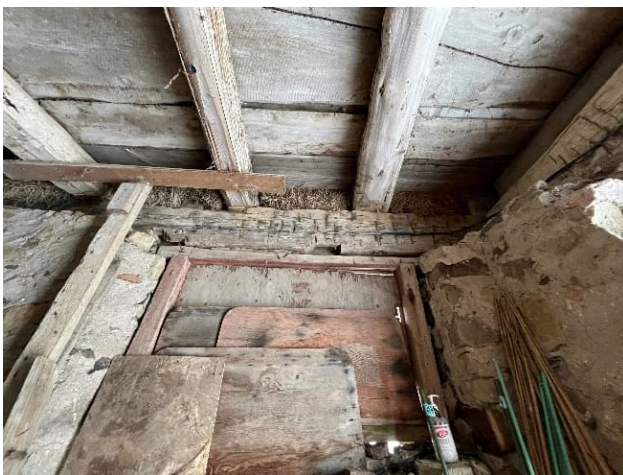
Plate 32: Hand-squared sill with redundant mortises supporting log joists

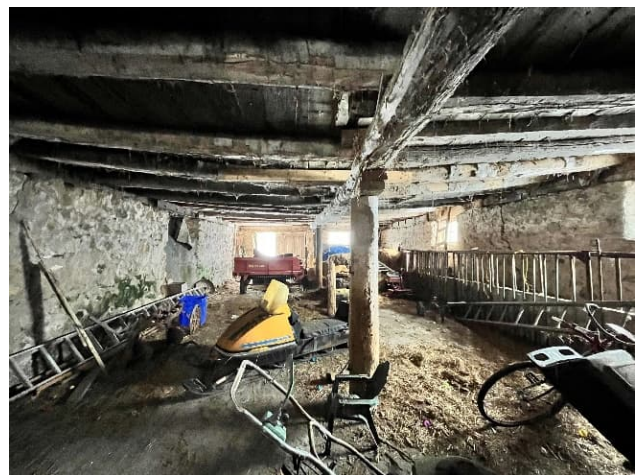
Plate 33: Longitudinal beam supported by posts

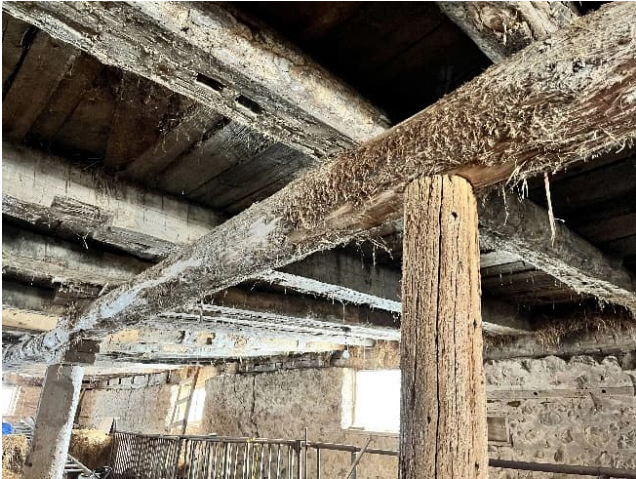
Plate 34: Redundant mortices in the hand squared joists

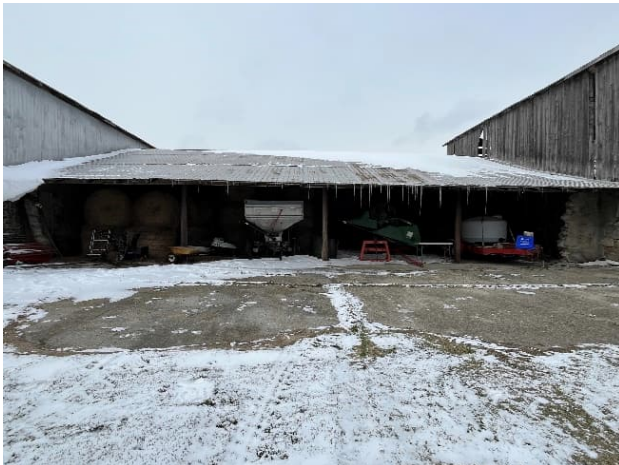
Plate 36: East elevation of the Connecting Shed

The Connecting Shed is used as a drive shed and is built with dimensional lumber and timber posts likely recycled from another structure. The Connecting Shed has a rectangular plan and measures approximately 12 m x 18 m. It has a metal-clad saltbox-type roof and is open on the east elevation (Plate 36 to Plate 39). Sections of stone walling within the Connecting Shed are remnants of the original two-level structure in this location (Plate 40 to Plate 43). There is no fenestration on the west elevation (Plate 42). The current Connecting Shed was constructed between the 1950s and 1970s.

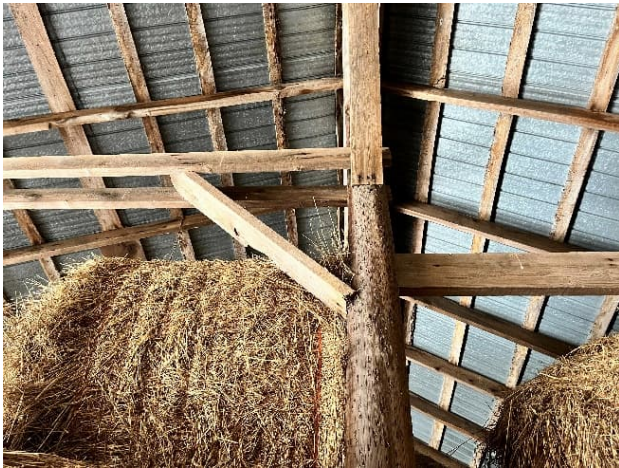
Plate 38: Recycled timber posts paired with dimensional lumber framing

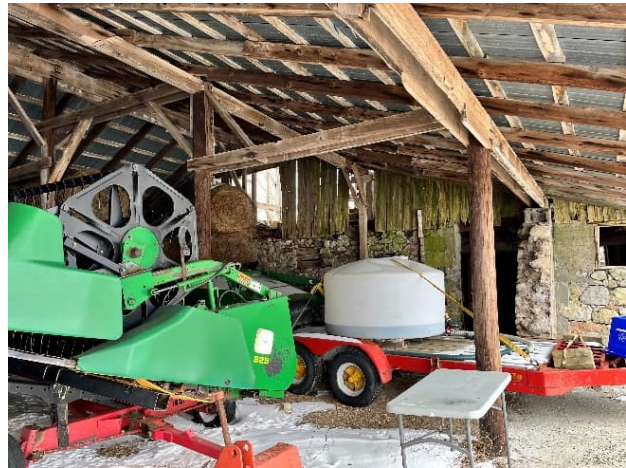
Plate 39: Wood posts and dimensional lumber framing

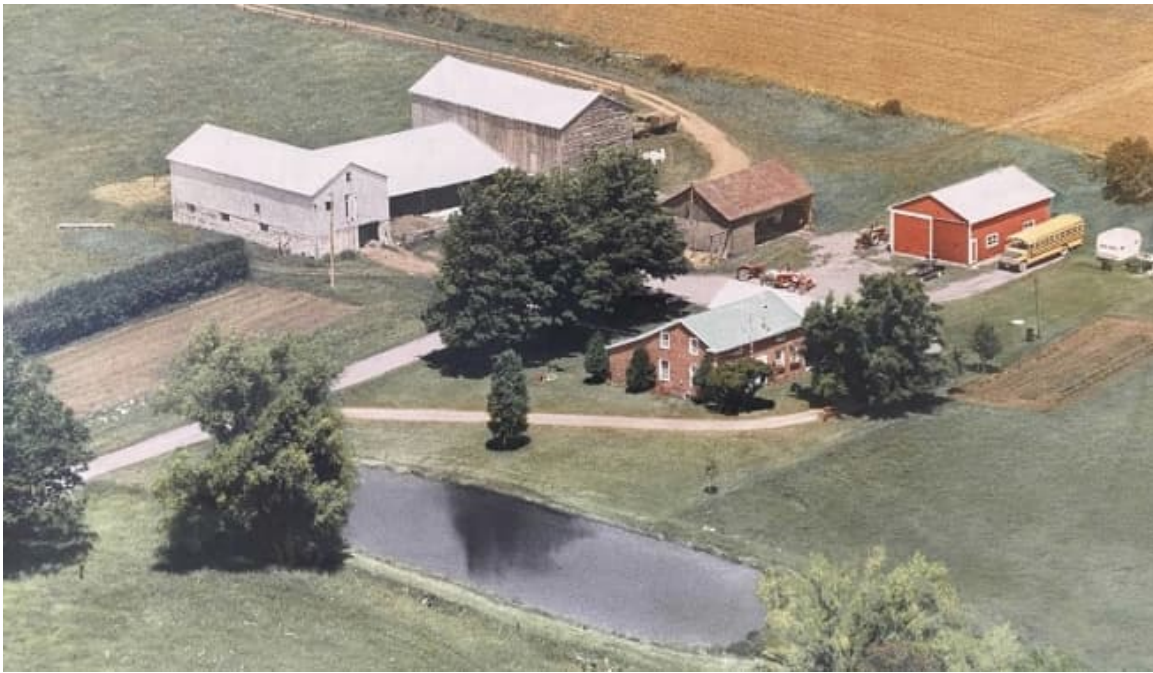
Plate 43: Photograph of the Study Area dating to the early 1970s showing the current one-level Connecting Shed

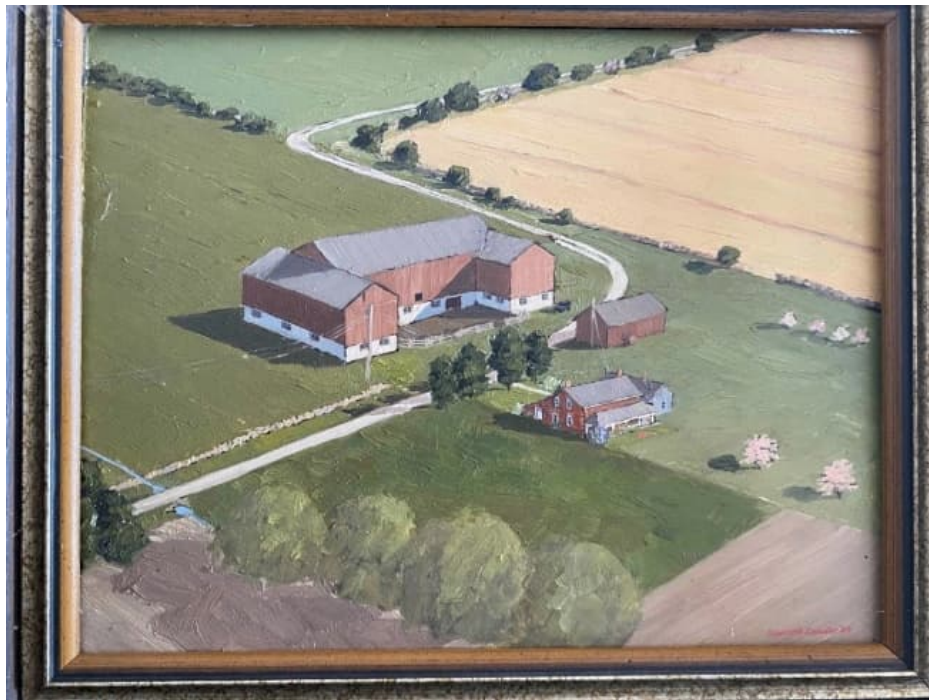
Plate 44: 1985 painting of the Study Area, based on photograph of the Study Area from the 1950s – note the two-level Connecting Shed

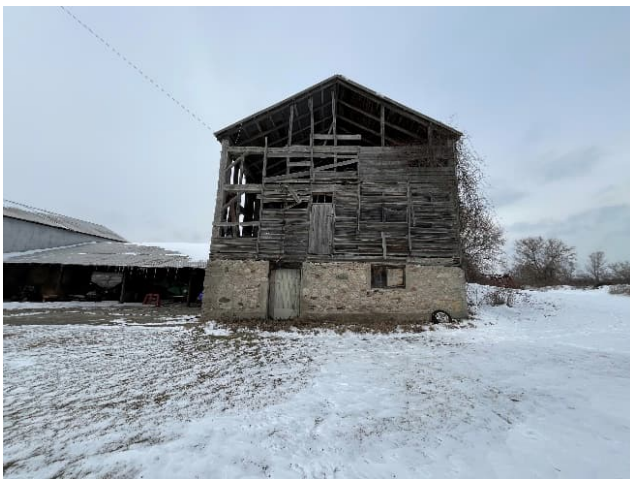
Plate 45: East elevation of the North Barn

The North Barn has a parged fieldstone foundation at the ground level and is timber framed with a front gable roof at the second level. The North Barn has a rectangular plan and measures 8.1 m x 18.9 m. Unlike the South Barn, the North Barn does not have cut stone quoins at the foundation and the parging is in concrete, and the cladding is in horizontal wood planking (where it survives). The North Barn is also slightly taller than the South Barn (Plate 45).

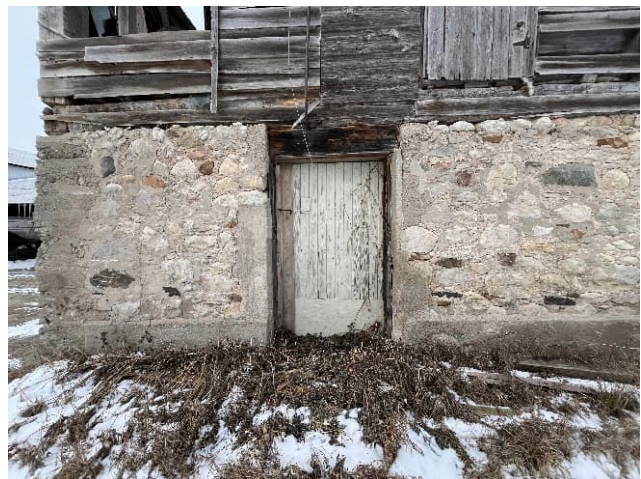
Plate 46: Entrance on the east elevation

The east elevation has an offset entrance with wood plank door (Plate 46) and wide blind window opening in the fieldstone foundation (Plate 47). At the foundation corners are large irregularly squared fieldstones (Plate 48).

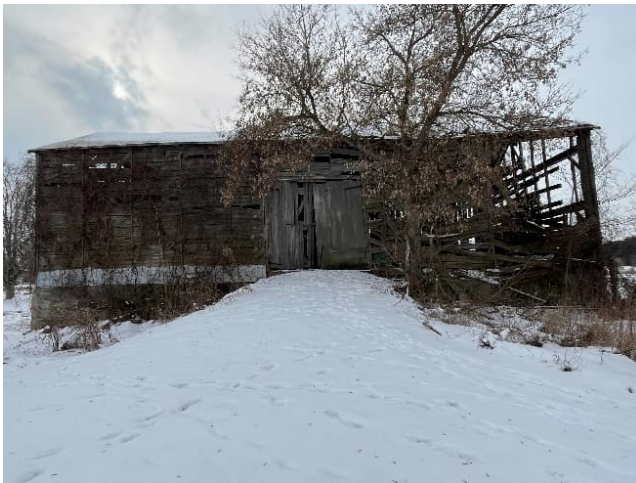
Plate 49: North elevation

The north elevation has an earth ramp that leads to the central bay doors (Plate 49, Plate 50, and Plate 51). The foundation parging here is concrete and has delaminated (Plate 52). There are two symmetrically placed wide windows in the west elevation foundation, both of which have lost their glazing. In the south window opening are paired windows, with one having two-over-two pane arrangement and the other having two-over-four (Plate 53, Plate 54, and Plate 55).

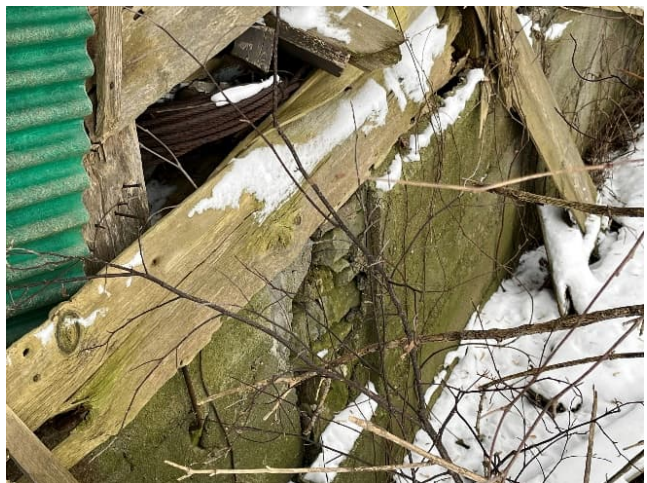
Plate 52: Delaminated concrete parging on the north elevation

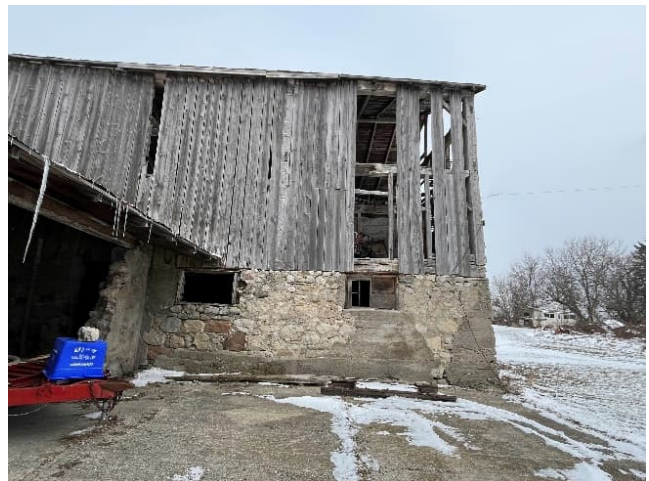
Plate 56: South elevation of the North Barn

Under the Connecting Shed (Plate 56) on the south elevation is an entrance to the foundation level of the North Barn, while to the east of the door are two window openings. Only the outer window framing survives in the opening nearest the Connecting Shed, while in the other is evidence that this opening initially had paired windows. A piece of plywood blinds the one paired window, but the vertical muntin and one horizontal muntin survive in the other window (Plate 57 and Plate 58).

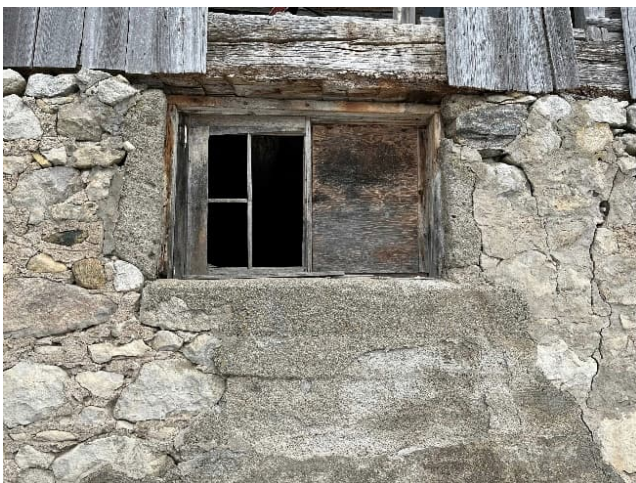
Plate 57: Partially blind paired window

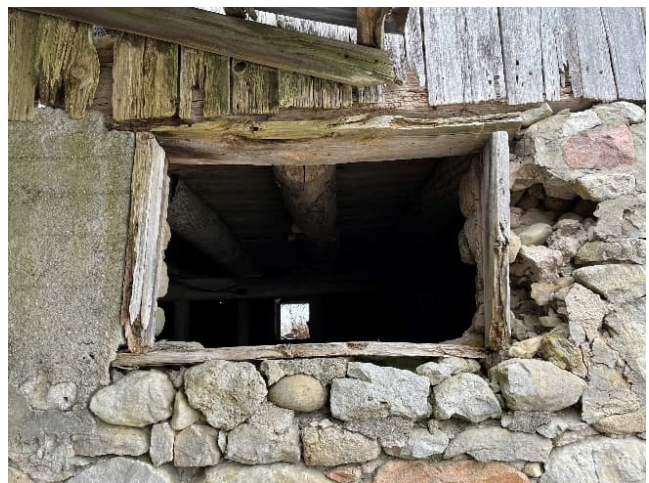
Plate 58: Wood framed window opening

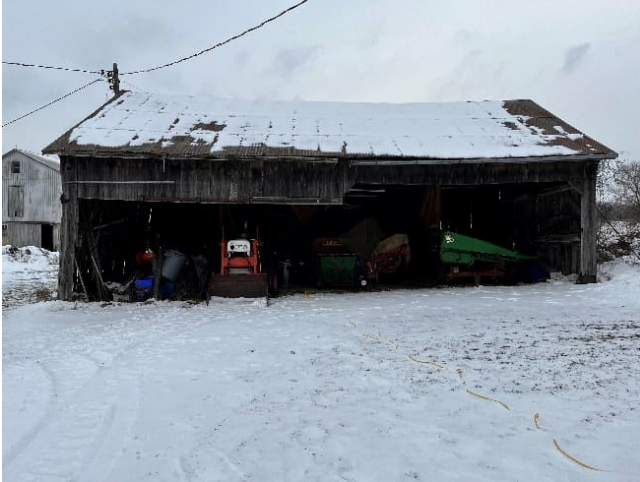
Plate 59: East elevation of the Drive Shed

East of the barn complex is the timber-framed Drive Shed (Plate 59 to Plate 62). The Drive Shed has a rectangular plan and measures approximately 7 m x 12 m. It has a gable roof with wide plank sheathing covered in corrugated sheet metal; some of the rafters are new wood (Plate 63). At the south gable is a diamond-shaped window (Plate 64) while on the north gable is a diamond-cross owl hole (Plate 65). The outline of the original opening to the drive shed is visible in the board-and-batten siding on the west elevation (Plate 66). The east side of the structure is an open bay.

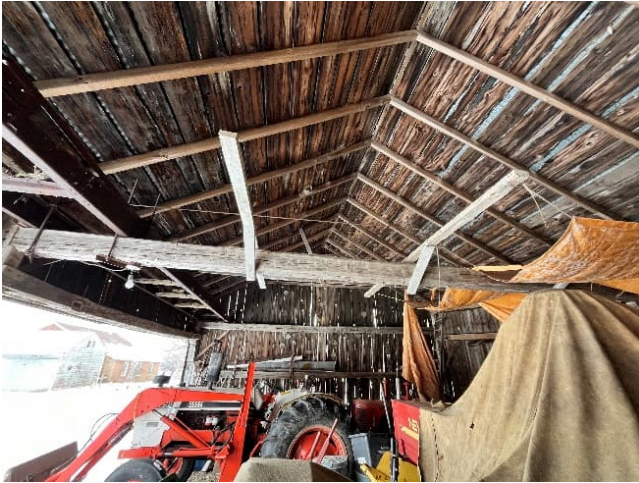
Plate 63: Wide plank sheathing on rafters

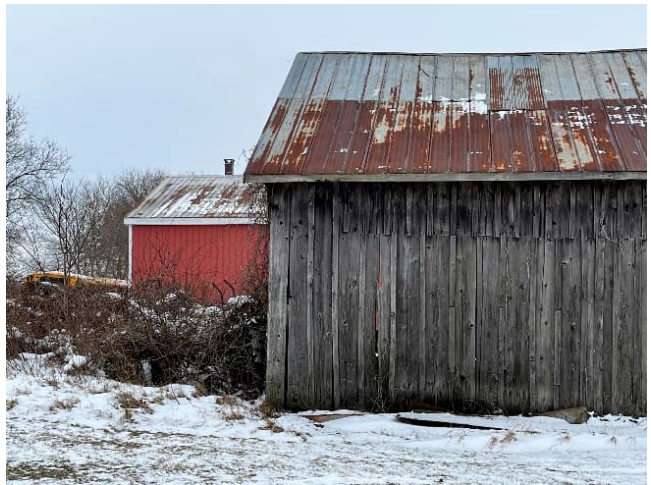
Plate 66: Outline of original entrance on west elevation

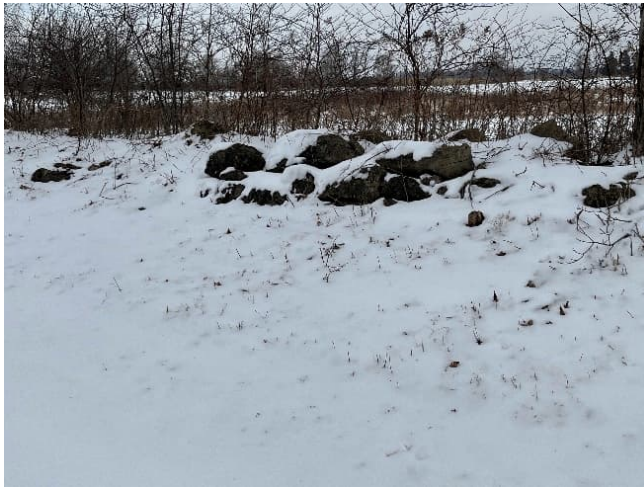
The landscape elements that contain CHVI are the low fieldstone wall that runs along either side of the driveway and the mature treeline along the driveway and ROW. The fieldstone wall was most likely constructed of stones picked from the nearby agricultural fields (Plate 67 to Plate 69). The mature tree line along the driveway and ROW acts as a windbreak (Plate 70 to Plate 72).

Plate 67: Portion of the fieldstone wall on the east side of the driveway
