HERITAGE IMPACT ASSESSMENT

18667 MISSISSAUGA ROAD, TOWN OF CALEDON, REGIONAL MUNICIPALITY OF PEEL, ONTARIO

PROJECT NO.: OCUL2216

UPDATED REPORT DATE: SEPTEMBER 18, 2025

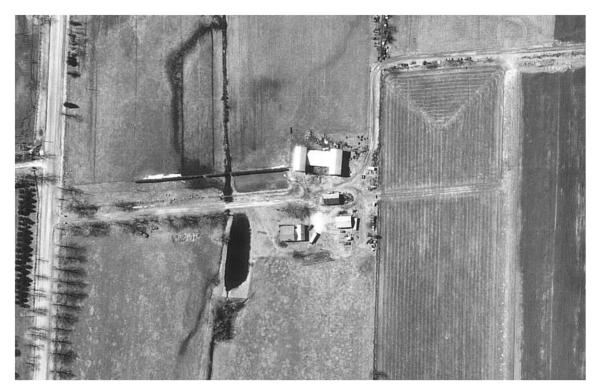
Plate 1: 1985 aerial photograph showing the Study Area

1985 (Plate 1)	Provided by the Town of Caledon	 The H-shaped barn configuration is visible Addition of a small pond at the front of the house
1994 (Figure 9)	1994 National Topographic System, Orangeville Sheet (Department of Energy, Mines and Resources 1994)	 Building complex shown in the same configuration as earlier mapping. "Airfield, Condition Unknown" labelled at the rear of the property. Associated landing strip is oriented approximately northwest-southeast through the Study Area.
2001-2022	Online Google Earth Aerial Imagery	 The configuration of the Study Area is little changed from the 1954 aerial photograph.

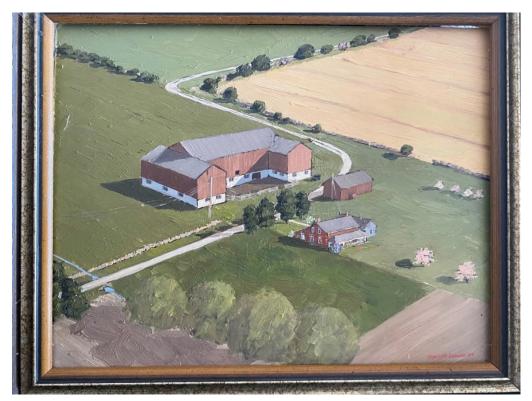
Plate 2: 1985 painting of the Study Area based on an earlier 1950s photograph (provided by the tenant)

In addition to historical mapping and aerial imagery, a painting of the Study Area and an oblique aerial photograph were provided by the current tenant (Plate 2 and Plate 3). Though produced in 1985, the painting of the Study Area was based on a 1950s photograph (Plate 2). The painting depicts the H-shaped barn comprising three Central Ontario style barns with gable roofs and the older outbuilding (identified as Outbuilding No. 1 in Section 4) is shown with an opening on the northwest elevation, towards the driveway. The house has a veranda on the north and east elevations of the house, and the summer kitchen is present north of the house. Additionally, the painting illustrates a laneway connecting to the adjacent property at 18722 Main Street.

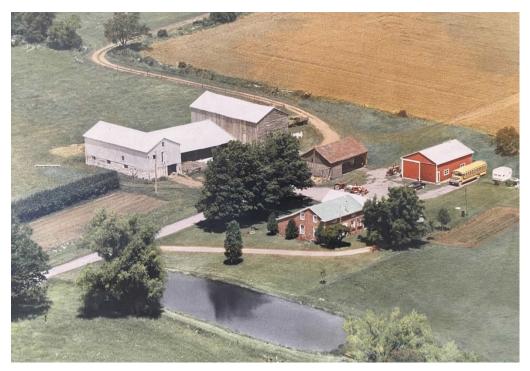
Plate 3: Oblique aerial photograph of the Study Area dating to the early 1970s (provided by the tenant)

The oblique aerial photograph dates to the 1970s (Plate 3) and indicates several changes had taken place since the 1950s: the centre barn in the barn complex was replaced, the southernmost barn was reclad, the east entrance to Outbuilding No. 1 was opened, a second outbuilding was constructed to the east of Outbuilding No. 1 (identified as Outbuilding No. 2 in Section 4), and the veranda on the east elevation of the house was dismantled.

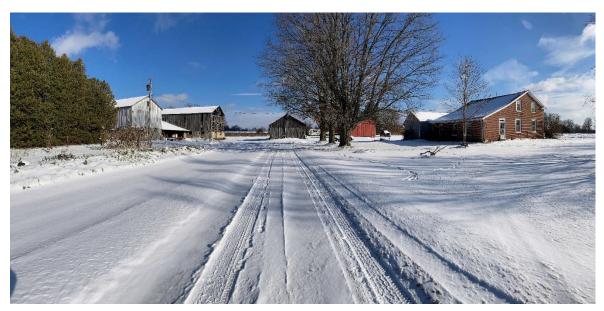
Plate 7: View from the driveway towards house, facing northeast

The farmhouse is accessed from Mississauga Road by a long gravel driveway that leads to the central building complex (Plate 7 and Plate 8). The driveway is bordered with mature treelines, which also extend along the north side of the road right-of-way (ROW) (Plate 9). Fieldstones have been collected and dry laid to create low walls that line the lower southern portion of the driveway as well as along the north side of the road ROW (Plate 10). A painting based on a photograph of the property dating to the 1950s shows that this fieldstone wall may have extended further in the past (Plate 2). Circulation routes link the building complex with the surrounding agricultural fields and the neighbouring property at 18722 Main Street. A small tributary of the Credit River traverses the property west of the farmhouse.

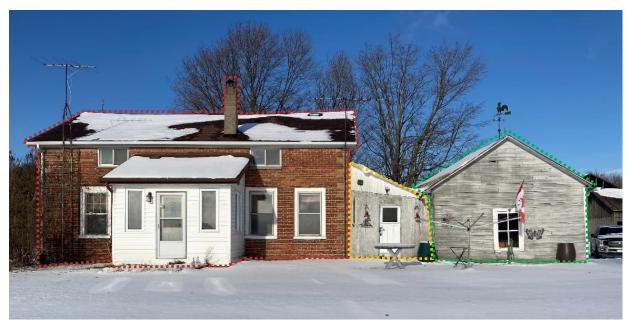
The farmhouse is composed of four elements: the original main block, rear addition, side passage, and summer kitchen. These are described individually in the following subsections. The four elevations of the structure are shown in Plate 13 to Plate 17. The house is oriented in a northeast to southwest fashion but for ease of description it is described as a north-south orientation; as explained below, the east elevation is the front or principal façade.

Plate 13: Front façade (east elevation) of the farmhouse, showing original main block (outlined in red), side passage (yellow), and summer kitchen (green).

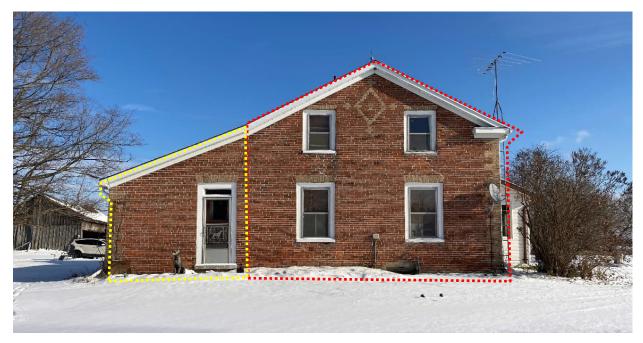
Plate 14: South elevation, original main block is outlined in red, rear addition is outlined in yellow

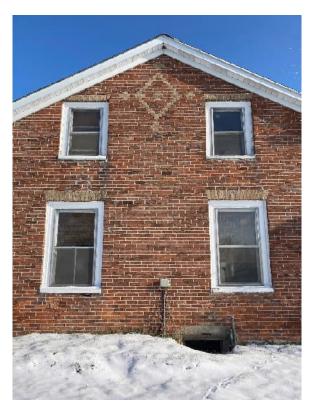
Plate 18: South elevation of main block

The original main block of the house is a one-and-a-half-storey structure with a rectangular footprint and a low gable roof with returned eaves. The red brick exterior has contrasting buff brick detailing in the form of quoins, flat arches, and a diamond cross motif in the south gable. That all of the masonry is laid in stretcher bond strongly suggests that the main block construction is wood frame with brick cladding. The foundations of the main block are parged field stone.

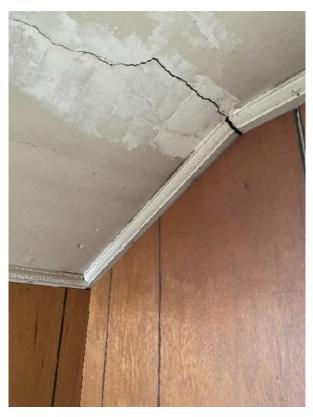
The southeast room is decorated with faux wood panelling and wallpaper on the walls and carpet over linoleum flooring (Plate 49). Both window openings (of the south and east elevations) appear to be original and in good condition (Plate 50 through Plate 52). Cracks and subsequent repairs are evident in the plaster of the ceiling (Plate 54).

Evidence of deterioration is present throughout the second floor of the main block. Peeling paint and wallpaper as well as cracks in the plaster of the walls and ceilings were noted in all rooms.

Plate 54: Cracks and repairs of southeast room

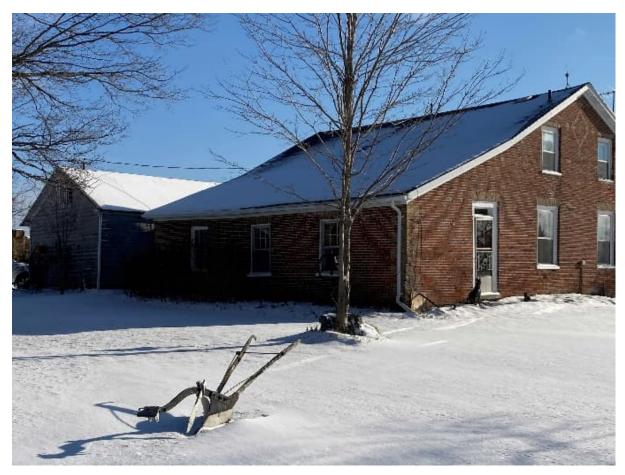
Plate 64: Oblique view of side addition

The one storey addition on the west elevation of the original main block is generally sympathetic in style and materials (Plate 64Plate 64). The shed roof of the rear addition creates a saltbox roofline for the entire structure. However, the brick masonry on this addition is clearly load bearing as it is laid in a common (also known as American) one-in-five bond. Buff bricks accent the window and door openings and quoins (Plate 65). The south elevation of the rear addition provides access with a doorway that is topped with soldier course buff brick voussoirs laid in a flat or jack arch and features a wood frame, plain trim, and a single, flat, rectangular transom window (Plate 67). A modern metal screen door acts as a storm door protecting a modern wood and glass door. A stone sill is present beneath the door. The west elevation includes three main floor windows, all six-over-six sash interior windows with painted wood trim and aluminum storm windows (Plate 68). All three window opening have a flat arch head of buff bricks in soldier course and a painted wood lug sill. One window, similar in materials and style, is now covered by the side passage but retains an original storm window (Plate 68). The rear addition has a stone foundation.

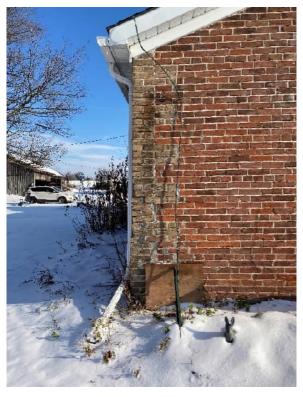
Plate 65: Detail of southwest corner, showing quoins

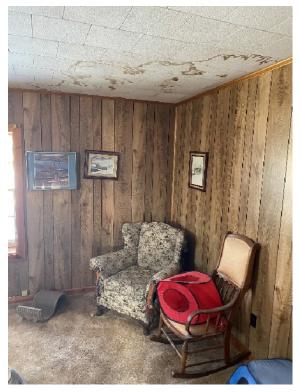
Plate 69: Rear addition living room

The living room has a tiled drop ceiling, faux wood panelling on the walls, and carpeted flooring (Plate 69 and Plate 70). There is a six-over six sash window on the west wall (Plate 71). The window has a wood frame and muntin that appear to be original. A new wood door provides exterior access on the south wall (Plate 70).

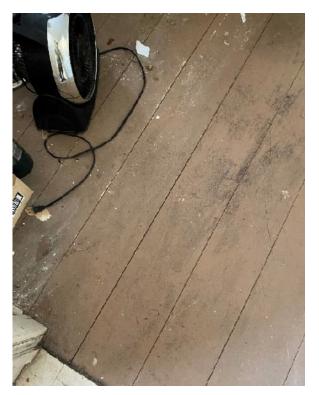
The storage room has painted wood floors, plaster walls (covered in wallpaper), and built-in wood cabinets on the east wall (Plate 72 and Plate 73). Two six-over-six hung windows are located on the west wall, both with wood frames (Plate 74). There is one six-over-six wood sash window on the north wall, looking into the side passage (Plate 75). There is a boarded-up window in the kitchen that acts as a nook on the west elevation of the original main block (Plate 76).

Plate 73: Wood floors of Rear addition storage room

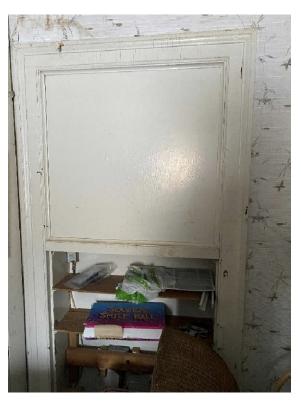
Plate 76: Former main block window as seen from rear addition

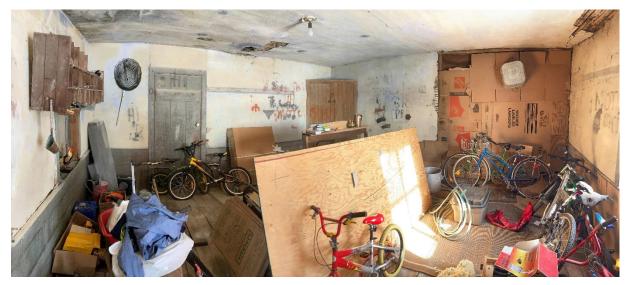
Plate 83: East storage room of summer kitchen

A summer kitchen is located north of the main block, connected to the house via the side passage, and is currently being used for storage. The summer kitchen is a simple rectangular gable wood structure clad in wood plank and with corrugated sheet metal roof cladding. The summer kitchen is constructed of hand-hewn timbers and consists of at least three bents. The summer kitchen has been partitioned into two rooms by a lath and plaster wall. The east room has been enclosed with a ceiling and has parged walls and horizontal wood plank wainscotting while the west half remains unfinished (Plate 83 and Plate 84). Both rooms have poured concrete flooring. The remains of a central brick chimney are present in the east half (Plate 85) There is a four-pane ground level fixed window centred on the east elevation of the structure and an upper level fixed window on the west elevation (Plate 17). The structure is constructed with hand hewn timbers and mortise and tenon joints (Plate 86). The lack of redundant mortises (unutilized and irregularly located mortise cuts) indicate the timbers are original construction and not built from recycled timbers. Wide plank sheathing on the rafters have been covered in corrugated sheet metal (Plate 87). While the rafters appear to have been replaced, the plank sheathing seems to be original. The boards' width and live edges indicate they were most likely first-generation logging in the area. Based on the massing, timber-frame construction, and some of the board sheathing dimensions, it can be assumed the summer kitchen was built in the 19th century, possibly not long after the main block was erected.
