CBM AGGREGATES

HERITAGE IMPACT ASSESSMENT

1420 CHARLESTON SIDEROAD, TOWN OF CALEDON,
REGIONAL MUNICIPALITY OF PEEL, ONTARIO

PROJECT NO.: OCUL2216

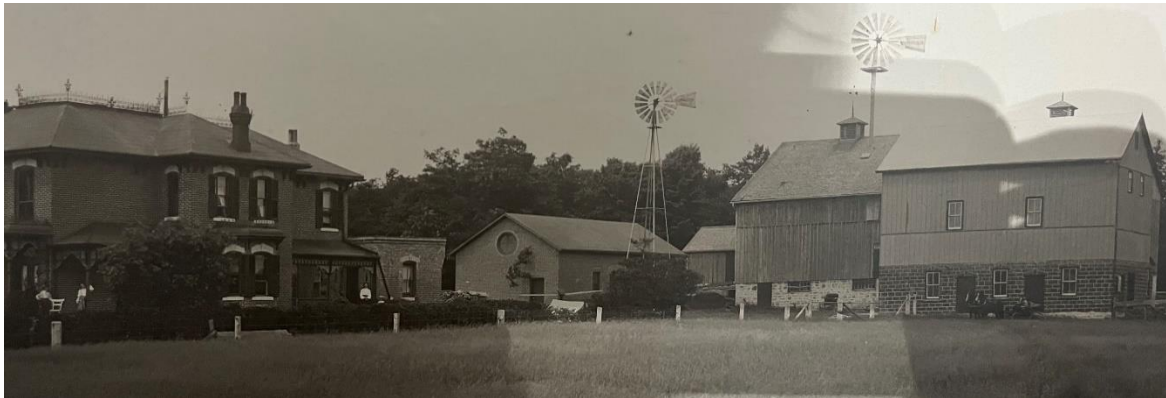
Plate 1: Historical photograph of the house and outbuildings, date unknown.

An undated photograph of the farm complex shows the house and several outbuildings, likely during the first decade of the 20th century (Plate 1). The two-storey brick house is seen as fully constructed, including a rear tail or summer kitchen. To the rear of the house is a single storey brick building with a gable roof and circular gable window. The stone foundation barn is partially visible at the rear of the property, clad with wood and featuring a gable roof with two cupolas and a weathervane. A smaller timber framed structure is seen in the background, between the barn and the brick outbuilding which appears to be of the same style and construction as the barn. It is unclear if this structure is freestanding or part of the barn. Obscuring the barn, to the north of the house, is a two-storey carriage house with stone foundations, brick masonry on the ground floor, likely load bearing, and the upper storey clad in wood, with a gable roof. The windows of the ground floor are accented with stone segmental arch heads and lug sills.

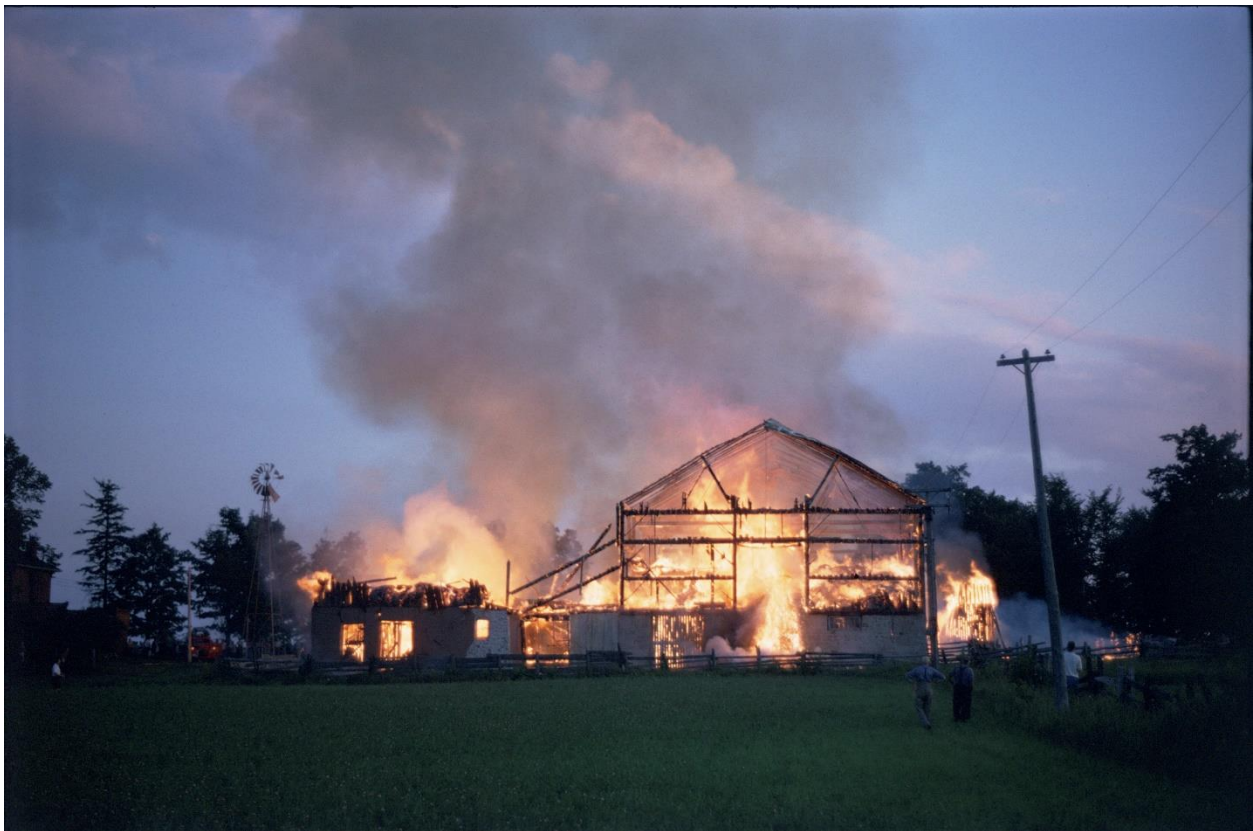
Plate 2: Barn fire, July 1964.

The barn with stone foundation, visible in Plate 1, burned down in July 1964 (Plate 2). Oral history from Carol Coulter Crews, who lived on the adjacent farm at 18473 Main Street, notes that only the tractor was saved from the Cameron barn fire, as it was in the garage (Caledon Heritage Foundation 2024). John H. sold the property in 1968 and died in 1973 (Find a Grave 2020). The property changed hands several times in the decades followed the Cameron's ownership before being sold to the current owner, St. Marys Cement Inc. in 2022. It appears that the Study Area was severed from the surrounding agricultural fields in the 1970s, as a reference plan dated May 20, 1976 shows a survey of the property boundaries in the same configuration as present-day.

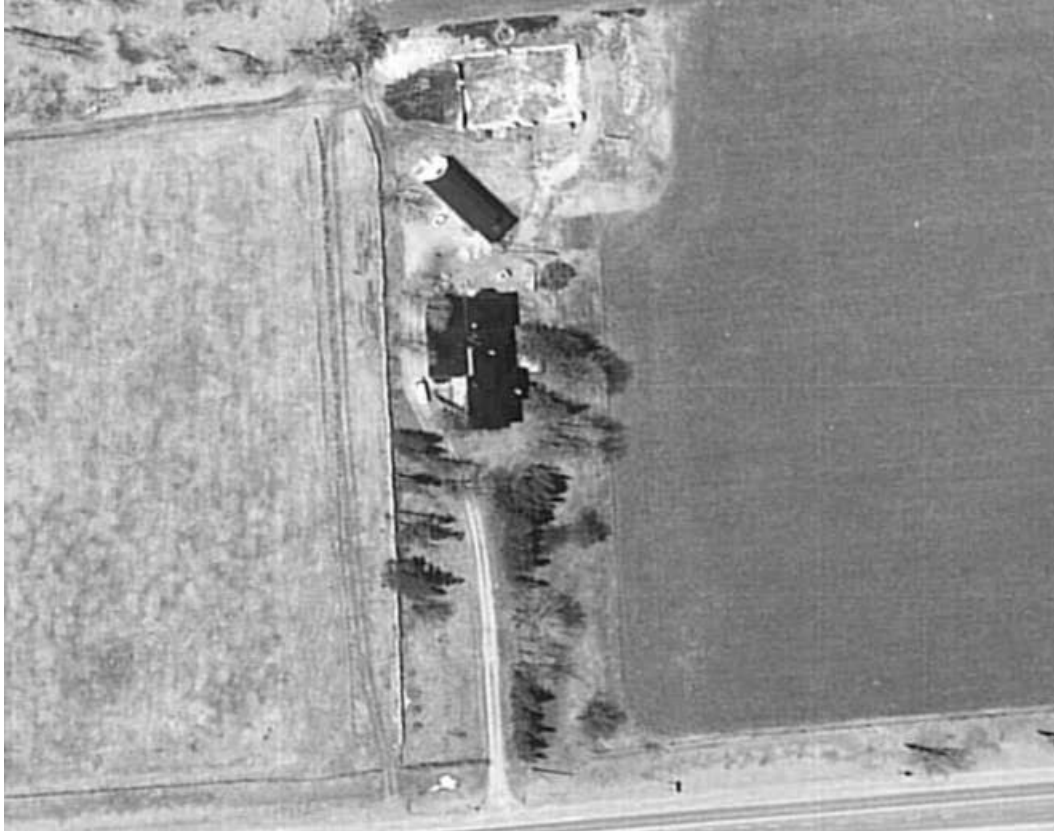
Plate 3: 1985 aerial photograph showing farm complex

An outbuilding at the rear of the Study Area is northwest of the house. It is oriented east-west and is wood clad with a gambrel roof (Plate 13). Based on aerial photographs and topographic mapping this building was constructed between 1973 and 1985 (Figure 6 to Figure 9 and Plate 3).

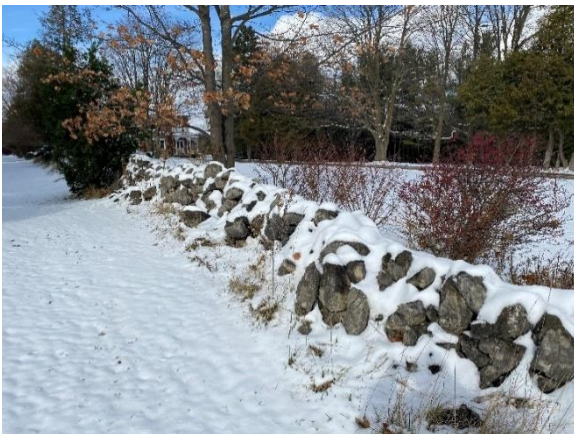
Plate 12: Low fieldstone wall along the southwest side of the Study Area

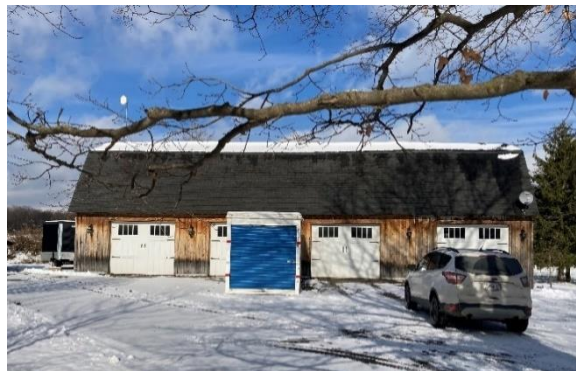
Plate 13: Late 20th-century outbuilding

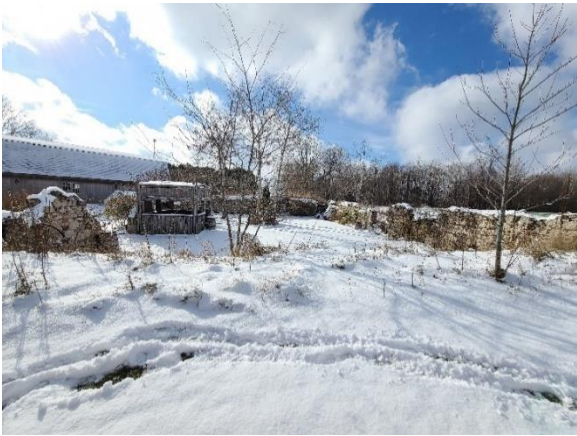
Plate 14: Barn foundation ruins, looking southwest

The parged fieldstone ruins of an earlier barn are also located at the rear of the Study Area and oriented approximately northeast-southwest along the northwest boundary (Plate 14). Etched into the parging is “G.A.C./H.R.C./J.H.C./MAYS(?)/190_/_8_”, likely the initials of George A. Cameron (G.A.C) and his sons, John H. Cameron (J.H.C.) and Hilton R. Cameron (H.R.C.), who would have been children at this time (Plate 15). It could not be determined whether this etching is part of the original construction or a later repair. It was noted during the site visit that a wooden covered area has been added to the ruins, featuring red brick flooring (Plate 14). This barn is visible in the early 20th-century photograph that shows the barn as a timber frame structure with a gable roof (see Plate 1) and burned down in July 1964 (see Plate 2). Gable roofed barns are often earlier than those build with a gambrel roof, although in this case we know from the engraving that the barn dates to the first decade of the 20th century, at the latest (McIlwraith 1997).

- 5 A Heritage Documentation Report and Salvage Plan shall be conducted for the property with a focus on the barn foundation ruins on the property.

- a Options should be explored which retain the barn foundation ruins. If the barn foundation ruins are retained in situ, a Heritage Documentation Report and Salvage Plan is not required.

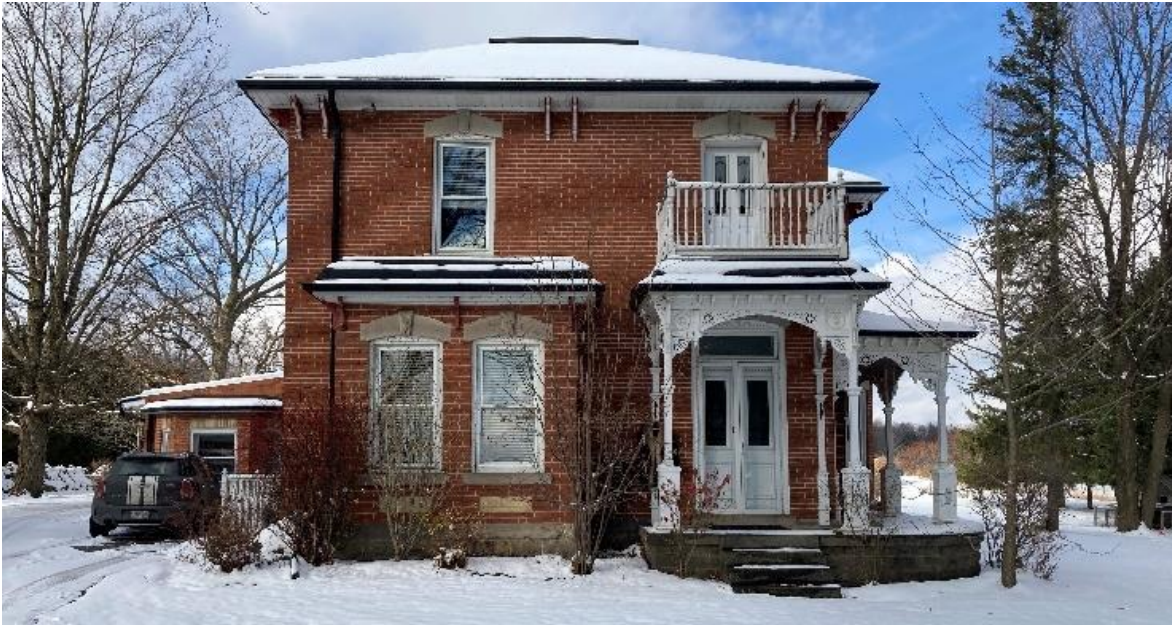
Plate 16: South (front) elevation, facing Charleston Sideroad

The farmhouse is composed of three elements: the original main block, a rear tail, and the rear and side addition on the north and west sides of the house. These are described individually in the following subsections. The four elevations of the structure are shown in Plate 16 to Plate 20. The house is oriented in a northwest to southeast fashion but for ease of description it is described in a north-south orientation where the south (front) elevation is on the southeast and the north (rear) elevation is on the northwest.

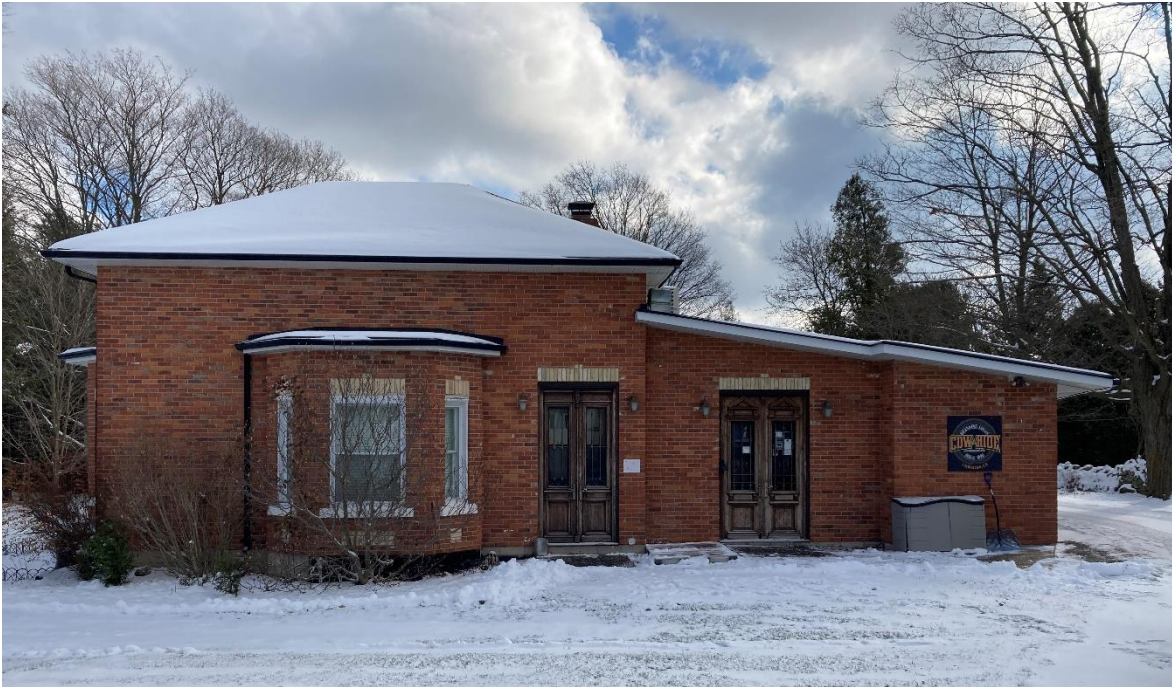
Plate 18: North (rear) elevation (rear and side addition visible only)

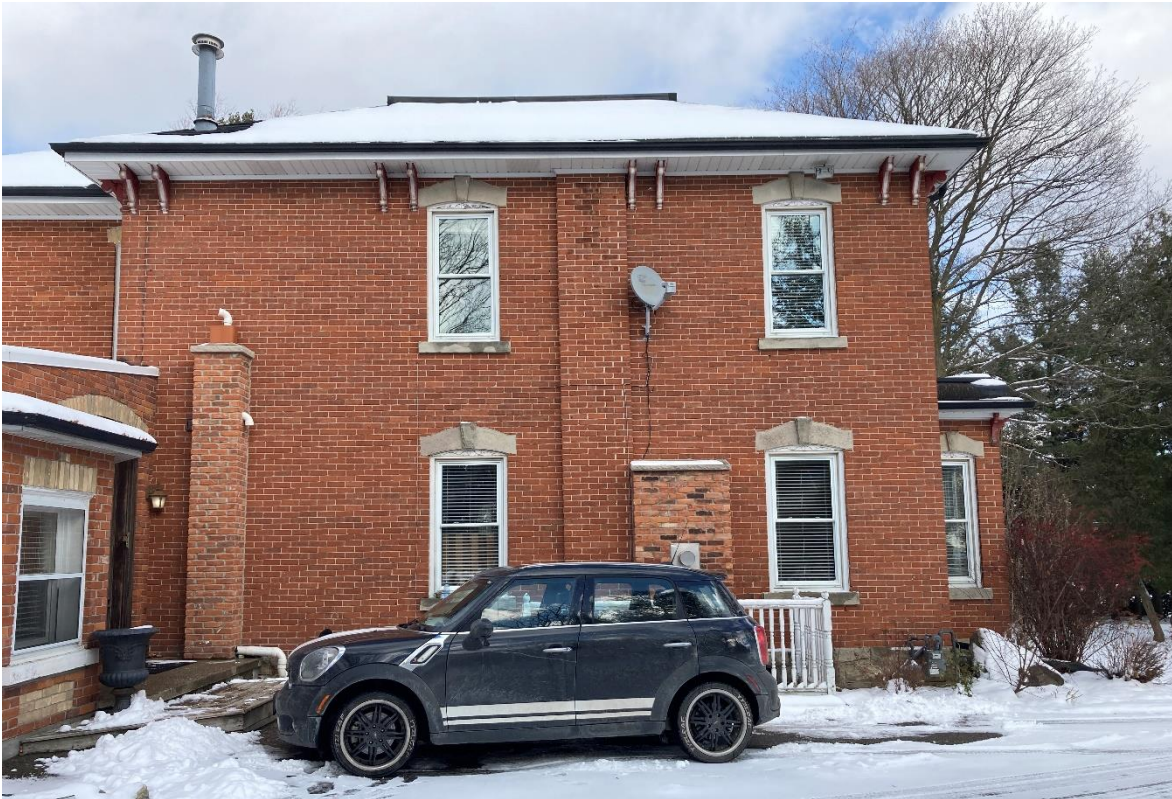
Plate 20: South portion of the west elevation of original main block

The historical photo of the house shows at least three chimneys on the main block. An internal chimney on the east elevation and external chimneys on the north and west elevations are no longer extant (compare Plate 21 to Plate 20, Plate 29, and to Plate 39). At the time of the field review, the west elevation features the original west elevation chimney, as well as two external vents that extend the height of the first storey and are constructed of brick masonry (Plate 20 and Plate 38). Neither of the two external vents date to the original construction of the main block.

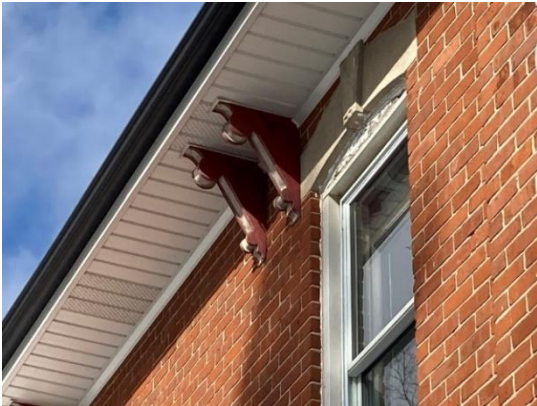
The original main block is a two-storey, red brick, Italianate-style farmhouse with an irregular footprint and a low-pitch truncated hipped roof clad in asphalt shingles. The original metal cresting is no longer extant (see Plate 1). At the roof's projecting eaves are decorative paired brackets on all elevations (Plate 22). The main block stands on an ashlar stone foundation, three courses of which are visible on the exterior, and the topmost course of stone has chiselled margins (Plate 24). The red-brick walling, laid entirely in a stretcher bond pattern, suggests that the house is frame construction with brick veneer; however, given its high quality, the masonry could also be load-bearing, with the inner and outer wythes connected with metal ties.

Plate 22: Overhanging eaves and paired bracket detail

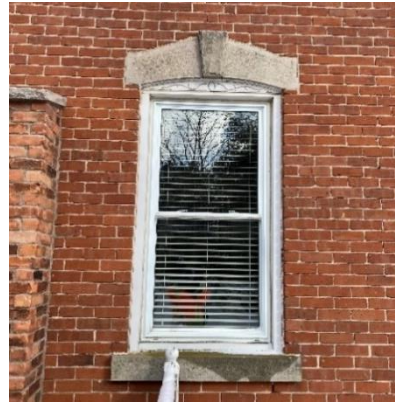
Contrasting with the red brick are the stone segmental arch heads and lug sills of the window and door openings. The stone heads have central and projecting "keystones" while the lug sills are bush hammered with chiselled margins (Plate 23). Generally, the windows of the main block are identical in style and materials except for the second storey windows on the west elevation, which have buff brick arched heads that may be a repair or replacement for the stone heads (Plate 37). Some windows were wood, double-hung and protected by storms, but others have been replaced in vinyl, including those at the foundation level on the west elevation. A 2022 home inspection report notes that some of the wood windows have not opened for many years and are seized (Home to Home Inspections Ltd. 2022).

Plate 23: Main block window example

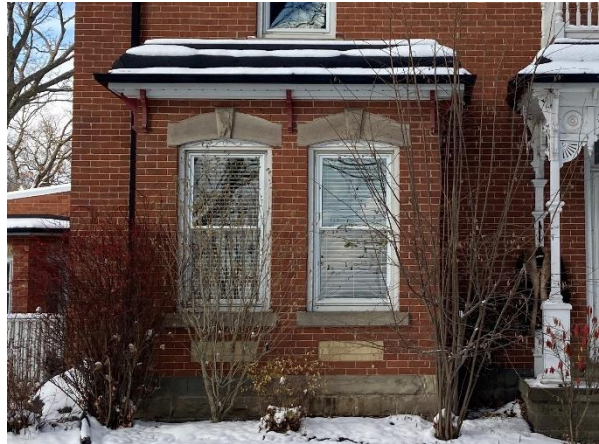
The south elevation features a box bay window with mansard roof and paired brackets (Plate 25). Four windows are on the bay, one narrower window on either side and a pair matching the remaining windows of the main block on the face, all with the same decorative elements (decorative stone heads, decorative arched wooden frames, and stone lug sills) (Plate 26). The paired windows on the face are accented further by recessed buff brick panels below each window.

Plate 25: South elevation box bay window

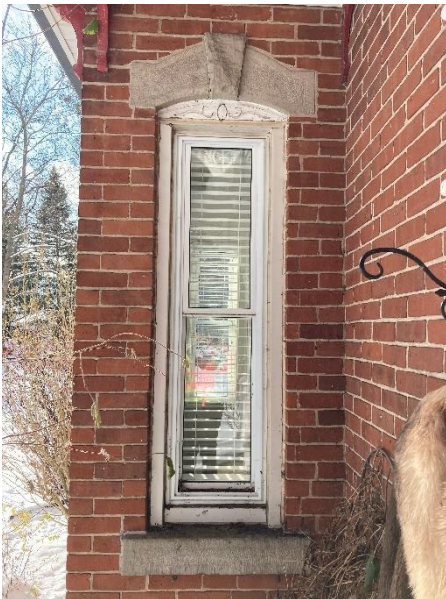
Plate 26: Detail of box bay side windows

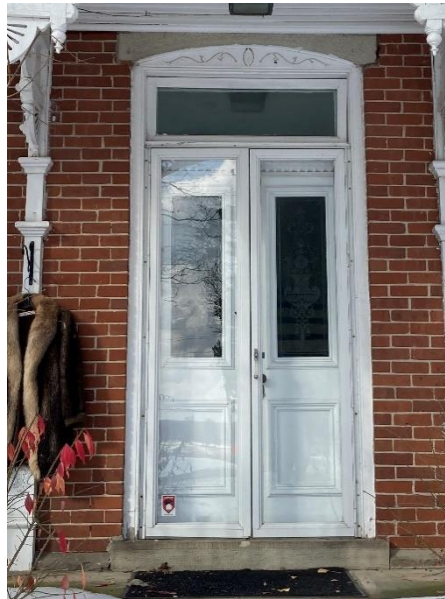
The main entrance on the south façade has a double door with flat transom (Plate 27). The doors are protected by double storms and hung within a wooden frame topped with the same decorative arched head and decorative stone arch and sills as the windows. Although the transom lights appear to date to the main block's original construction, the storm doors are modern replacements. It was unclear based on exterior view alone whether the interior doors are also recent replacements.

Plate 27: Main entrance doorway (south elevation)

Access to the main entrance is via a porch that wraps around the south and east elevations, extending from the main entrance on the south elevation to the "tower" element of the east elevation (Plate 27). Its stone foundation is continuous and extends the length of the porch (Plate 28 to Plate 30). Two roofs cover the porch, one for the portion on the south elevation and one for the east elevation. The south porch has a mansard roof with second-storey door, which is also visible in the historical photo (compare Plate 21 to Plate 16 and Plate 29). The east porch features a hipped roof, the underside of which is bellcast (Plate 31). Both porch roofs are accented with decorative paired brackets and supported by wooden arcades with square posts featuring decorative scrollwork and filigree accents (Plate 32 to Plate 33).

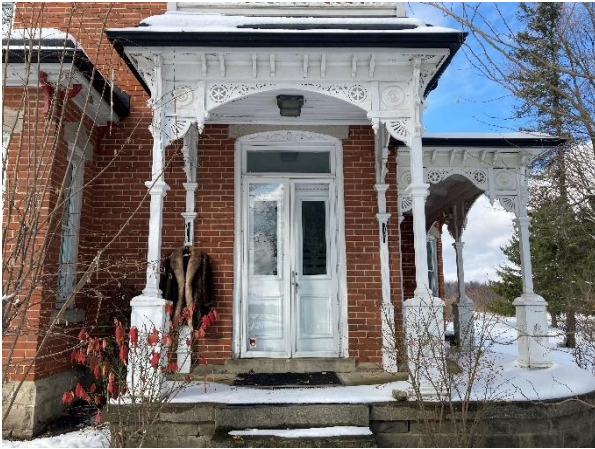
Plate 28: Main entrance porch

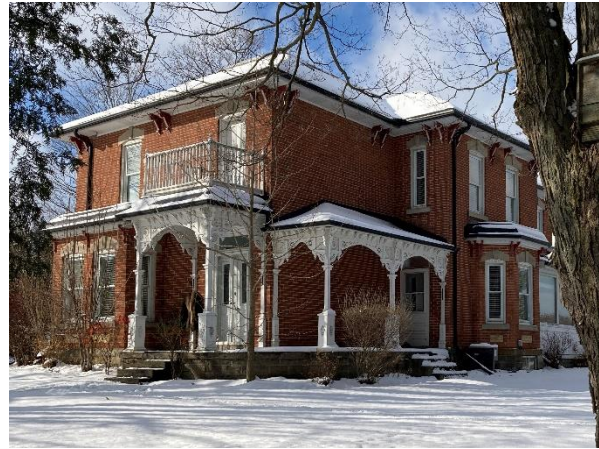
A second, canted bay window projects from the east elevation of the two-storey frontispiece that stands the full height of the main block and is topped by a hipped roof (Plate 29). This "tower" element is distinct to the Italianate style. This east bay features a mansard roof with paired brackets and three windows with the same stone heads and sills as seen throughout the main block, as well as recessed buff brick panels below the windows (Plate 35). The main block's east elevation also has an enclosed porch or sunroom that is set between the "tower" element and the rear tail to the main block (Plate 36). This porch was originally open but has since been enclosed (Plate 21). Photographs of the interior of the porch from the 2022 home inspection report suggest that portions of the structure date to the main block's initial construction and its roof is bellcast.

Plate 29: Side porch

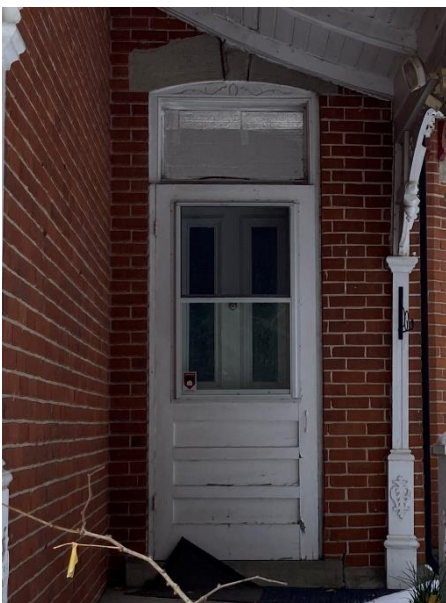
Plate 34: Second entrance to the house adjacent to the bay window on the east elevation

A second entrance to the house is located at the north terminus of the porch, on the south side of the east elevation's frontispiece or projection (Plate 34). The entrance is single leaf and similar in style to the main entrance in that it also features a flat transom, a storm door, and segmental arched head. The storm door is glazed with a large opening over three horizontal panels. This style of door is similar to the "five-cross-panel door" popular in the late 19th-to-early 20th centuries (Garvin 2001). It is likely that this storm door is original to the main block's construction, though the window appears to be a later addition. The transom was covered at the time of the site visit. On the west elevation is basement access, a modern addition built in cast-in-place concrete (Plate 38).

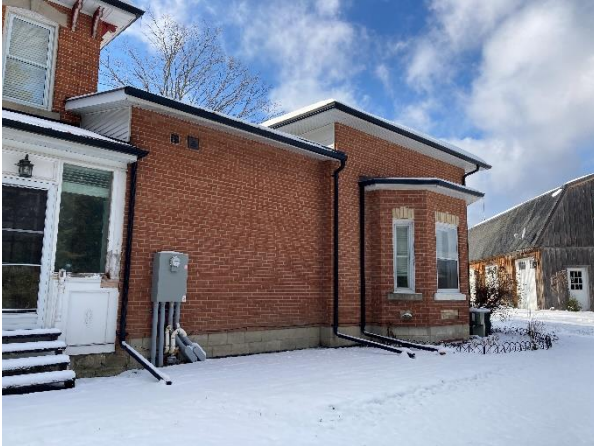
Plate 40: East elevation of rear tail, with rear addition visible on the right

Connecting the north elevation of the main block to the rear and side addition is the one-storey rear tail with a shed roof (Plate 40). This is probably the same rear addition seen in the historical photo, but has been reclad and the east elevation window in-filled (Plate 21). The structure may have been a summer kitchen for the main block and, like the latter structure, its stretcher bond brickwork indicates either brick-clad frame or double-wythe brick walls connected with masonry ties. The brickwork matches that of the rear and side addition and visible foundations appear to be cement block.

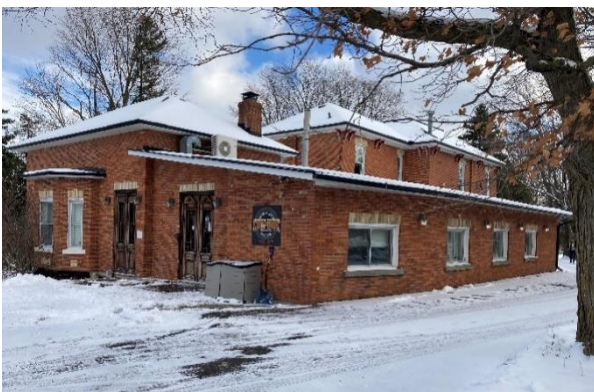
Plate 41: Perspective view of the north and west elevations of rear/side addition

The rear and side addition is comprised of two segments, both built in modern red brick laid in stretcher bond on cement block foundations. Based on their similar style, materials, and condition, these rear and side structures were likely constructed at the same time and so are discussed together. The rear structure has a square footprint and hipped roof while the side portion has a shed roof and extends along the west sides of the rear addition, rear tail, and main block (Plate 41).

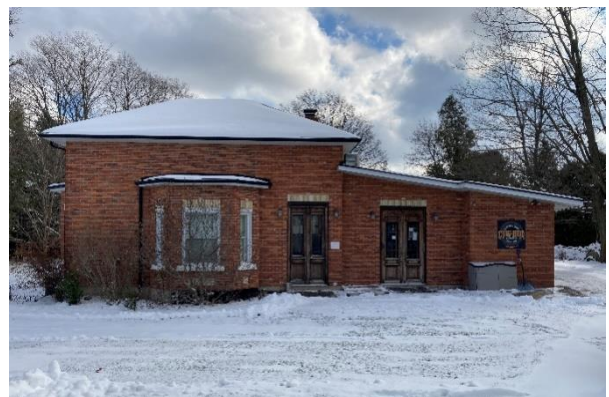
Plate 42: North elevation of rear/side addition

On the rear addition are canted bay windows on the north and east elevations, each of which has three windows with soldier course, buff-brick voussoirs laid in a flat arch at their head, painted stone lug sills, and buff brick niches below the windows (Plate 42 to Plate 44). A brick chimney is located inside the southwest corner.

Two entrances are on the north elevation, one for both the rear and side segments. Both entrances feature wood double doors with the same buff brick heads as the bay windows (Plate 42). A third entrance on the south elevation of the side addition is similar to the north elevation entrances, with the buff brick heads arched rather than flat (Plate 45). The south entrance also has a single-leaf door flanked by two side lights. Four square-shaped and sliding sash windows are on the west elevation of the side addition, also with buff brick heads but with stone lug sills that are bush hammered with chiselled margins (Plate 46). A bay window, similar in style to north and east elevations of the rear addition, is positioned on the south elevation, next to the entrance.

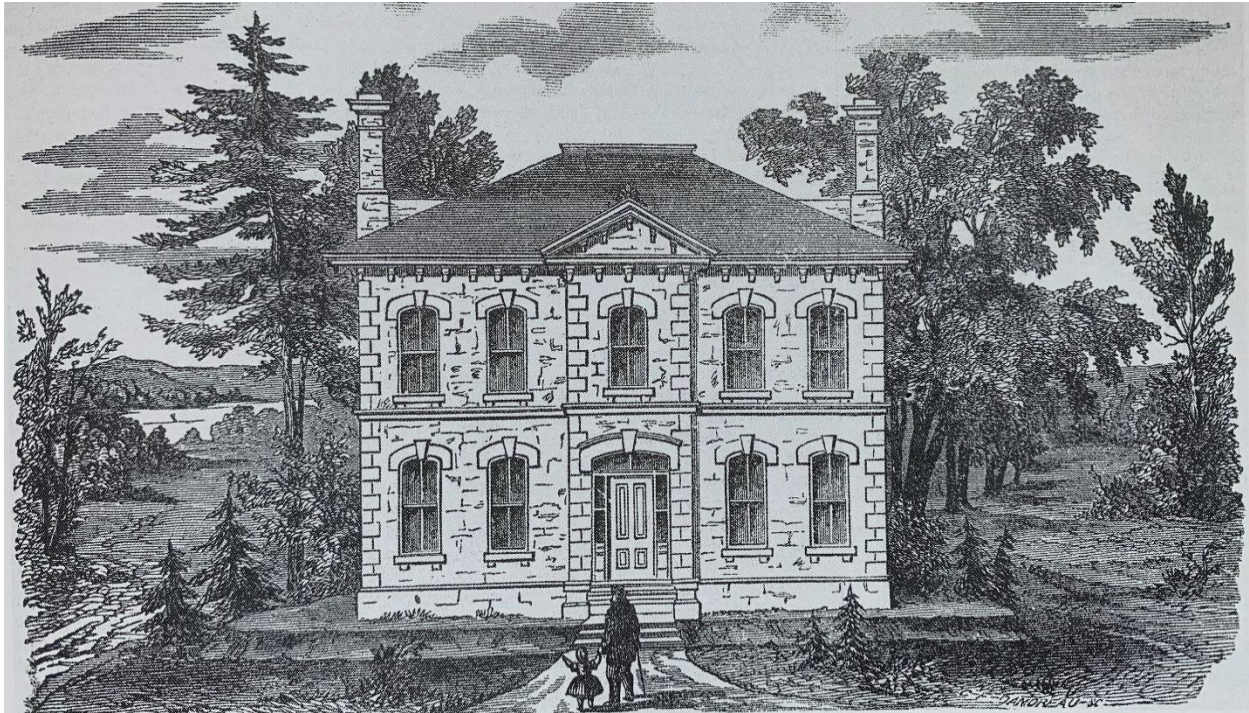
Plate 47: Italianate style model house from 1865 The Canada Farmer Journal (Blumenson 1990)

The house in the Study Area displays some architectural features characteristic to the Italianate style, such as the simple form with hipped roof, symmetrical façade with offset entrance, projecting frontispiece on the side elevation, projecting eaves with brackets, brick and stone accents (window cornices, sills, foundation) which create a dichromatic effect, carved stone window heads with keystones, and wooden arcaded porch.
