REPORT

Water Report Level 1/2

Proposed Caledon Pit / Quarry

CBM Aggregates, a division of St. Marys Cement Inc. (Canada)

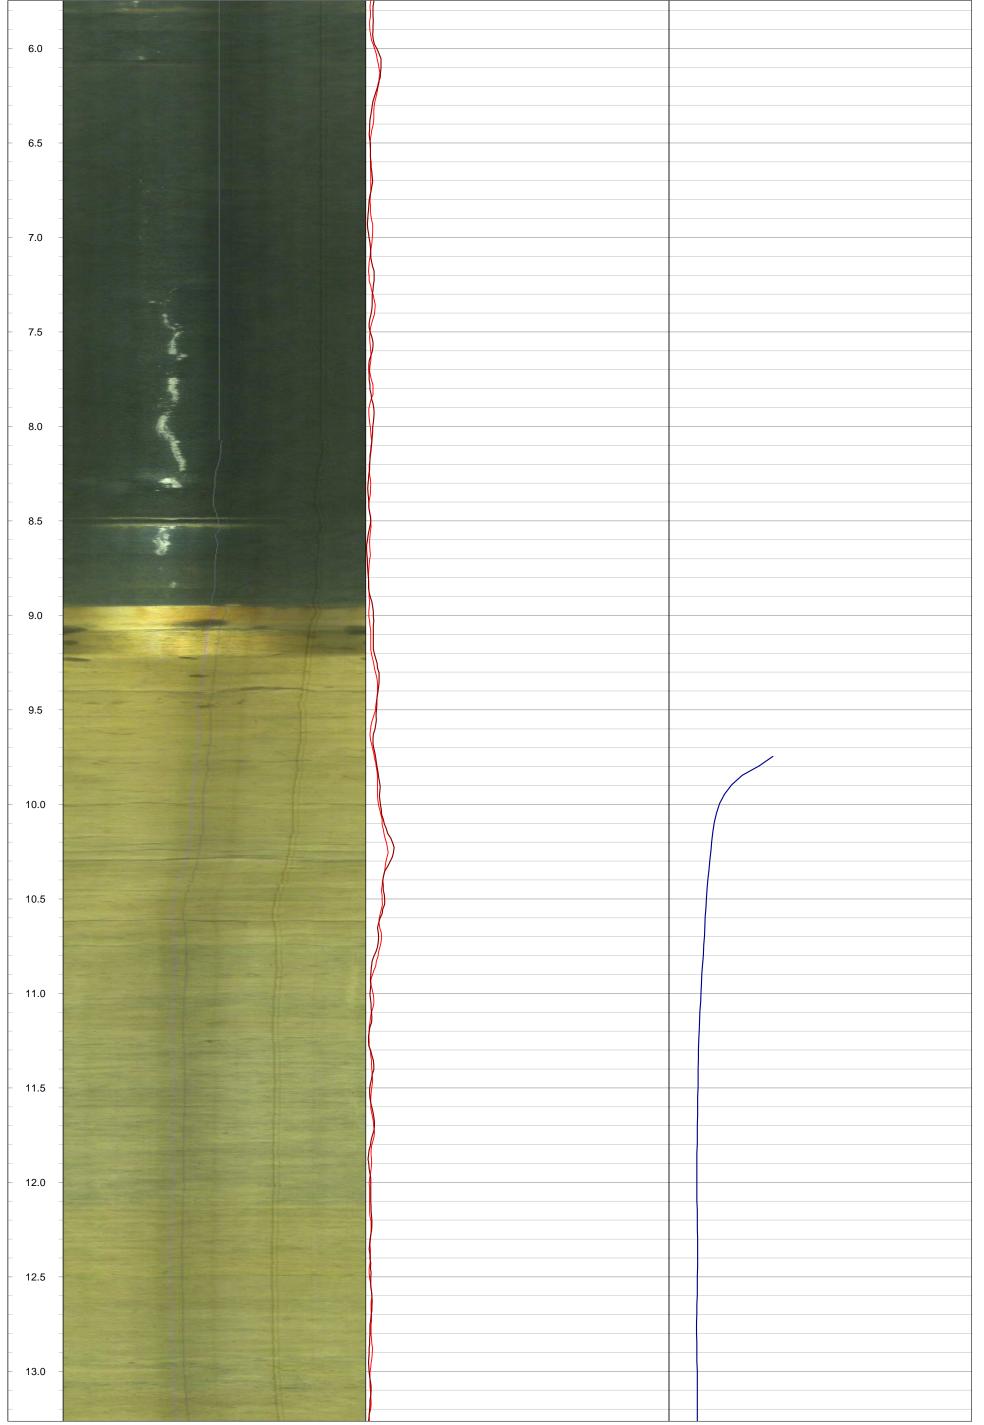
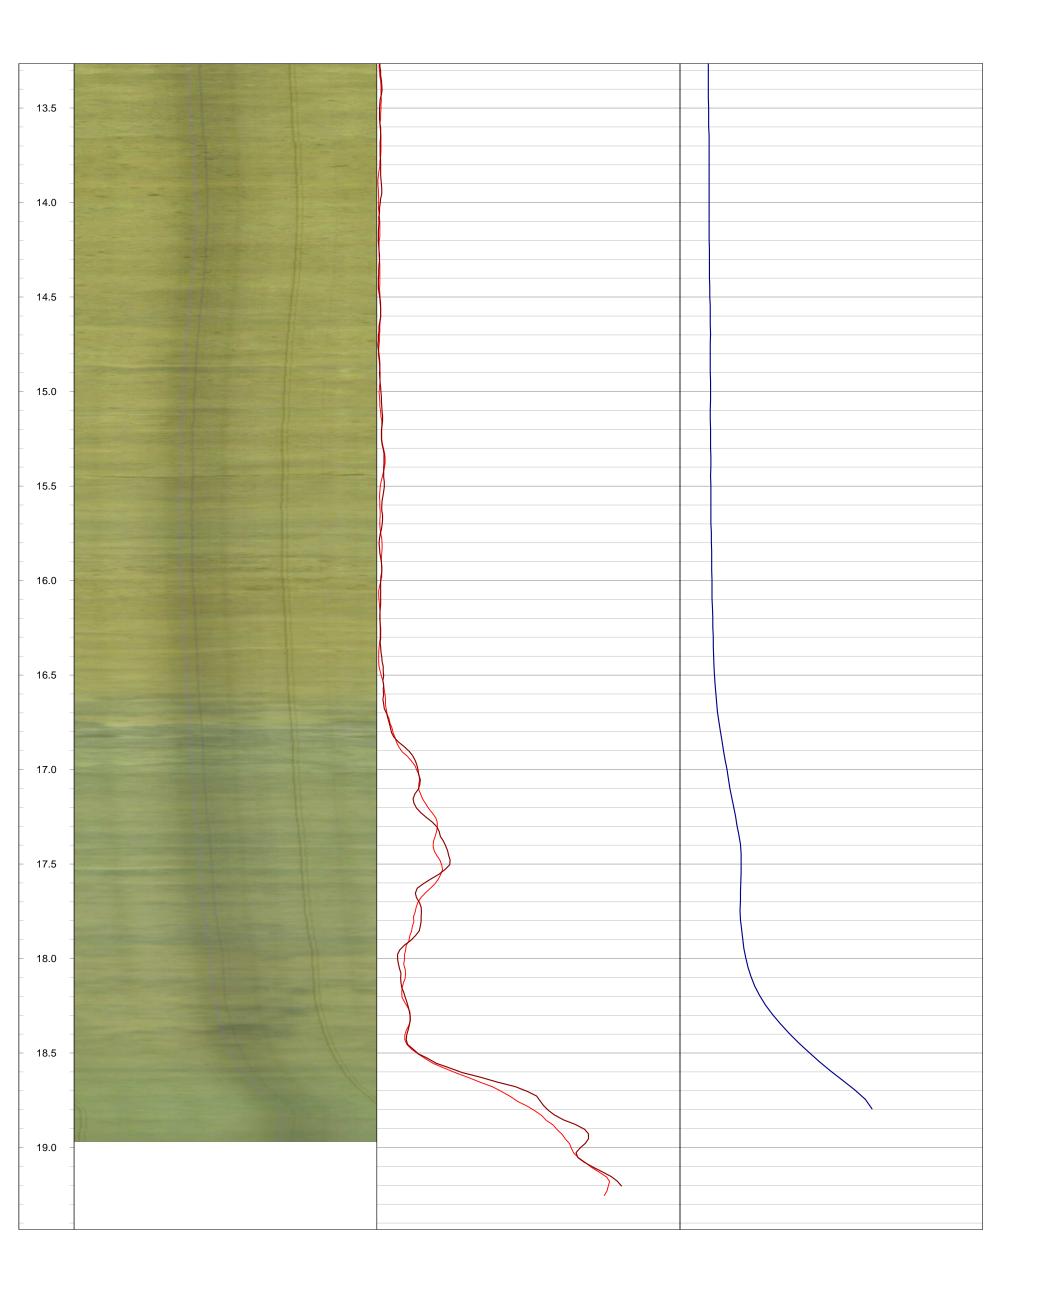
Geophysical Record of Borehole: BH20-11 (CAL)

Elevation: 411.07 m asl Casing Diameter: 152 mm Casing Stickup: 0.40 m ags Logged By: PG

Denti	OBI Image - MN			Natural Gamma - Down		Apparent Conductivity - Up		
Depth	0° 90°	180°	270°	0° 0 cps	200 0	mS/m	50	
1m:20m				Natural Gamma - Up				
				0 cps	200			
				\rangle				
0.5				V				
				<i></i>				
				\				
				<i>y</i>				
1.0								
1.5								
				V				
2.0)				
				\\				
				/				
0.5				//				
2.5								
				\ \ \ \ \ \ \ \ \ \ \ \ \ \ \ \ \ \ \				
3.0								
3.5				<u> </u>				
				Y				
4.0								
7.0								
4.5								
				X				
				V				
5.0		Section 1		——				
5.5				/)				
0.0

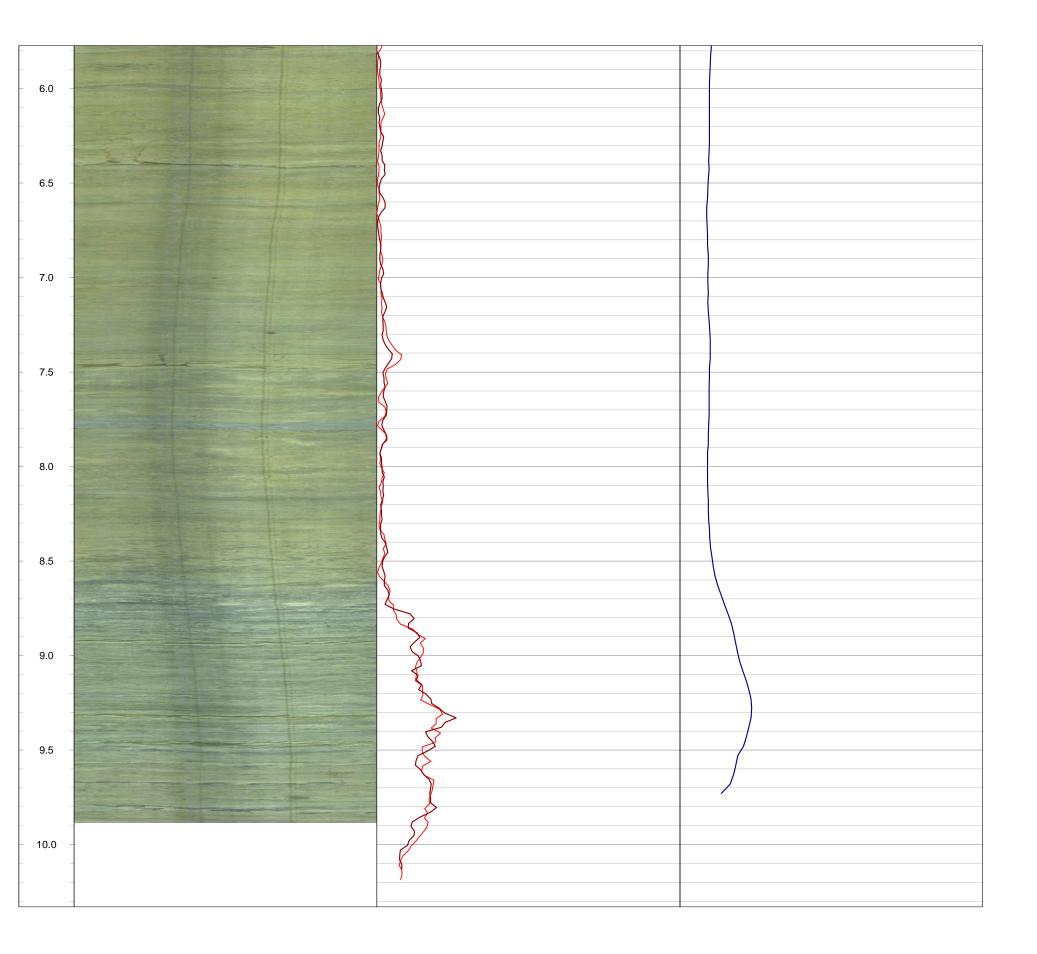
Geophysical Record of Borehole: BH20-12 (CAL)

Notes: OBI image opaque > 9.95 m

Б :			OBI Image - MN			Natural Gamma - Down			Conductivity - Up	
Depth	0°	90°	180°	270°	0° 0	cps	200	0	mS/m	25
1m:20m					0	Natural Gamma - Up cps	200			
0.5										
					2					
1.0										
					8					
1.5										
)					
2.0										
					\					
2.5										
3.0										
3.5		-								
		15		- Billion						
4.0										
4.5										
5.0				+						
J.U "			AL DE	T. T.						
					\nearrow					
5.5

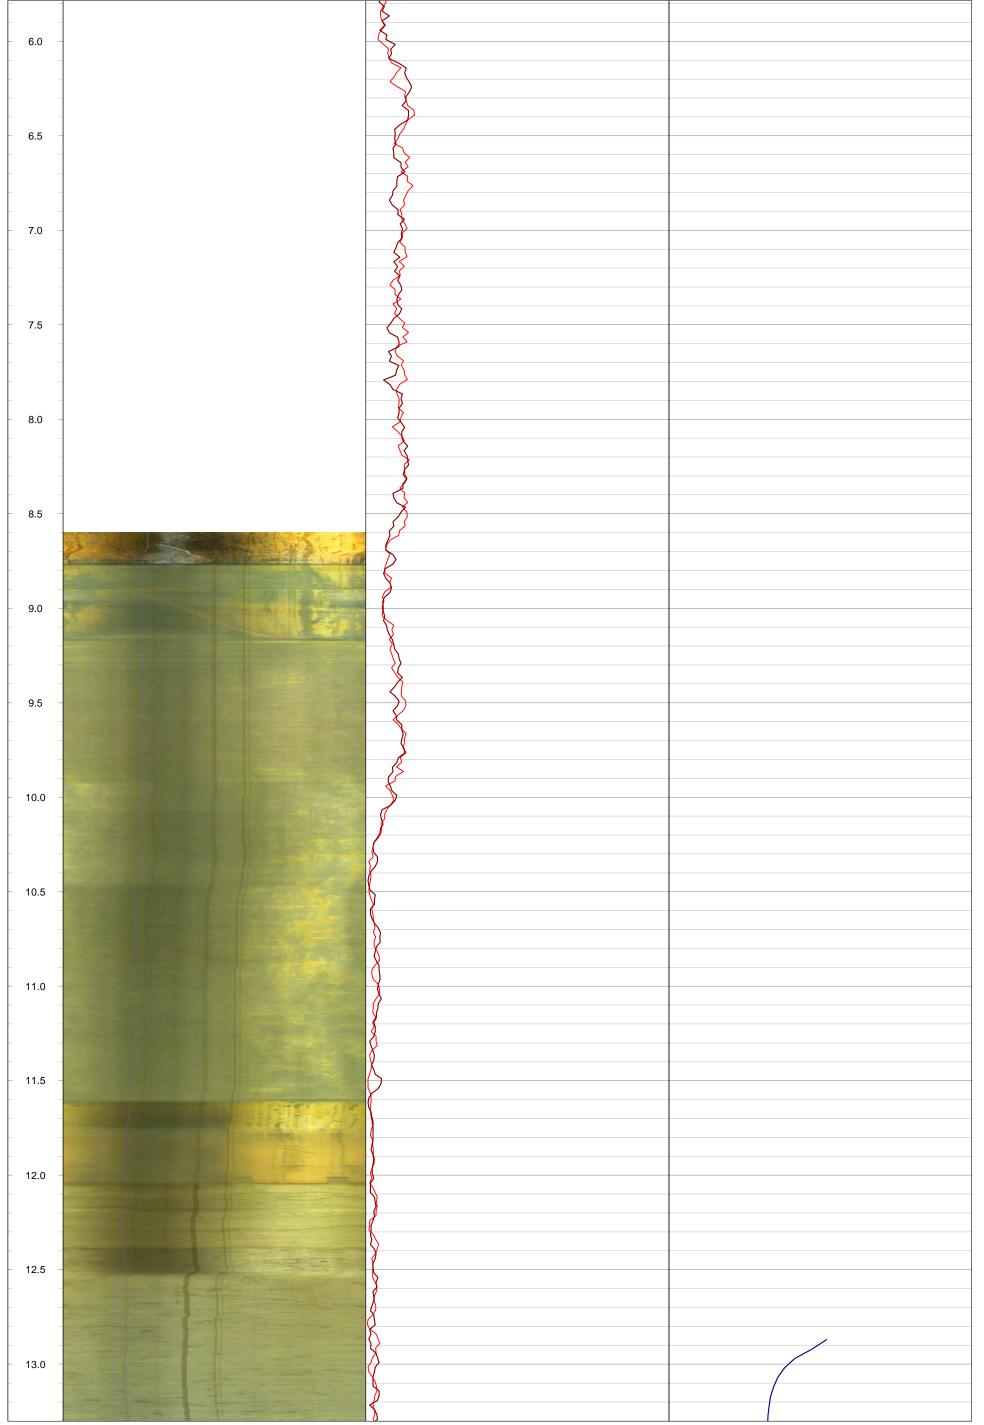
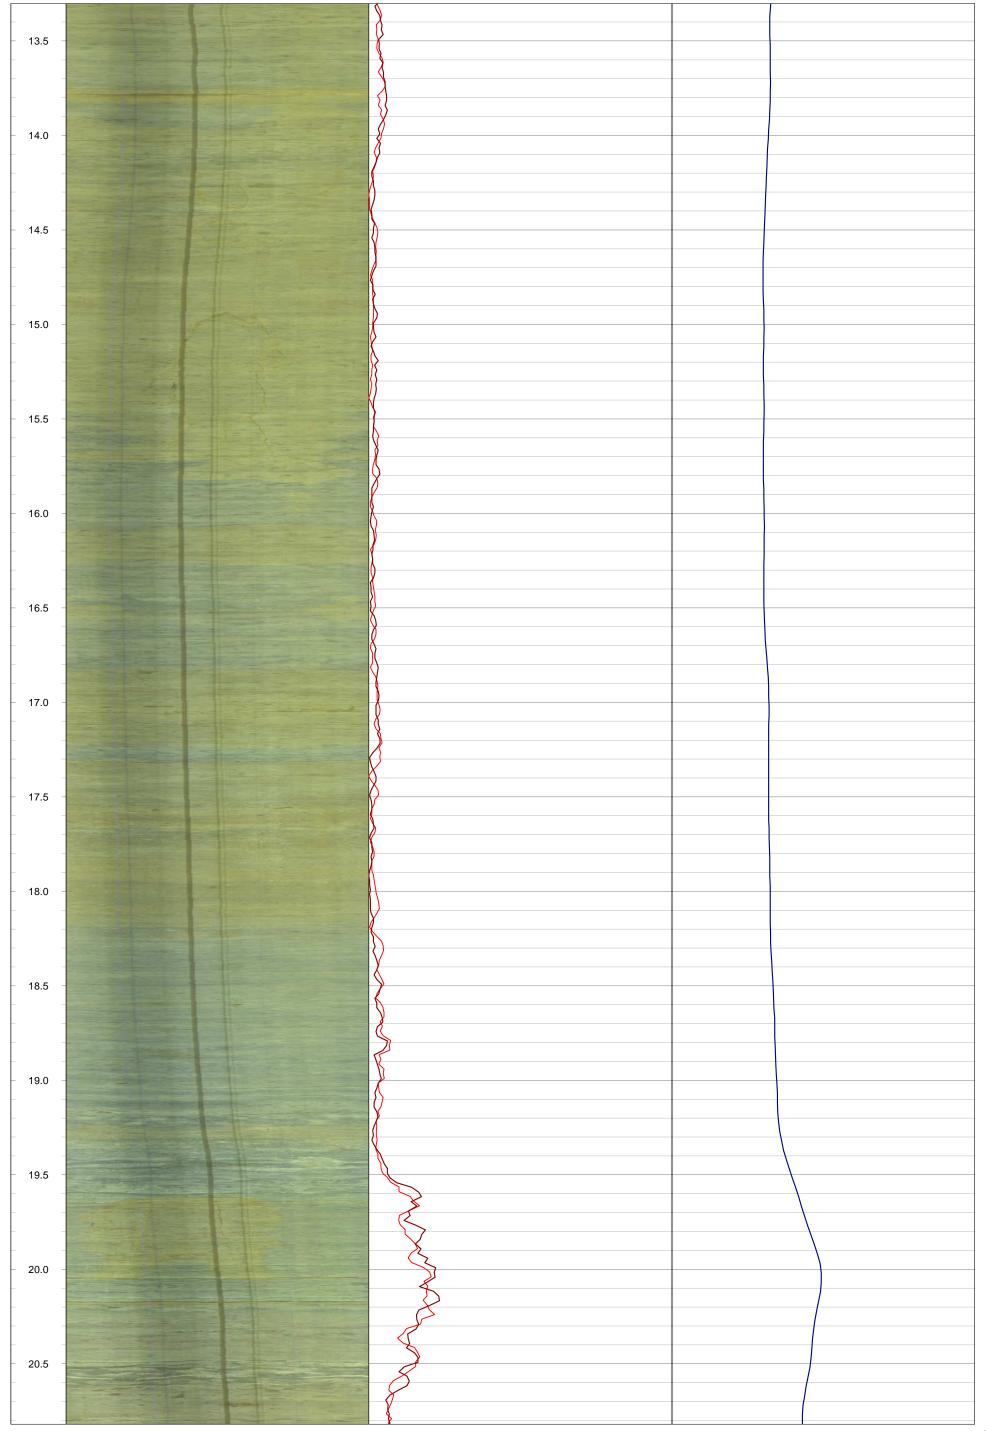
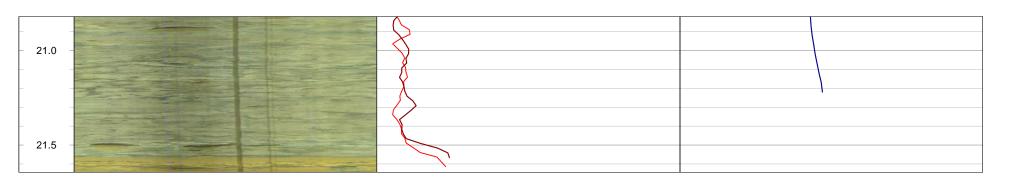
Geophysical Record of Borehole: BH20-13 (CAL)

Donti		OBI Image - MN		Natural Gamma - Do	own	Apparent Conductivity - Up		
Depth	0° 90°		270°	0° 0 cps	200 0	mS/m	25	
1m:20m				Natural Gamma - L	Jp			
				0 cps	200			
0.5								
				_				
1.0								
				3				
				<i>\{</i>				
				\				
1.5								
				3				
2.0				X				
	***************************************			\\\\\\\\\\\\\\\\\\\\\\\\\\\\\\\\\\\\\				
				>				
				\				
2.5								
2.0				\}				
				<i>\$</i>				
2.0								
3.0	7			3				
				8				
3.5				\$				
				\$				
				X.				
4.0				\$				
				\{				
				\rightarrow				
				× ×				
4.5				\				
				\$				
				{				
5.0				3				
				5				
				**				
				\sum				
5.5								
				<i>\\</i>				
	1			· 1

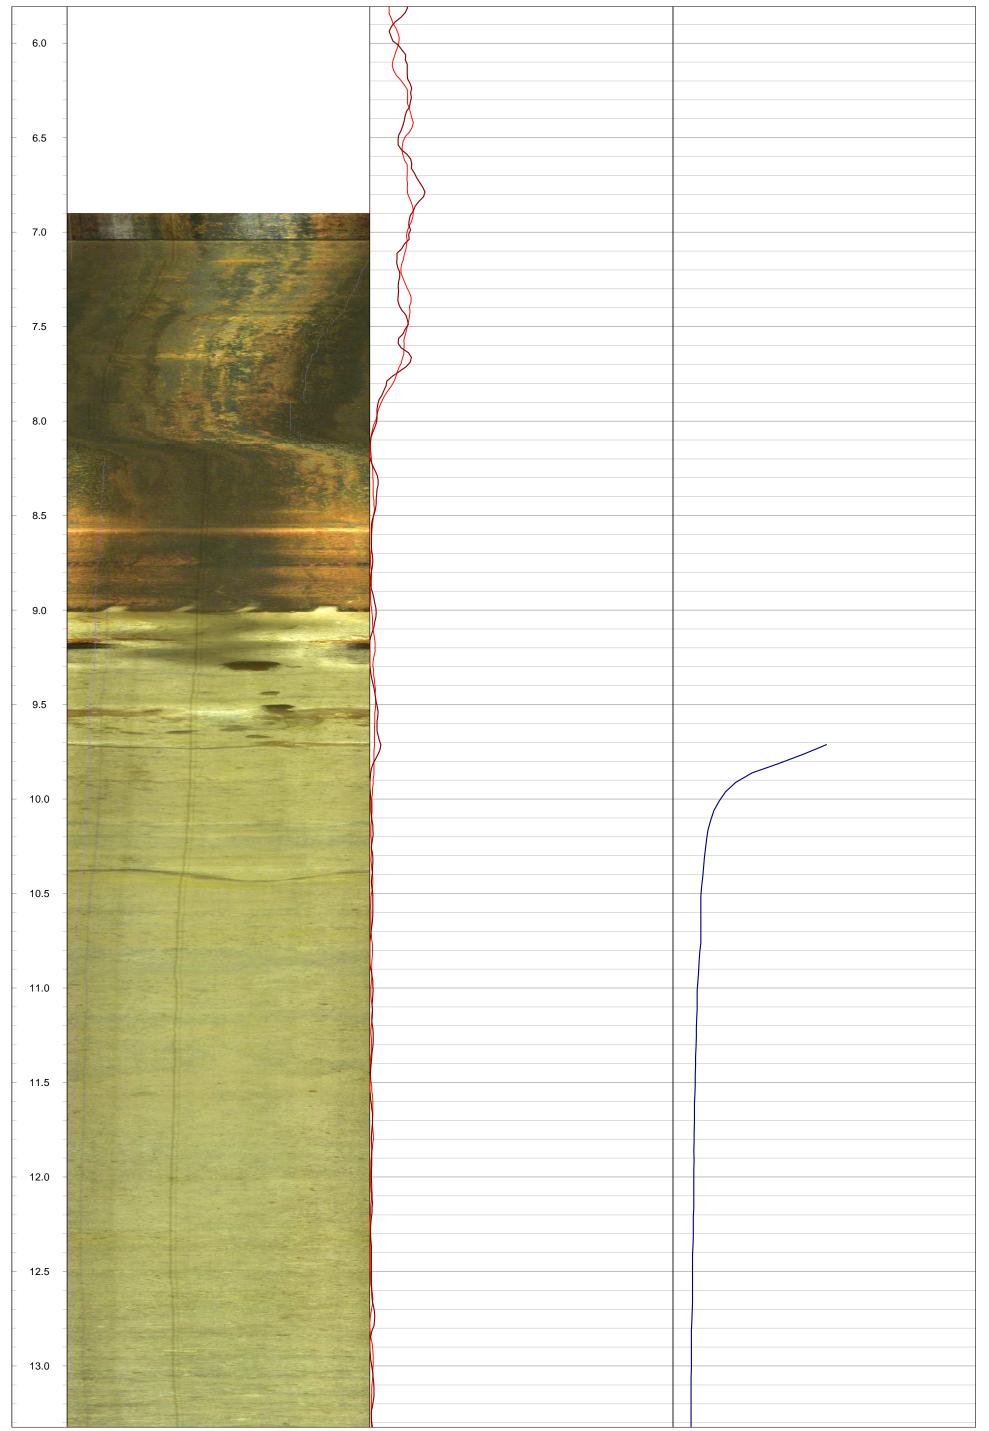
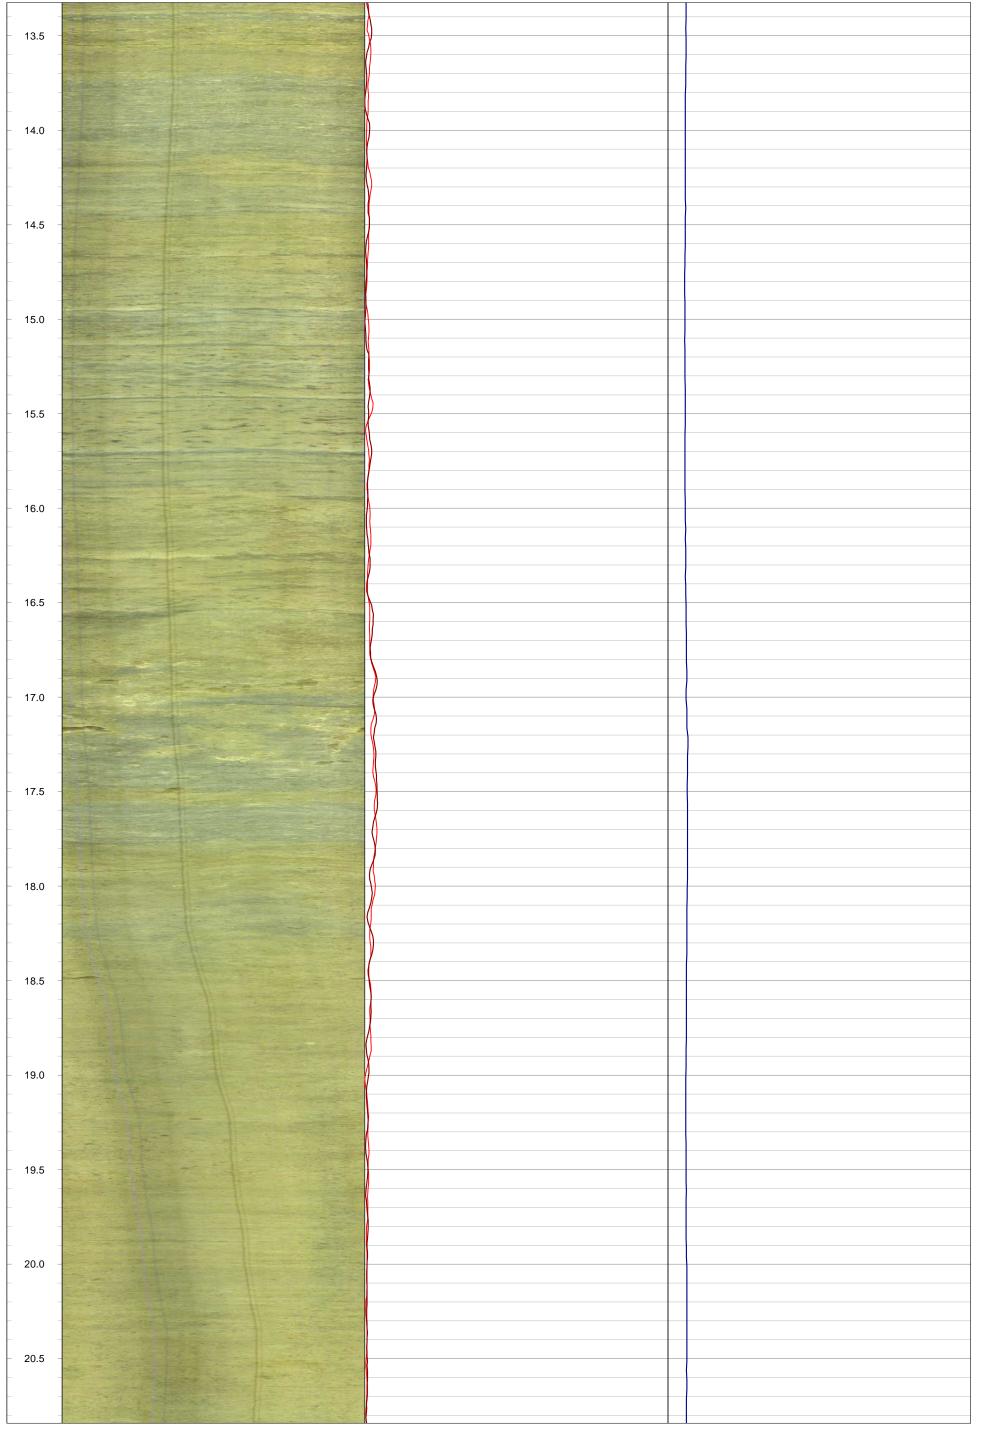
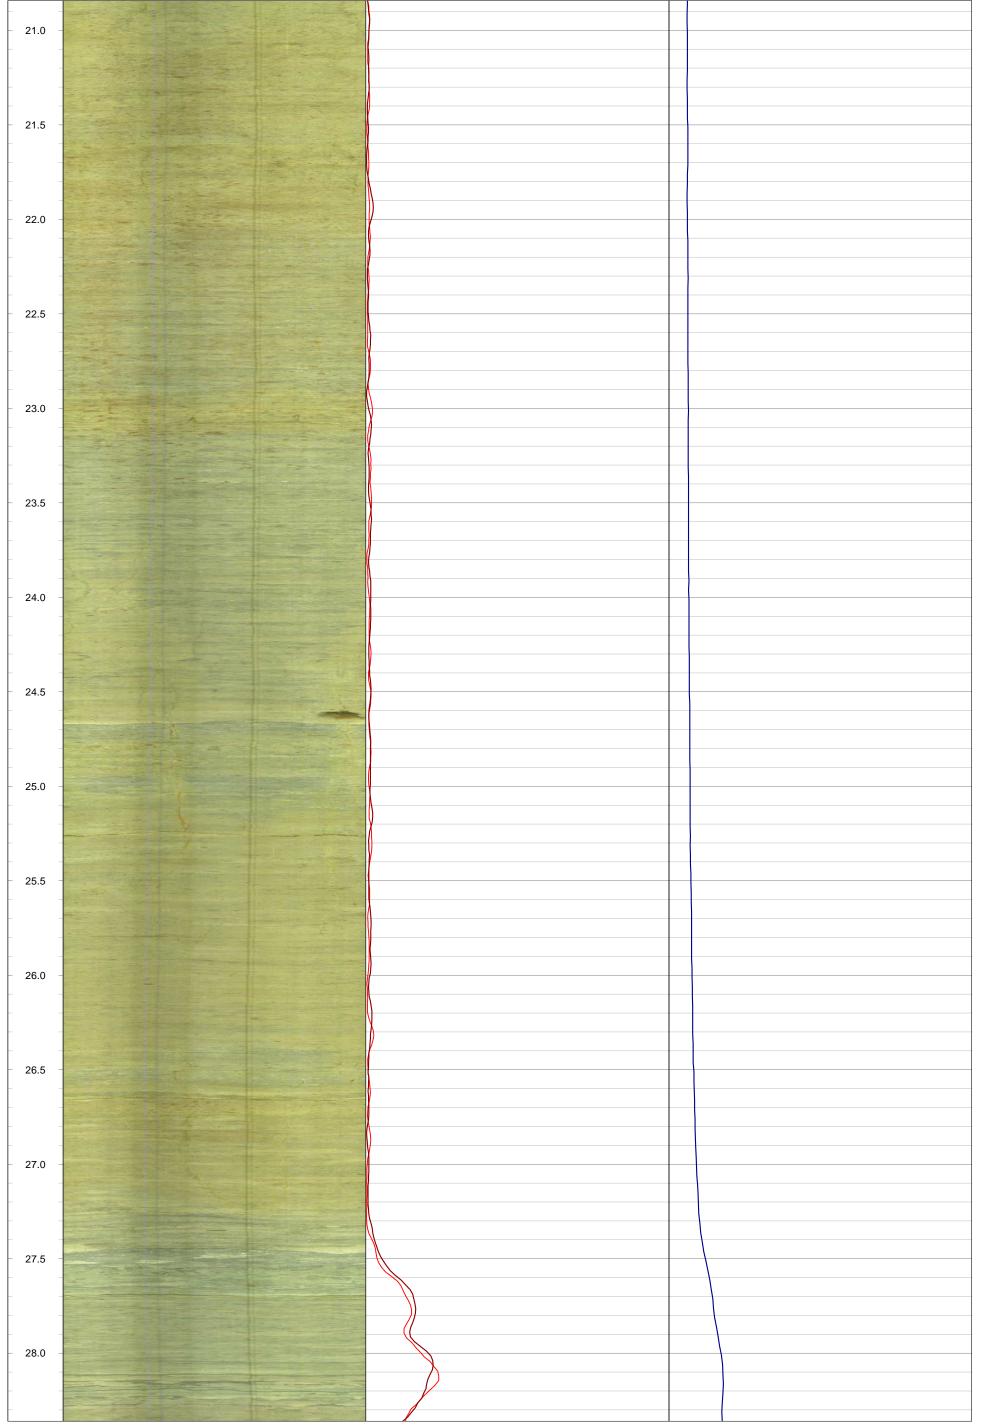
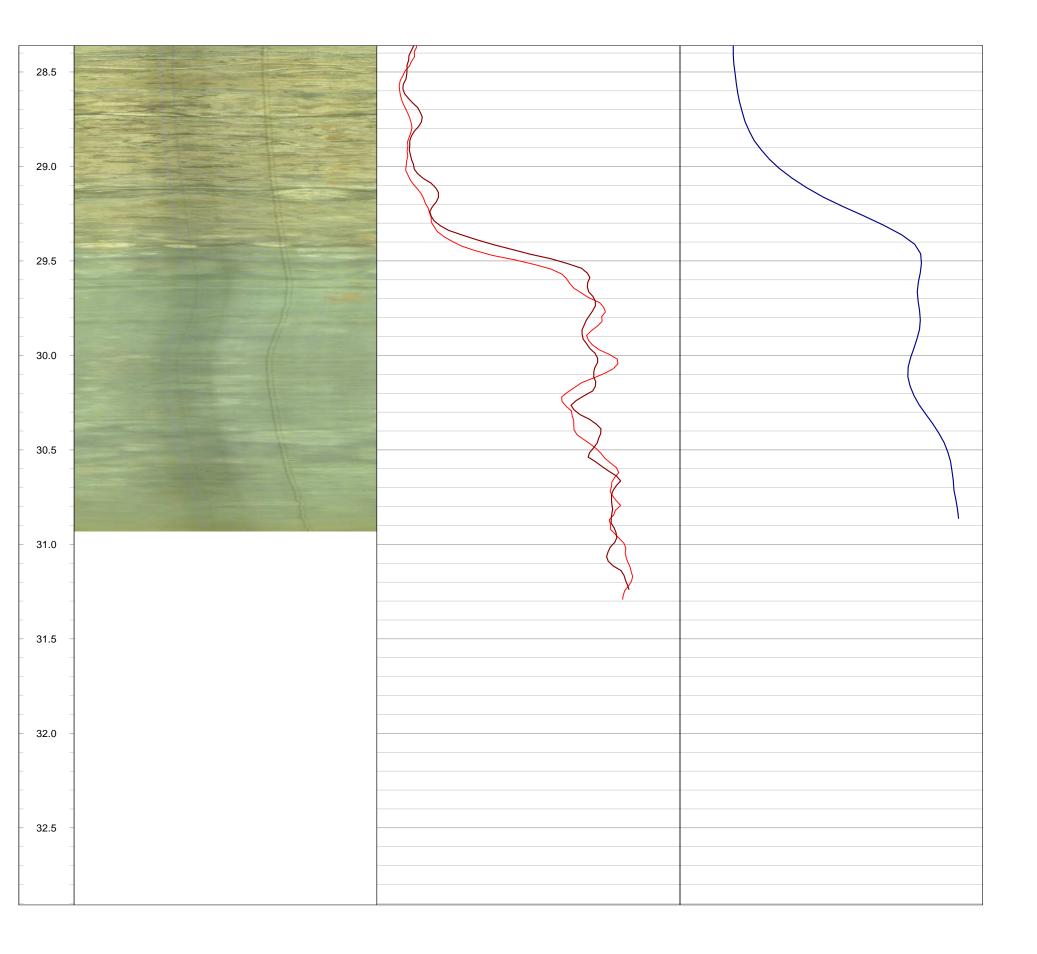
Geophysical Record of Borehole: BH20-15 (CAL)

Donth	OBI Image - MN	Natural Gamma - Down	Apparent Conductivity - Up		
Depth		0° 0 cps 200 0	mS/m 50		
1m:20m		Natural Gamma - Up			
		0 cps 200			
0.5					
		Y			
		\ \ \ \ \ \ \ \ \ \ \ \ \ \ \ \ \ \ \			
1.0					
		V			
1.5					
2.0		<i>y</i>			
		\			
2.5					
2.5					
3.0					
		<u> </u>			
		X			
3.5					
		<u> </u>			
4.0					
)			
4.5					
		X			
5.0		{ }			
- · -					
5.5					
		/ \

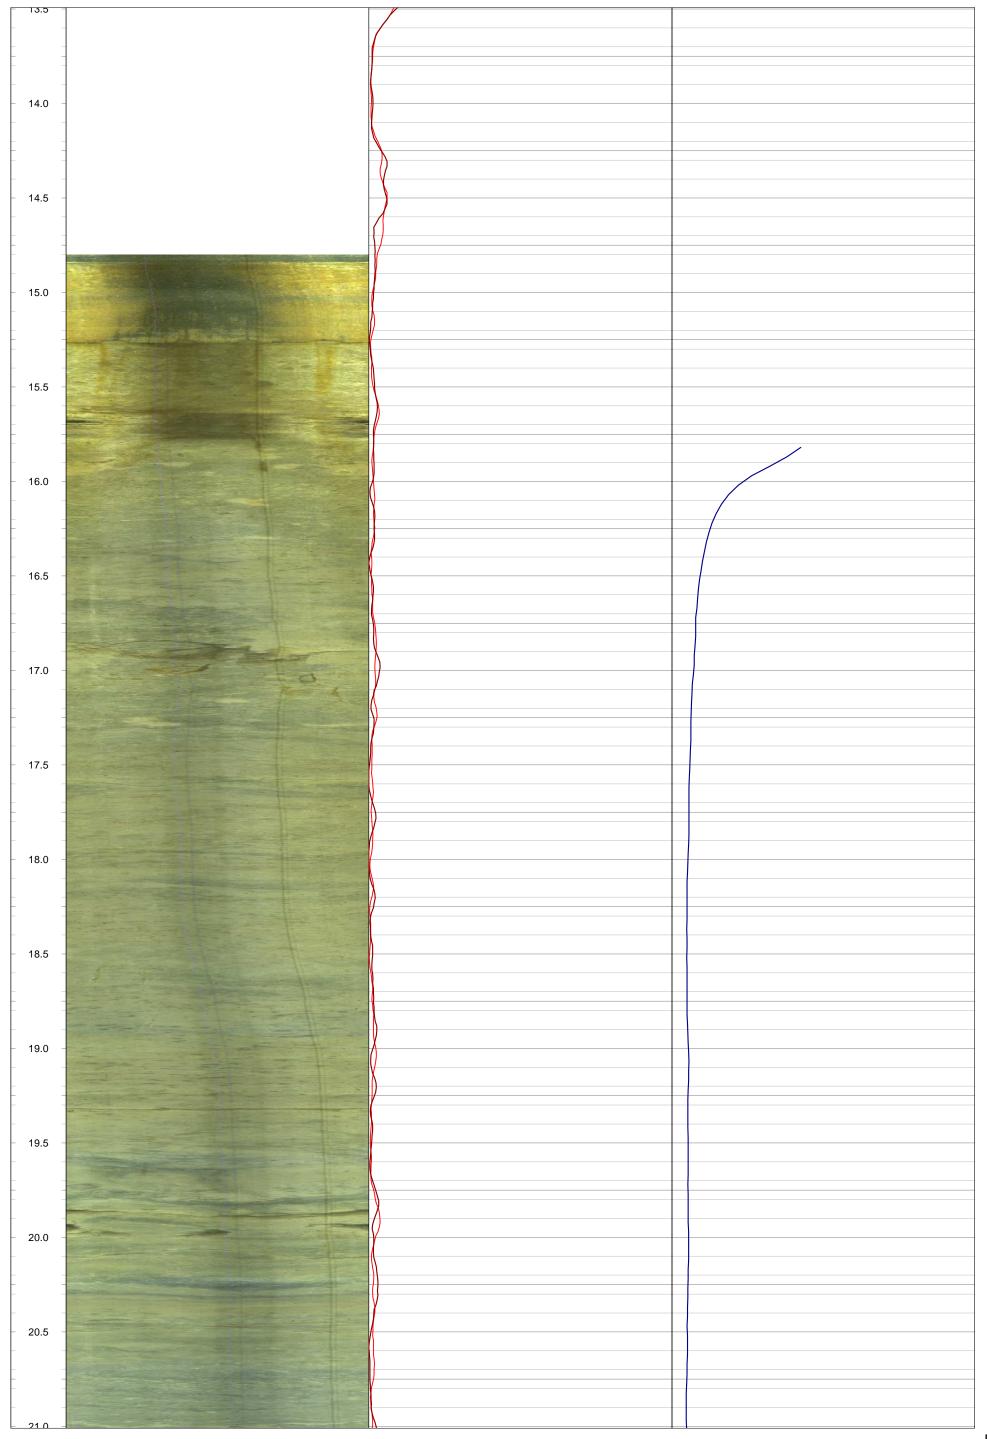
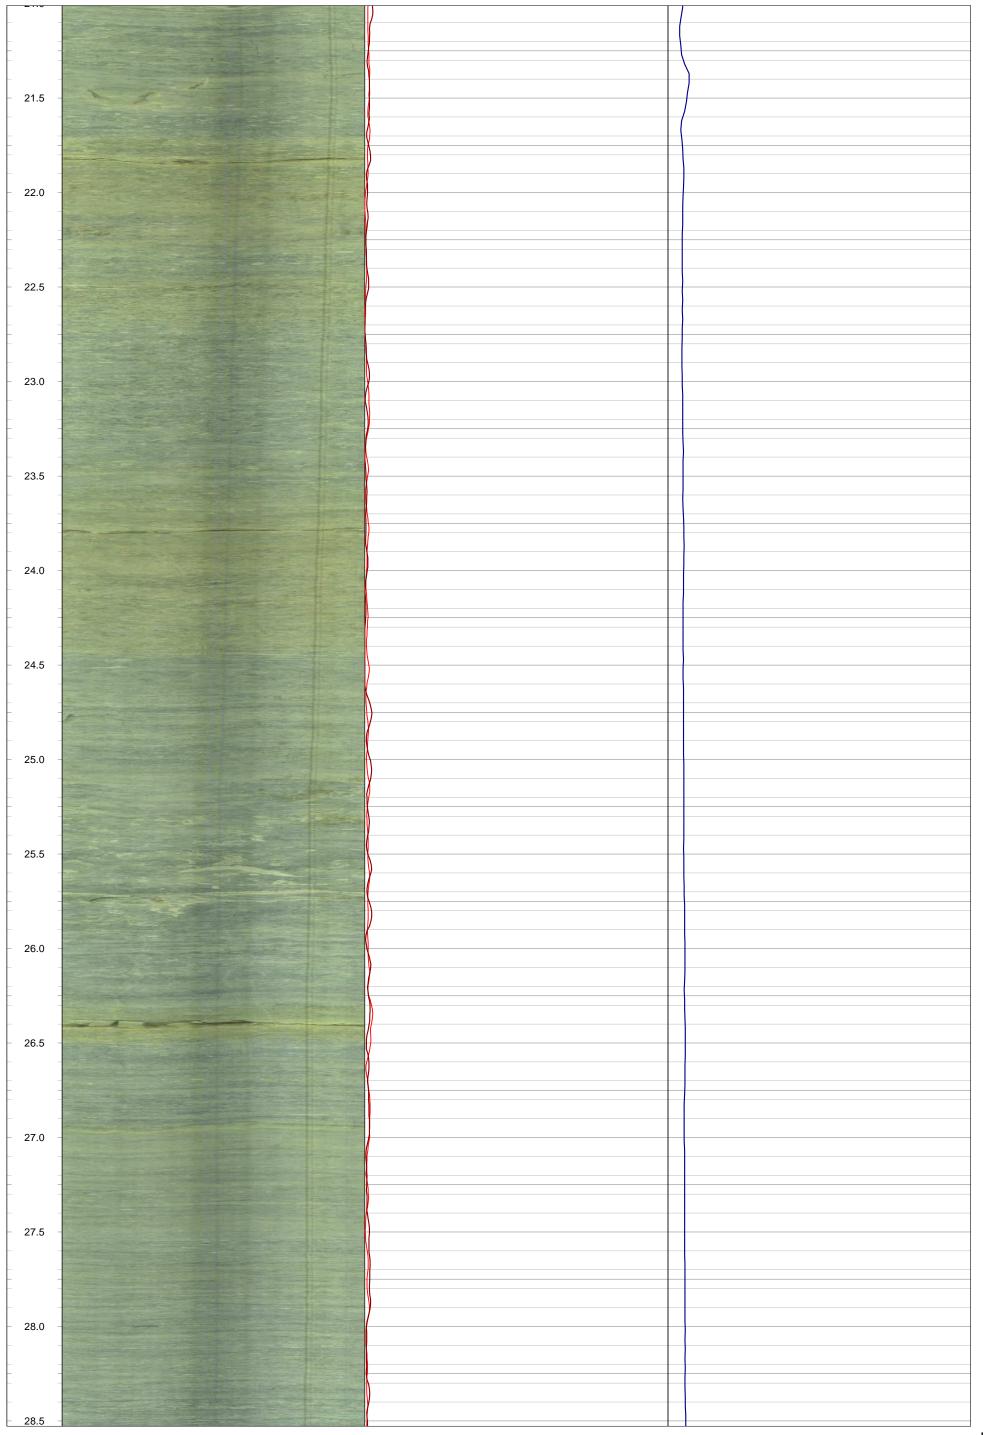
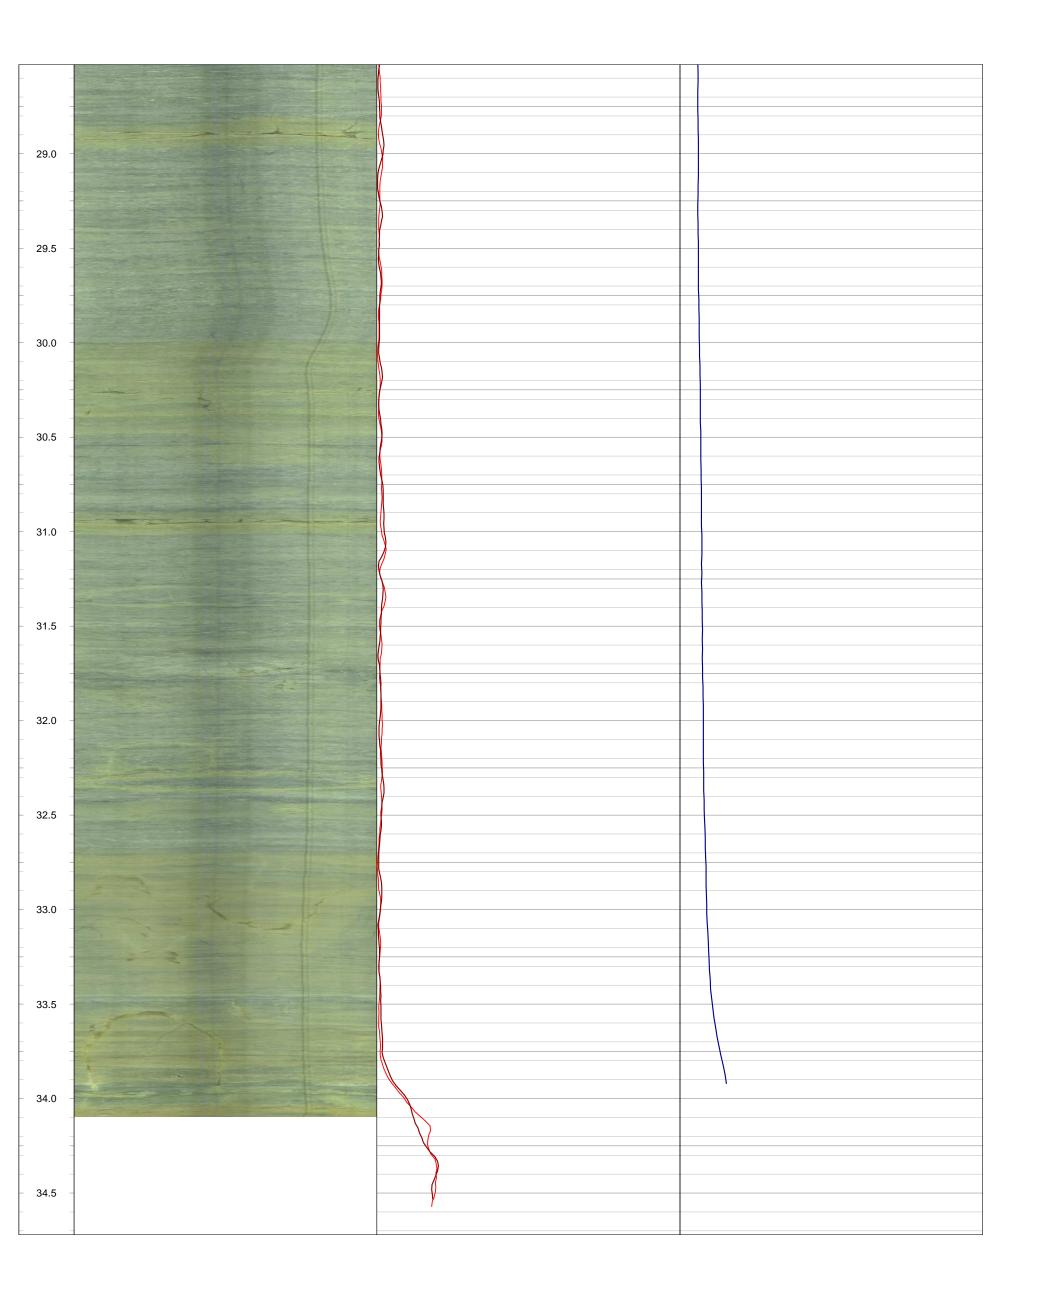
Geophysical Record of Borehole: BH20-16 (CAL)

Depth	OBI Image - MN		Natural Gamma - Down		Apparent Conductivity - Up	
Depth 0°	90° 180° 270° 0°	0	cps	200 0	mS/m	50
1m:20m		0	Natural Gamma - Up cps	200		
		\wedge	op C			
1.0						
1.5						
2.0						
2.5						
3.0						
3.5						
4.0						
4.5						
5.0						
		\				
		Ď				
5.5		<i>Y</i>				
		X

⊢ 60 ∃		
6.0		
-		
- 6.5 -		
0.0		
	<i>f</i>	
- 7.0 -		
	<u> </u>	
	\	
	(
- 7.5 -)/	
)	
- 8.0 -		
)	
-	\	
-	/ >	
- 8.5 -	<u> </u>	
0.0		
-		
	\ \ \ \ \ \ \ \ \ \ \ \ \ \ \ \ \ \ \	
	\	
- 9.0 -		
	\\	
	X	
- 9.5 -		
	X	
- 10.0 -		
	X	
	//	
	(/	
105		
10.5		
- 10.5 - 	Y .	
- 10.5 - 		
- 10.5 - 		
- 10.5 - 		
- 10.5 - 		
- 10.5		
- 11.0		
- 11.0		
- 11.0		
- 11.0		
- 11.0		
- 11.0		
- 11.0		
- 11.0		
- 11.0		
11.0 -		
- 11.0		
11.0 -		
11.0 -		
11.0		
11.0		
11.0		
11.0 -		
11.0		
11.0		
11.0		
11.0		
11.0 - 11.5 - 12.0 -

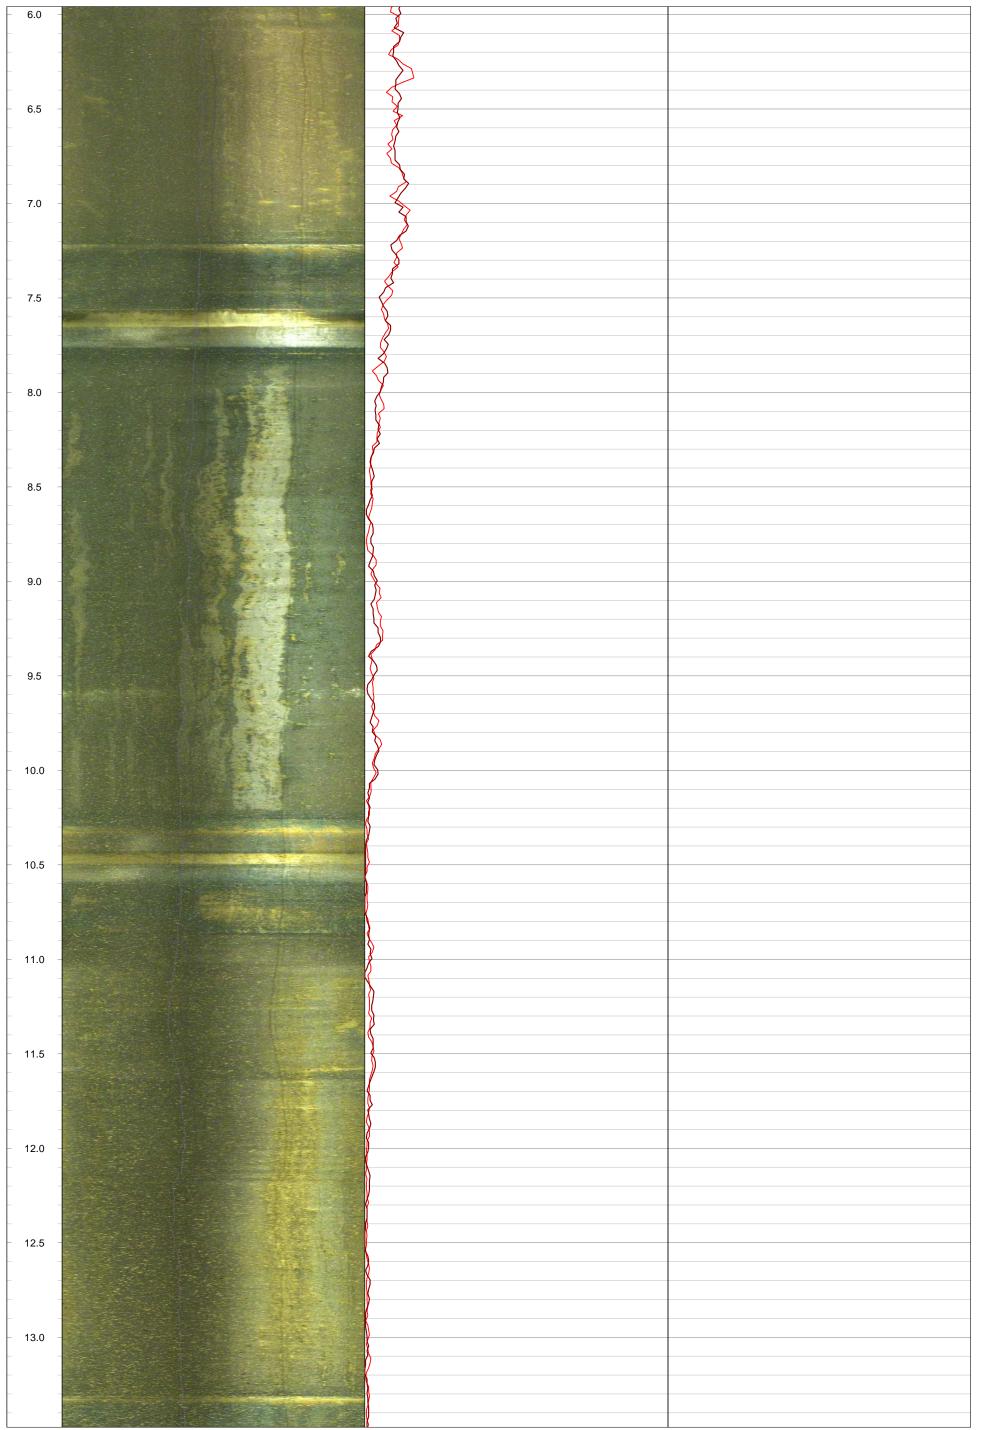
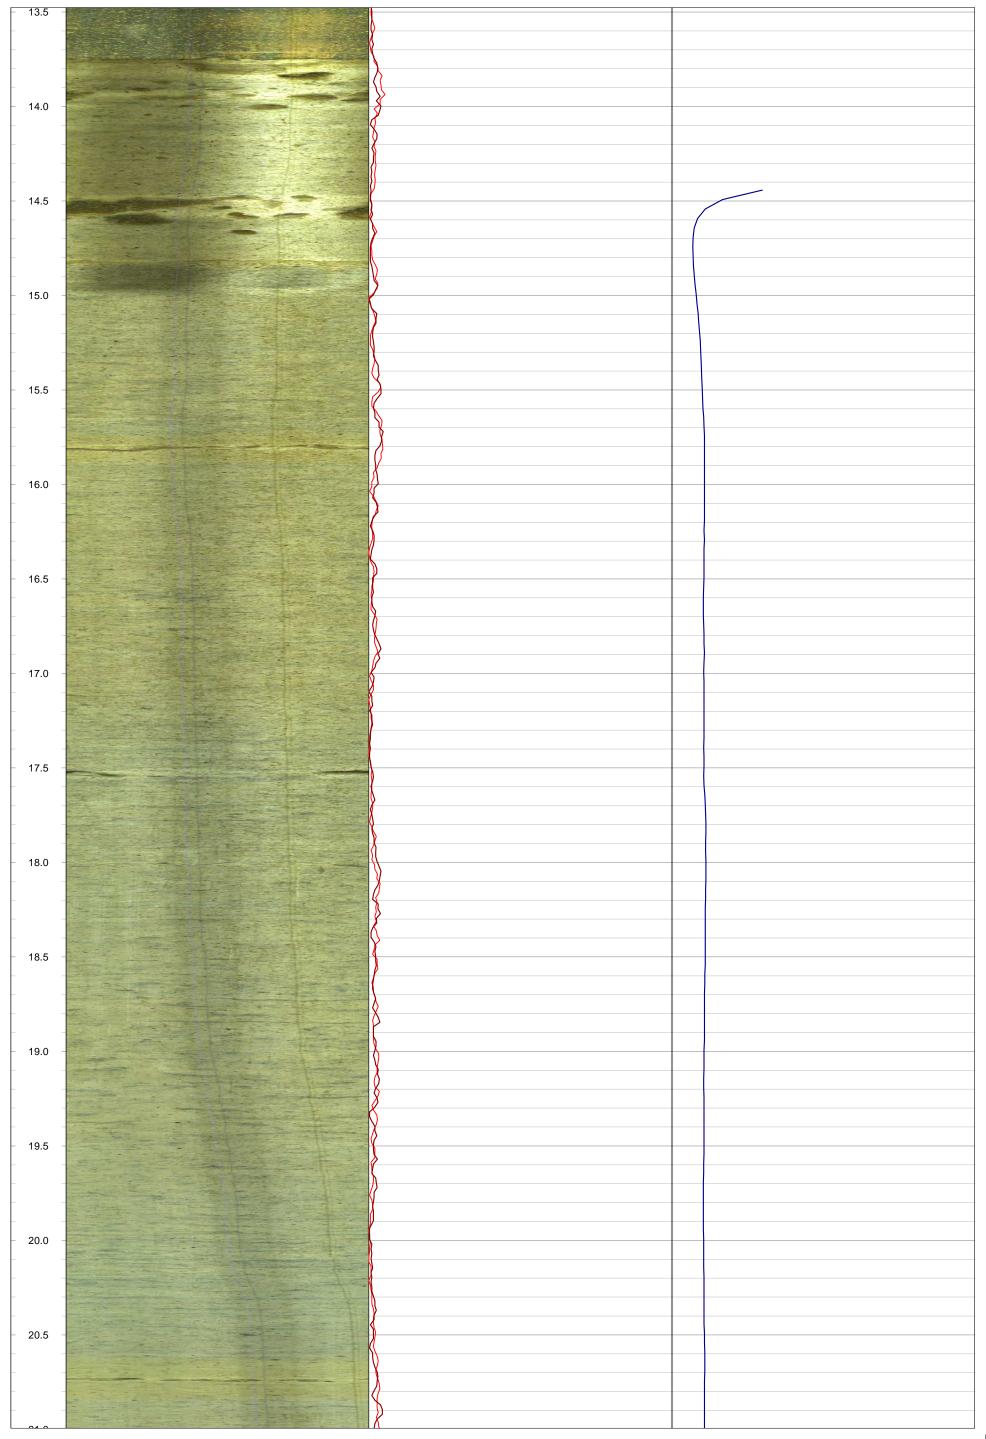
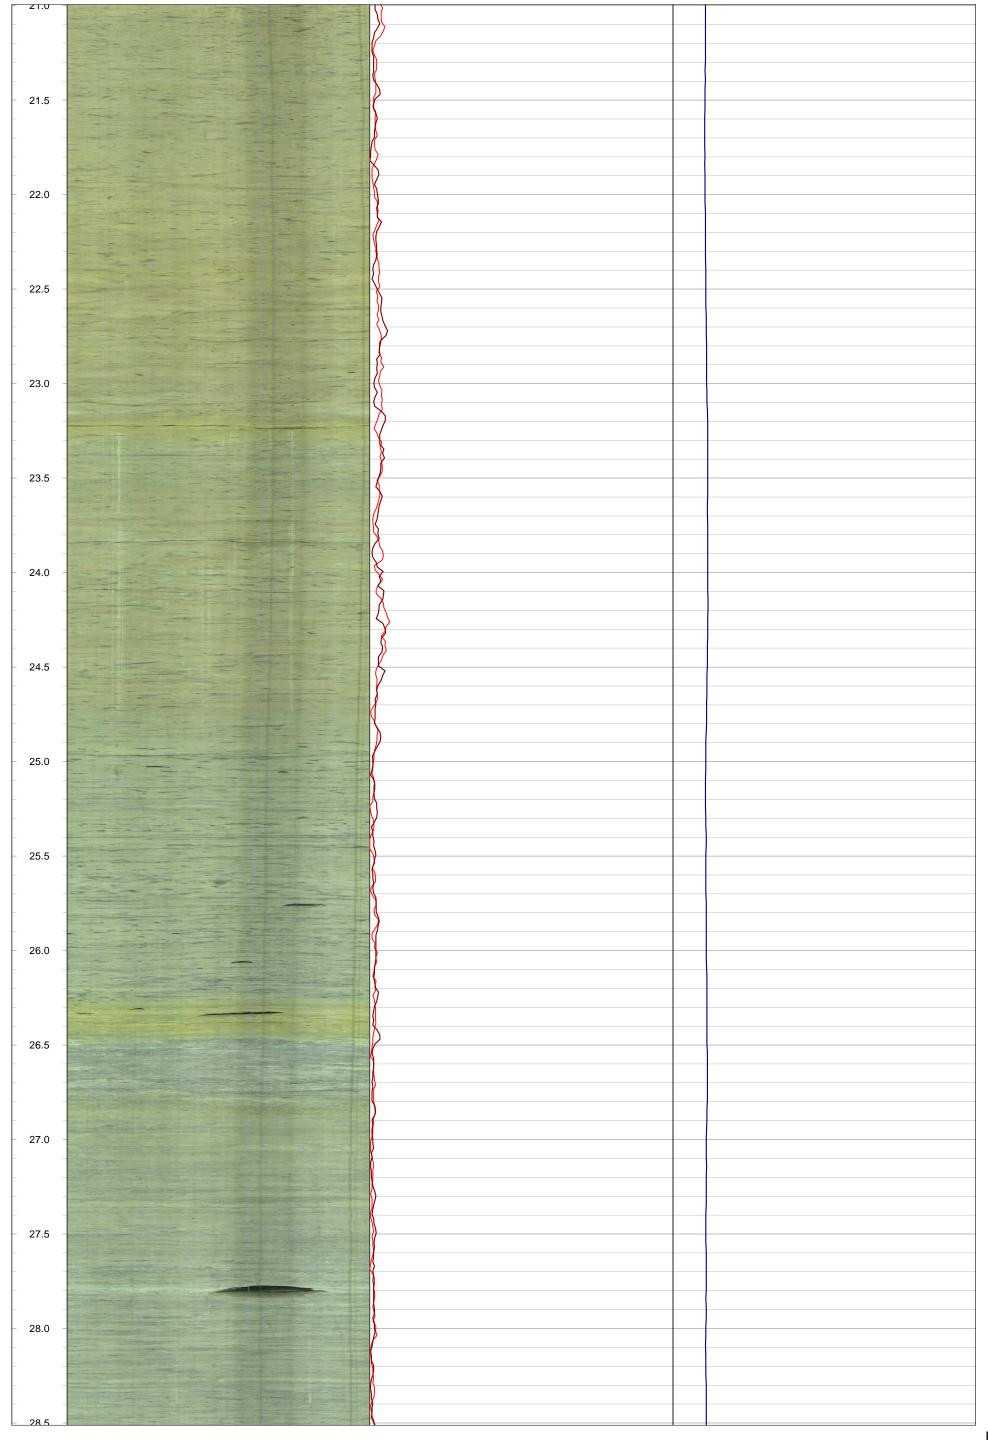
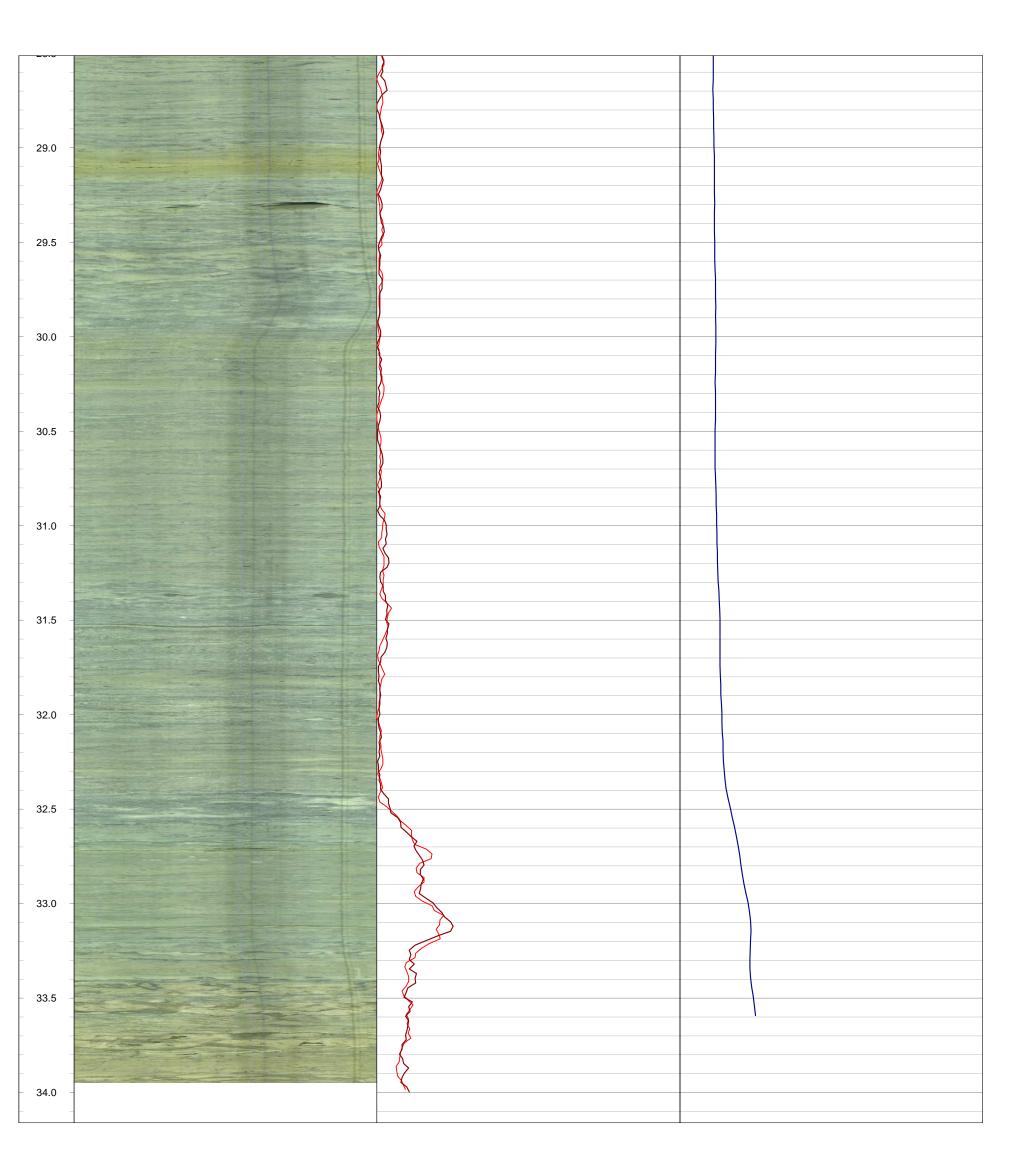
Geophysical Record of Borehole: BH20-17 (CAL)

Danili	OBI Image - MN	Natural Gamma - Down	Apparent Conductivity - Up
Depth	0° 90° 180° 270° 0°	0 cps 200	0 mS/m 50
1m:20m		Natural Gamma - Up 0 cps 200	
0.5		υ cps 200	
		J	
5010 (A)		\	
1.0			
1.0		8	
		\	
1.5			
		\	
		8	
		\	
2.0			
		Y	
an			
2.5			
2.0		\}	
3.0		\	
3.5			
		8	
4.0		\	
4.0		}	
		<i>\(\)</i>	
		<i>§</i>	
4.5			
		1	
		>	
5.0		\triangleright	
FF		\	
5.5		\	
		Y	
		<u> </u>
