REPORT

Water Report Level 1/2

Proposed Caledon Pit / Quarry

CBM Aggregates, a division of St. Marys Cement Inc. (Canada)

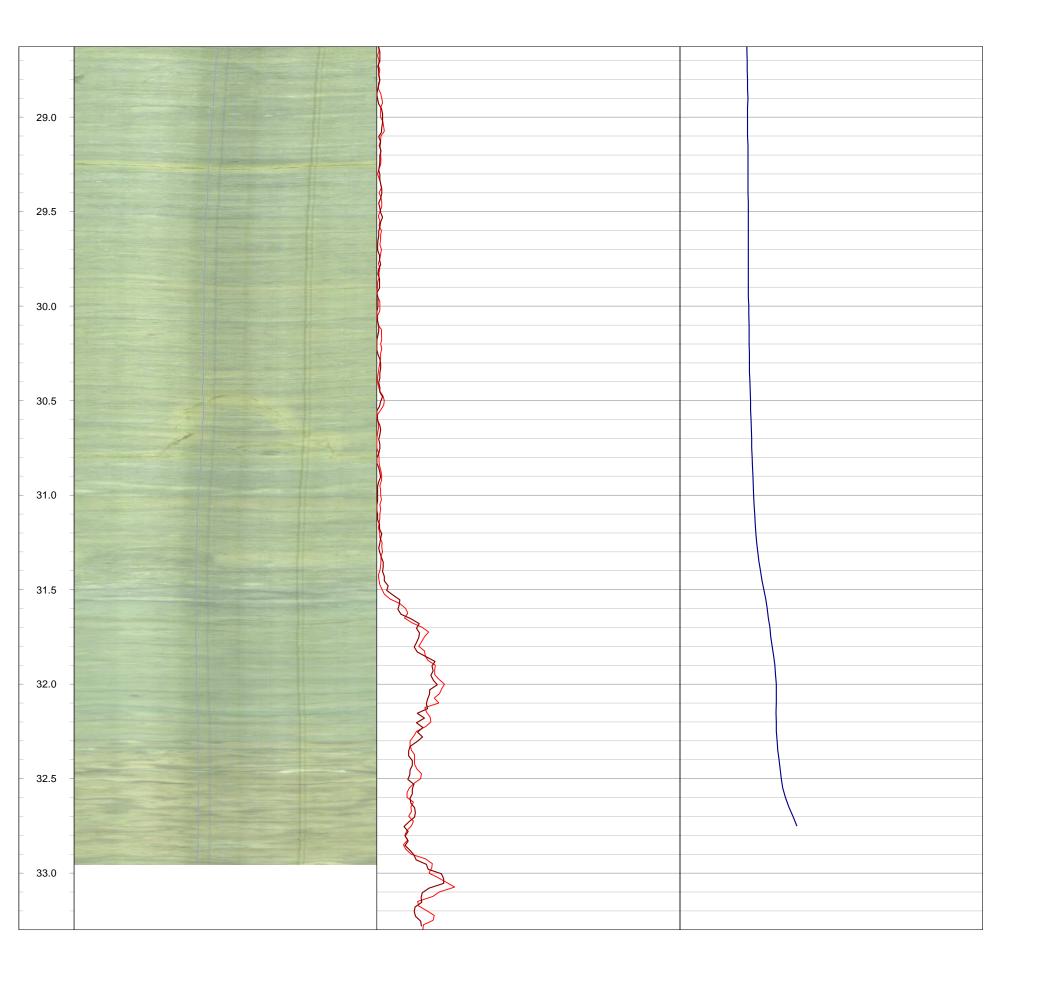
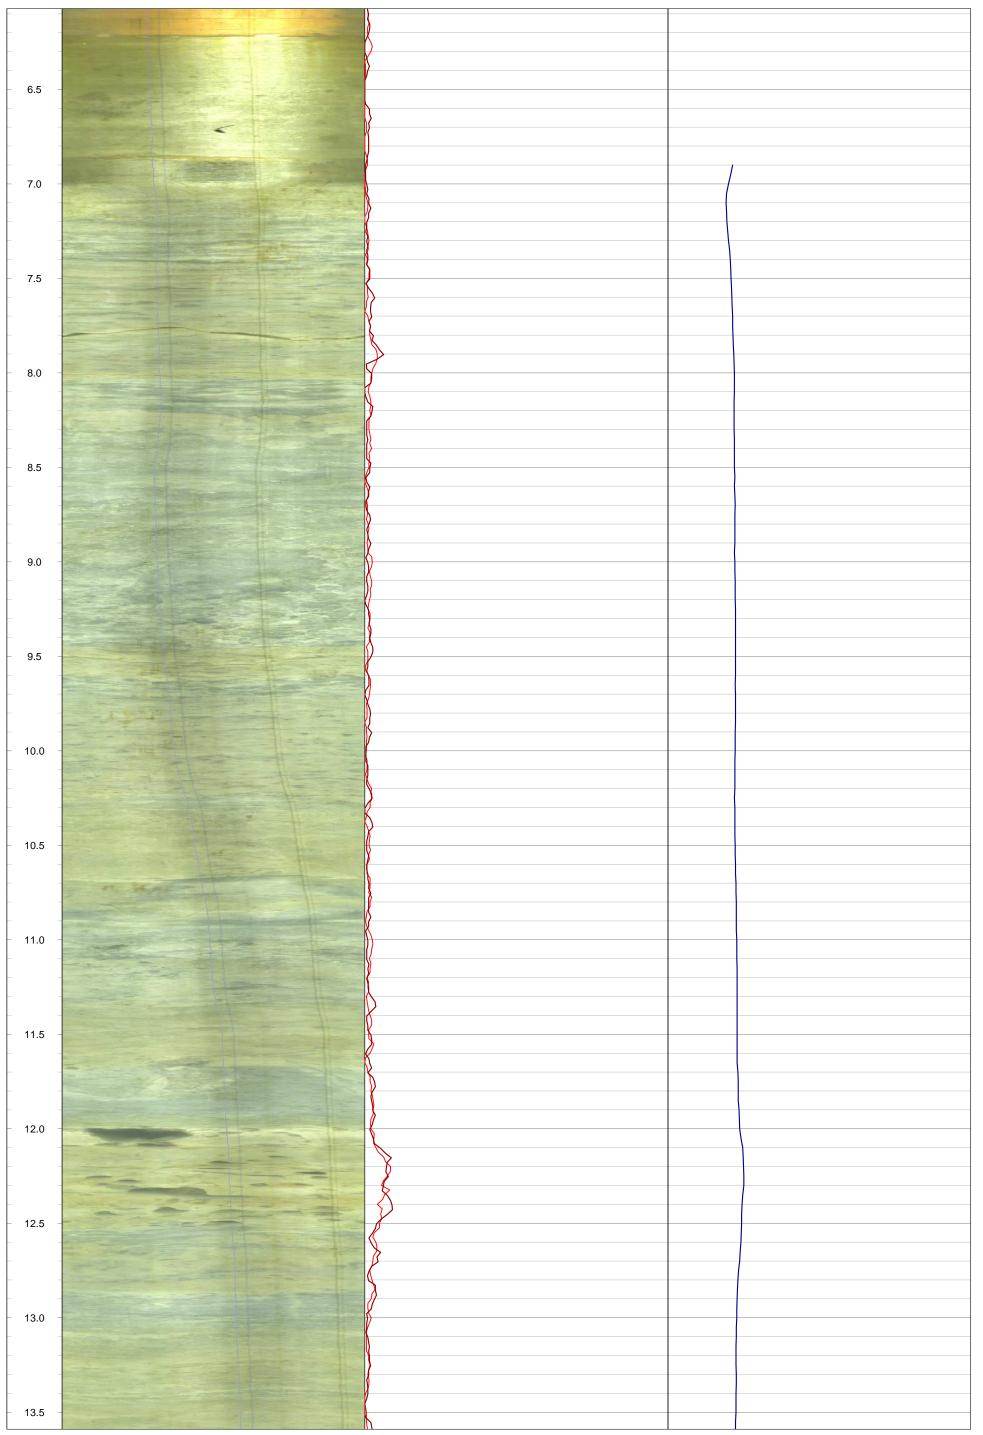
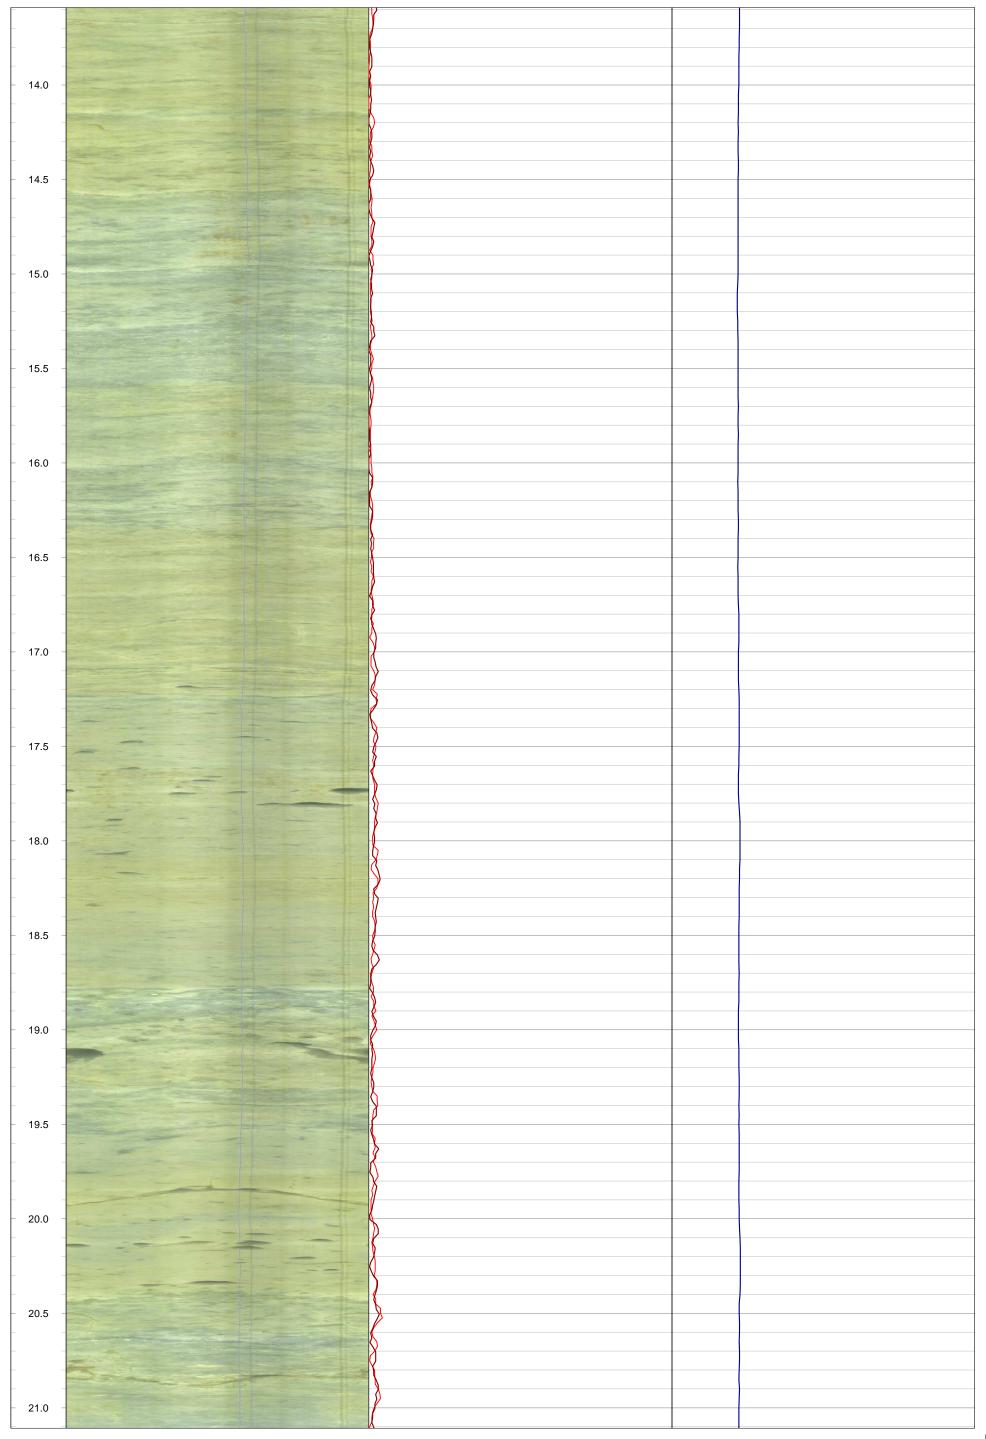
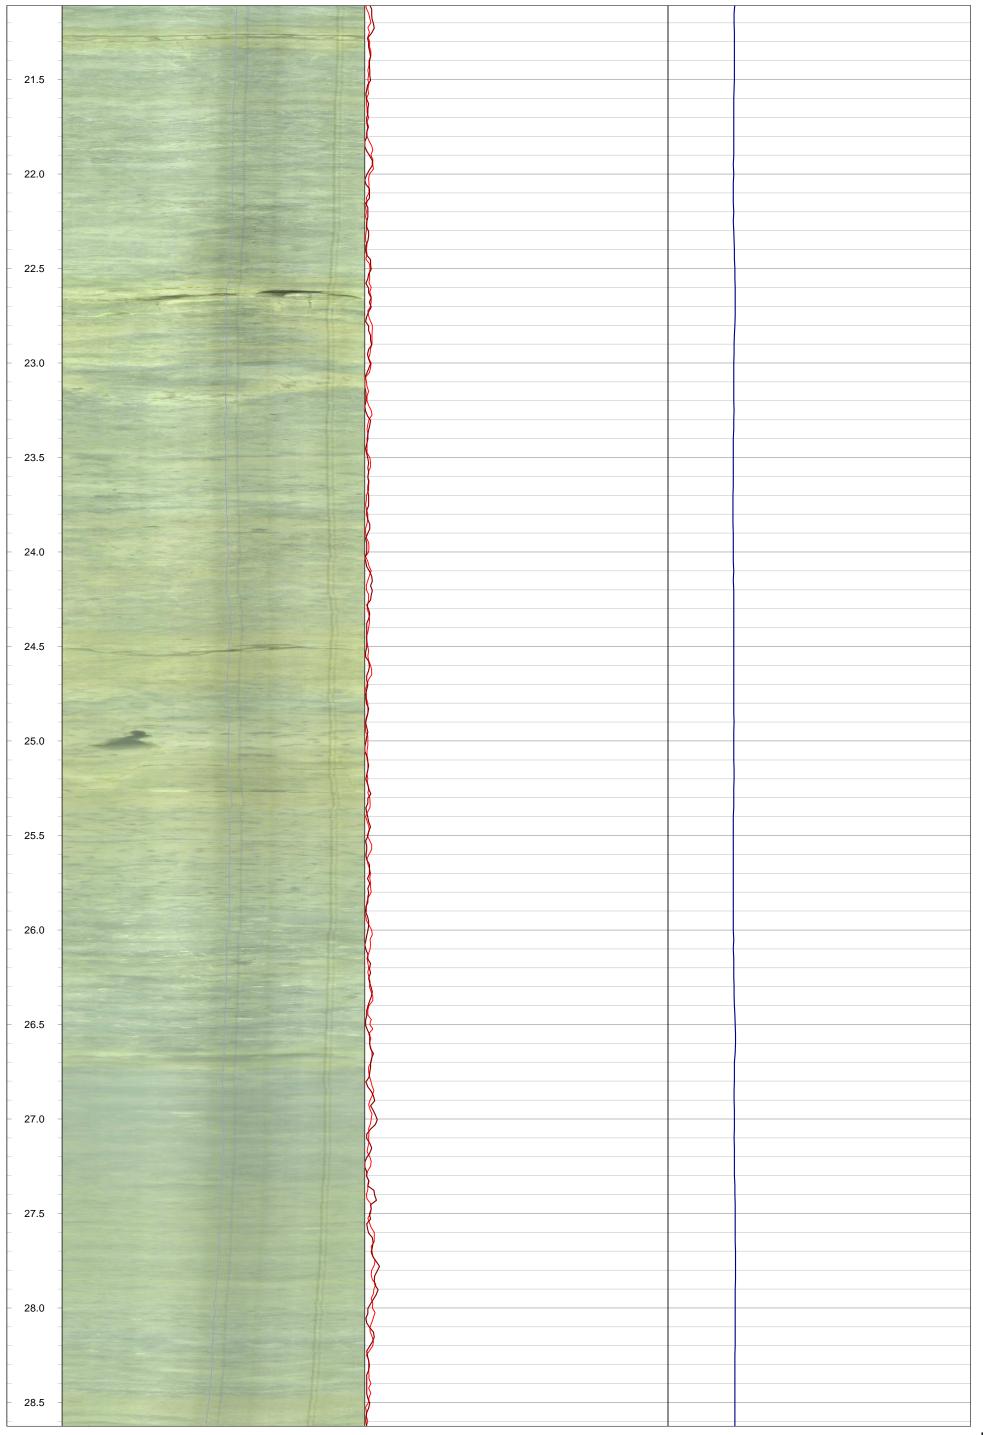
Geophysical Record of Borehole: BH20-22 (CAL)

OBI image opaque > 33.1 m bgs

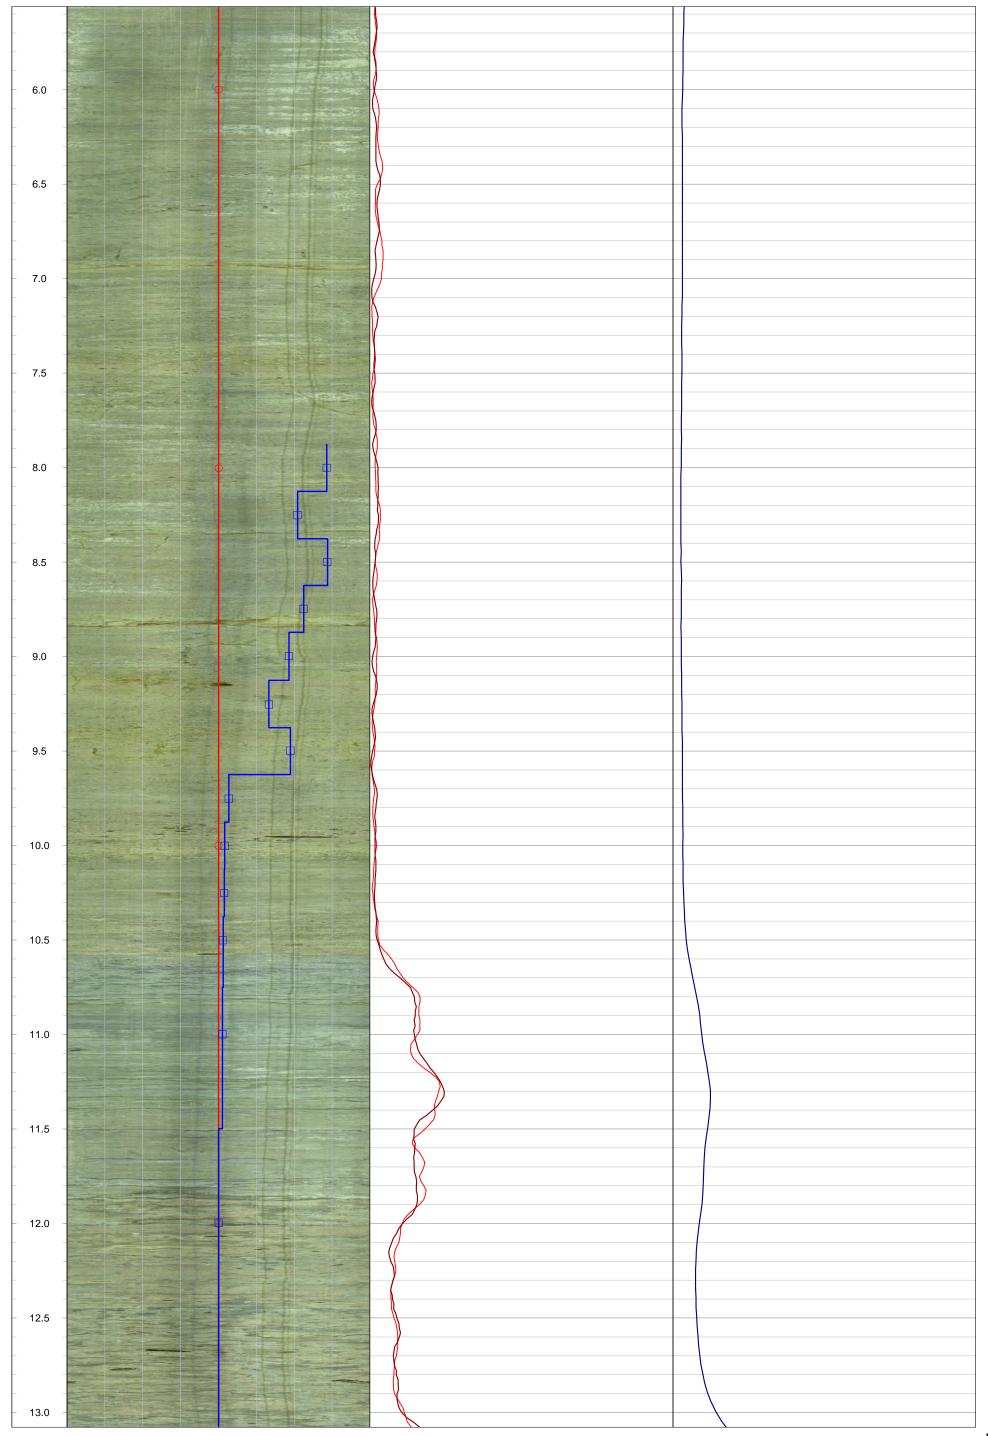
Heat Pulse Flowmeter Dynamic pump at 6.0 m below top of casing. Pump rate approximately 2.25 L/min.

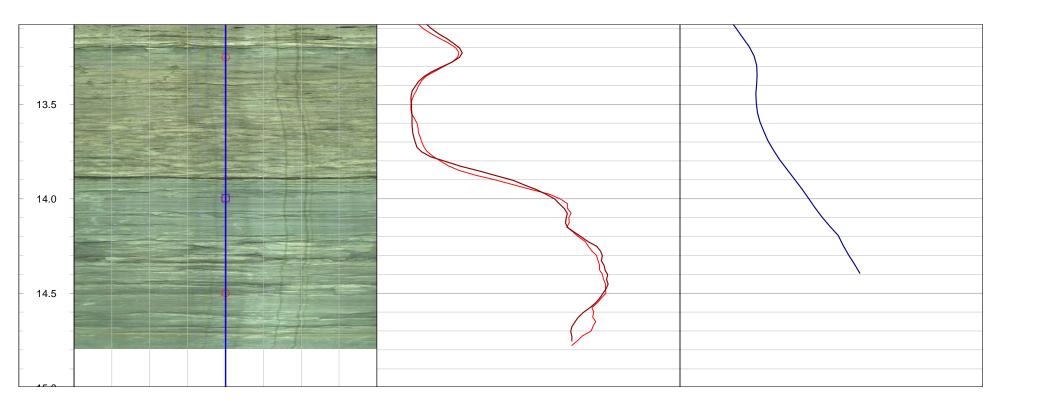
Geophysical Record of Borehole: MW20-06 (CAL)

Notes: Heat Pulse Flowmeter Dynamic pump at 4.0 m below top of casing. Pump rate approximately 2.75 L/min.

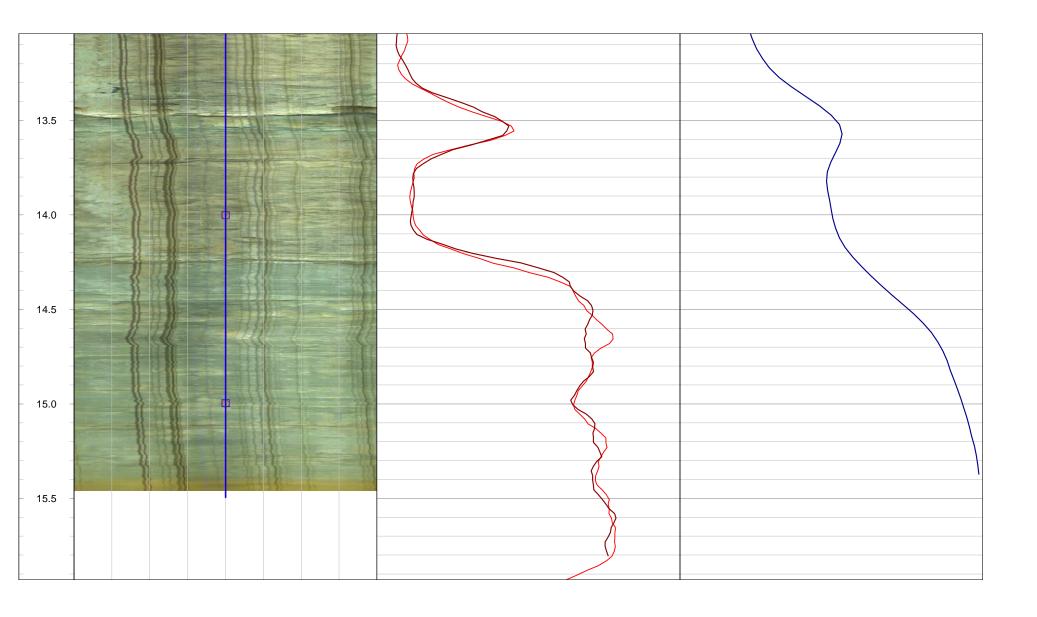
Geophysical Record of Borehole: MW20-07 (CAL)

Heat Pulse Flowmeter Dynamic pump at 2.1 m below top of casing. Notes:

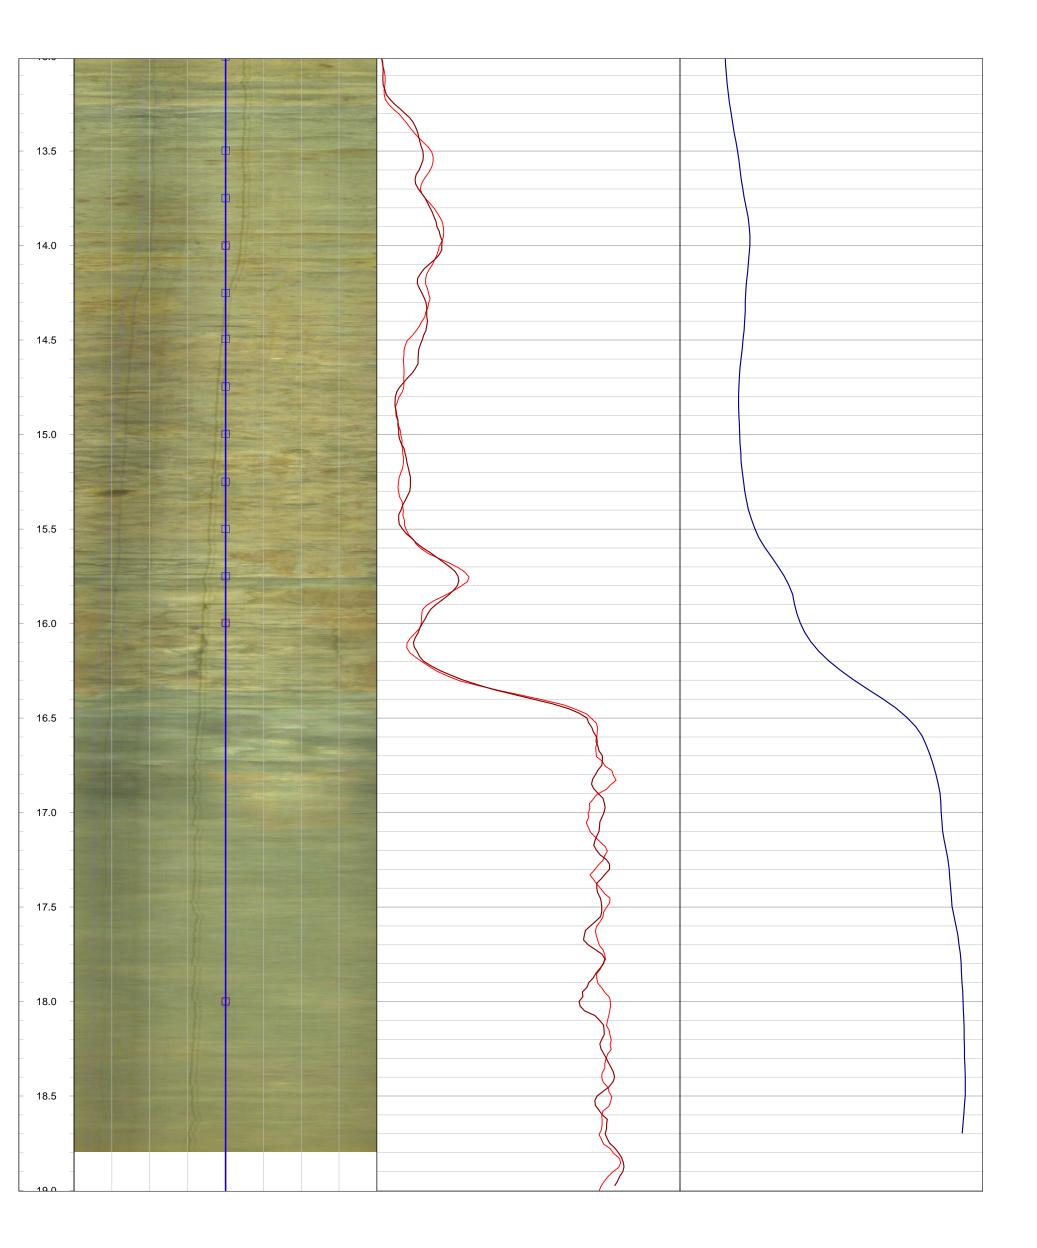
Geophysical Record of Borehole: MW20-08 (CAL)

Heat Pulse Flowmeter Dynamic pump at 2.1 m below top of casing.

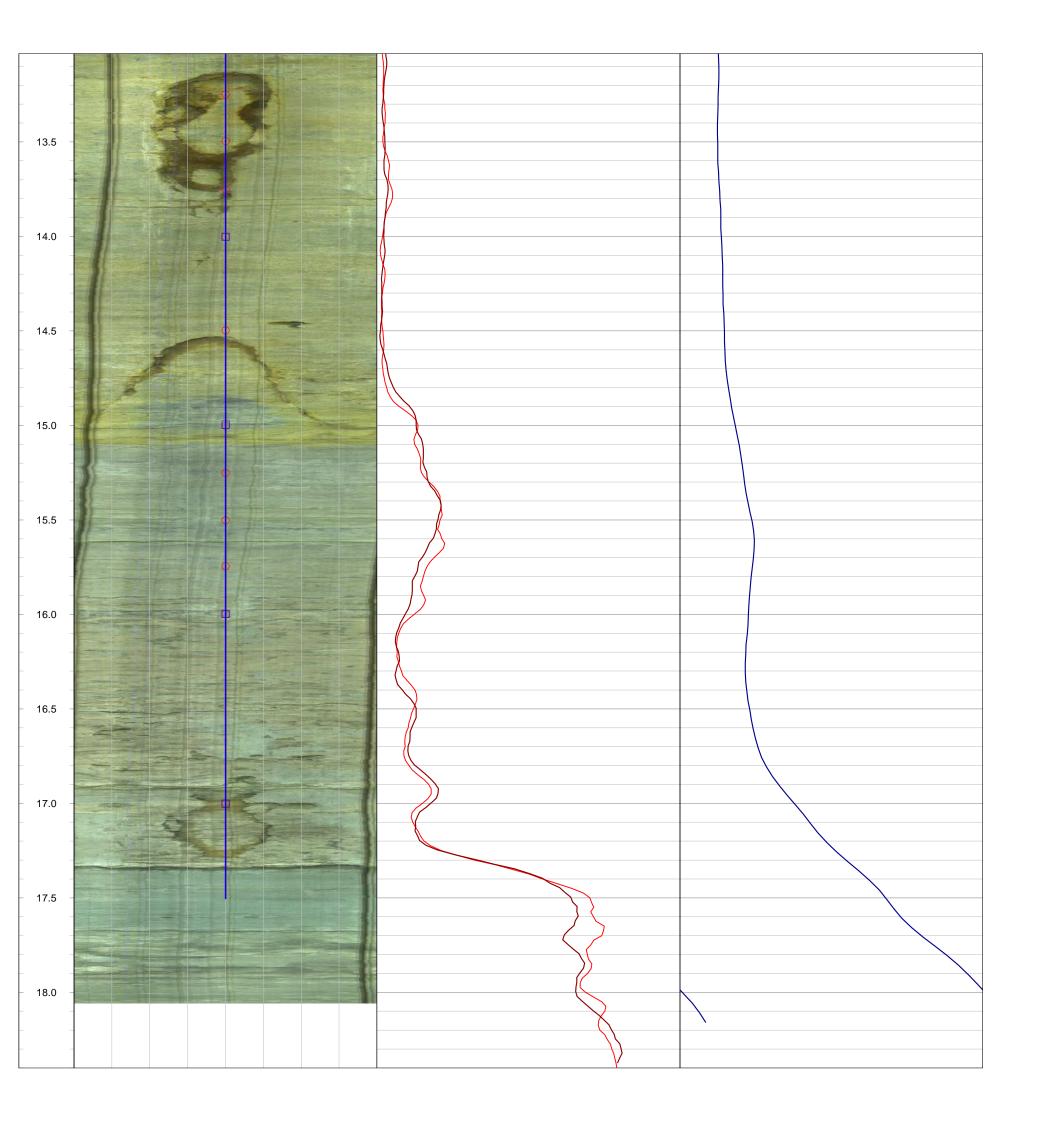
Geophysical Record of Borehole: MW20-09 (CAL)

Notes: OBI image opaque > 7.65 m bgs

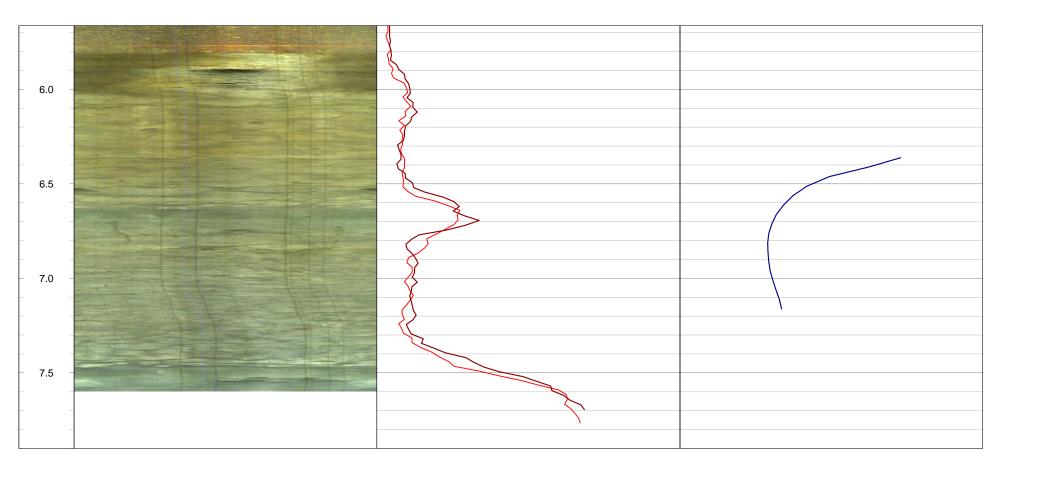
Geophysical Record of Borehole: MW20-10 (CAL)

Heat Pulse Flowmeter Dynamic pump at 10.5 m below top of casing. Pump rate approximately 2.72 L/min

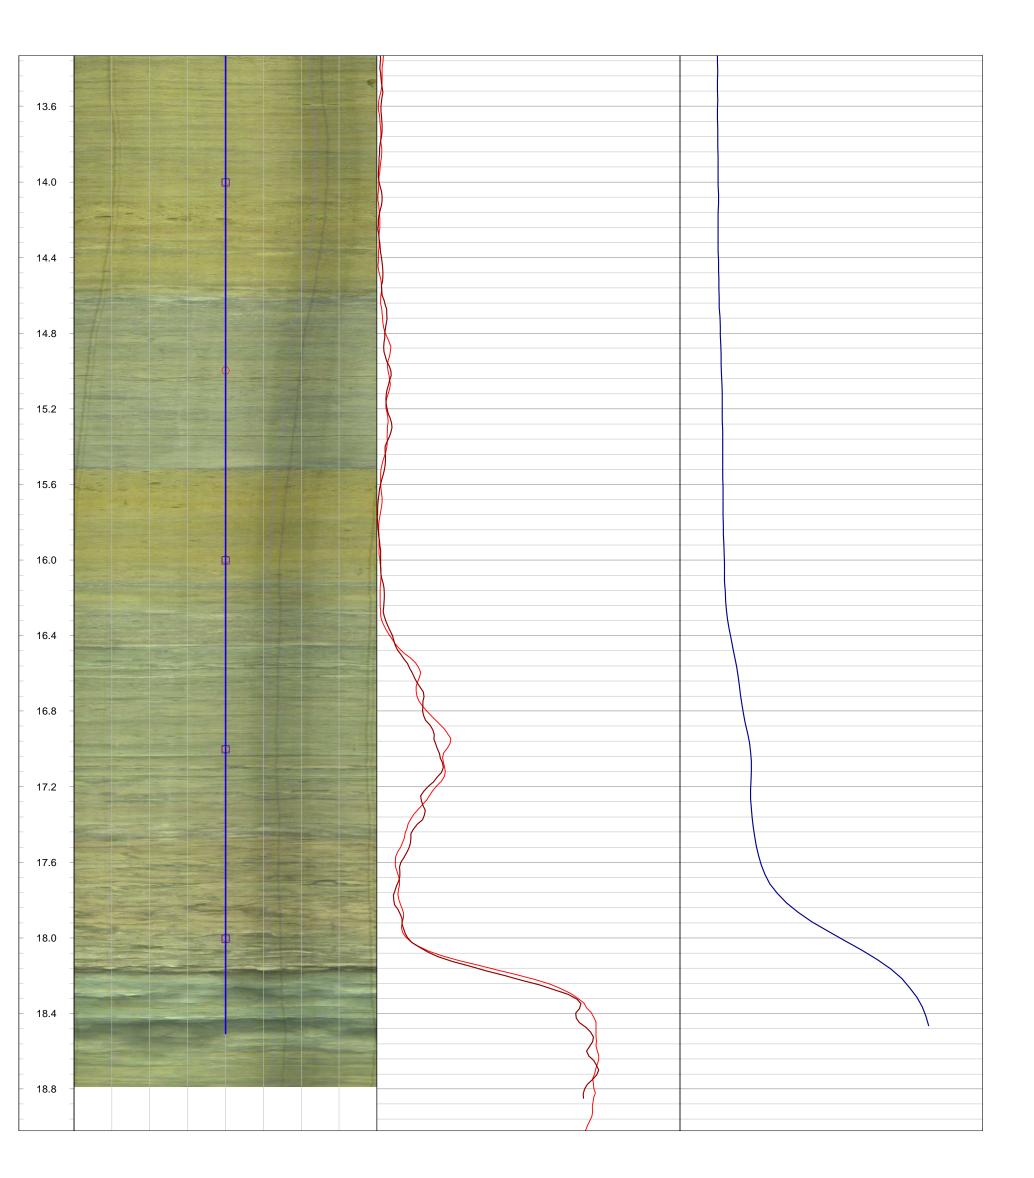
Geophysical Record of Borehole: MW20-12 (CAL)

Notes: Heat Pulse Flowmeter Dynamic pump at 4.5 m below top of casing. Pump rate approximately 2.30 L/min.

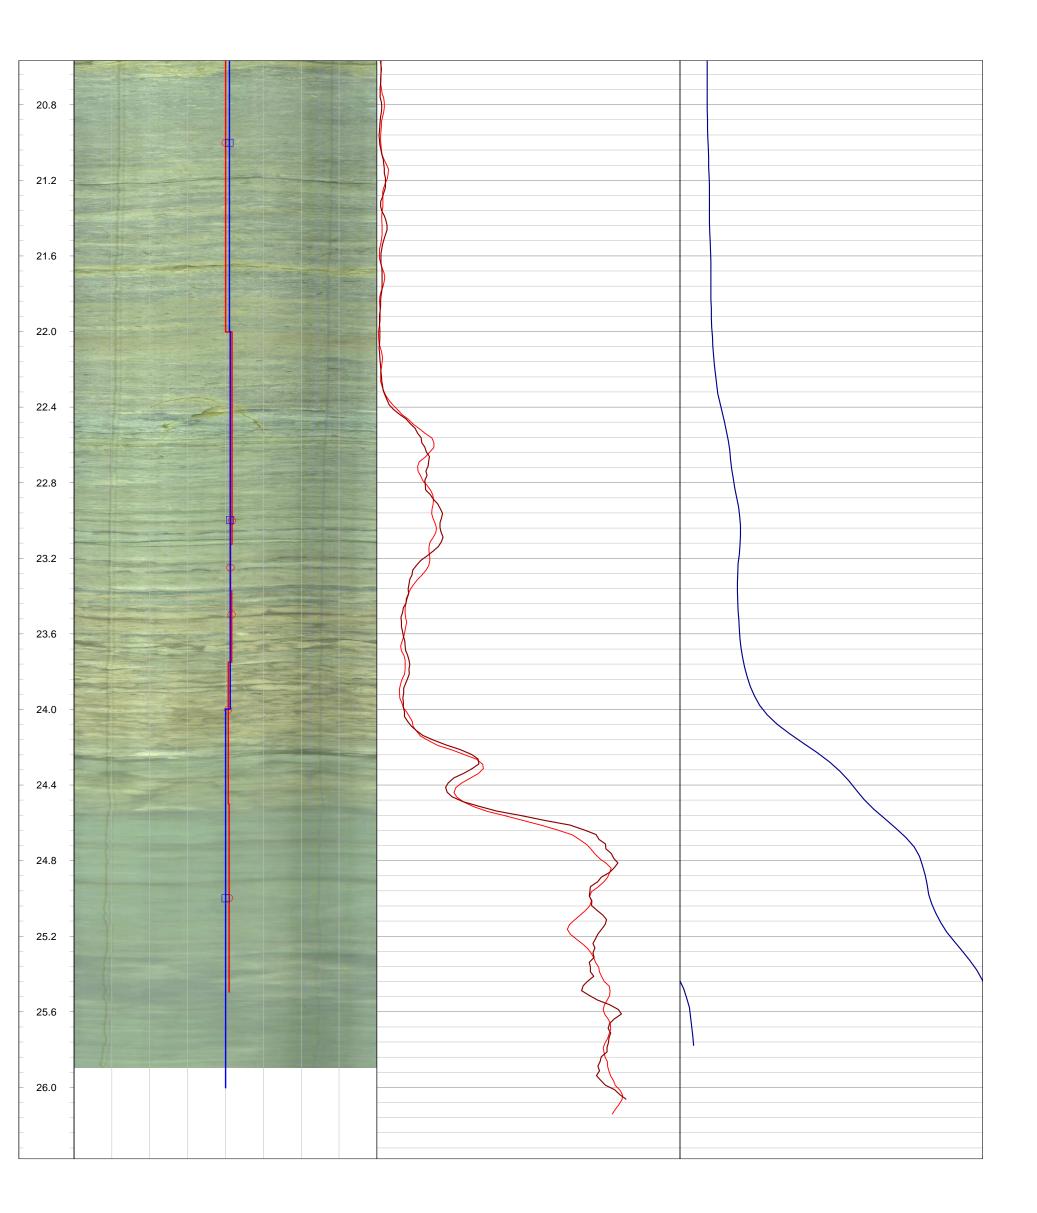
Geophysical Record of Borehole: MW20-15 (CAL)

Notes: OBI image opaque > 36.6 m bgs

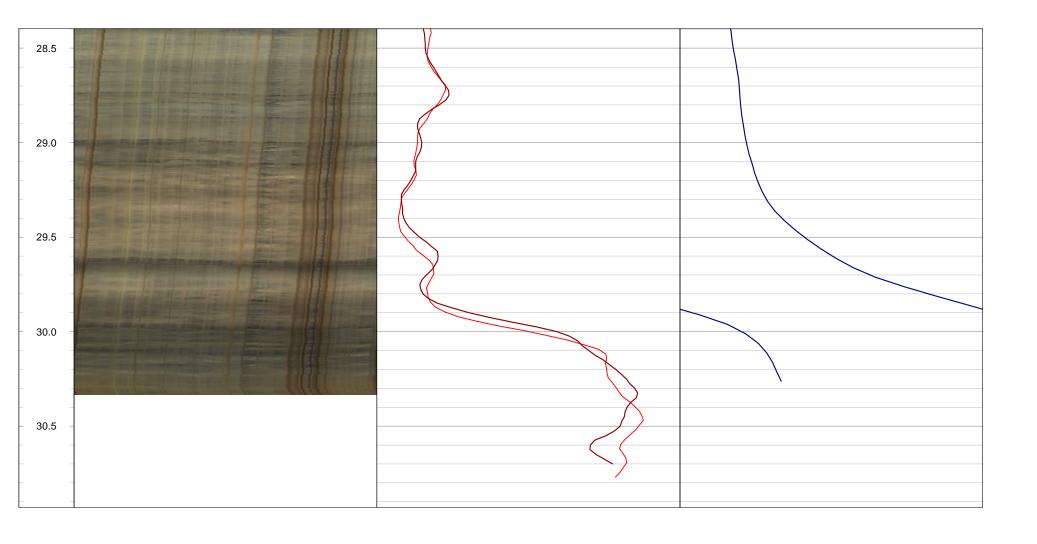
Geophysical Record of Borehole: MW20-23 (CAL)

OBI image opaque > 24.4 m bgs

Depth	0°	90°	OBI Image - MN	270°	 0	Natural Gamma - Down	200 0	Apparent Conductivity - Up mS/m	50
1m:20m						Natural Gamma - Up			
0.5	=				0	cps	200		
1.0					X				
					\				
1.5									
2.0									
2.5									
3.0									
3.5									
4.0									
4.5									
5.0									
5.5									
)

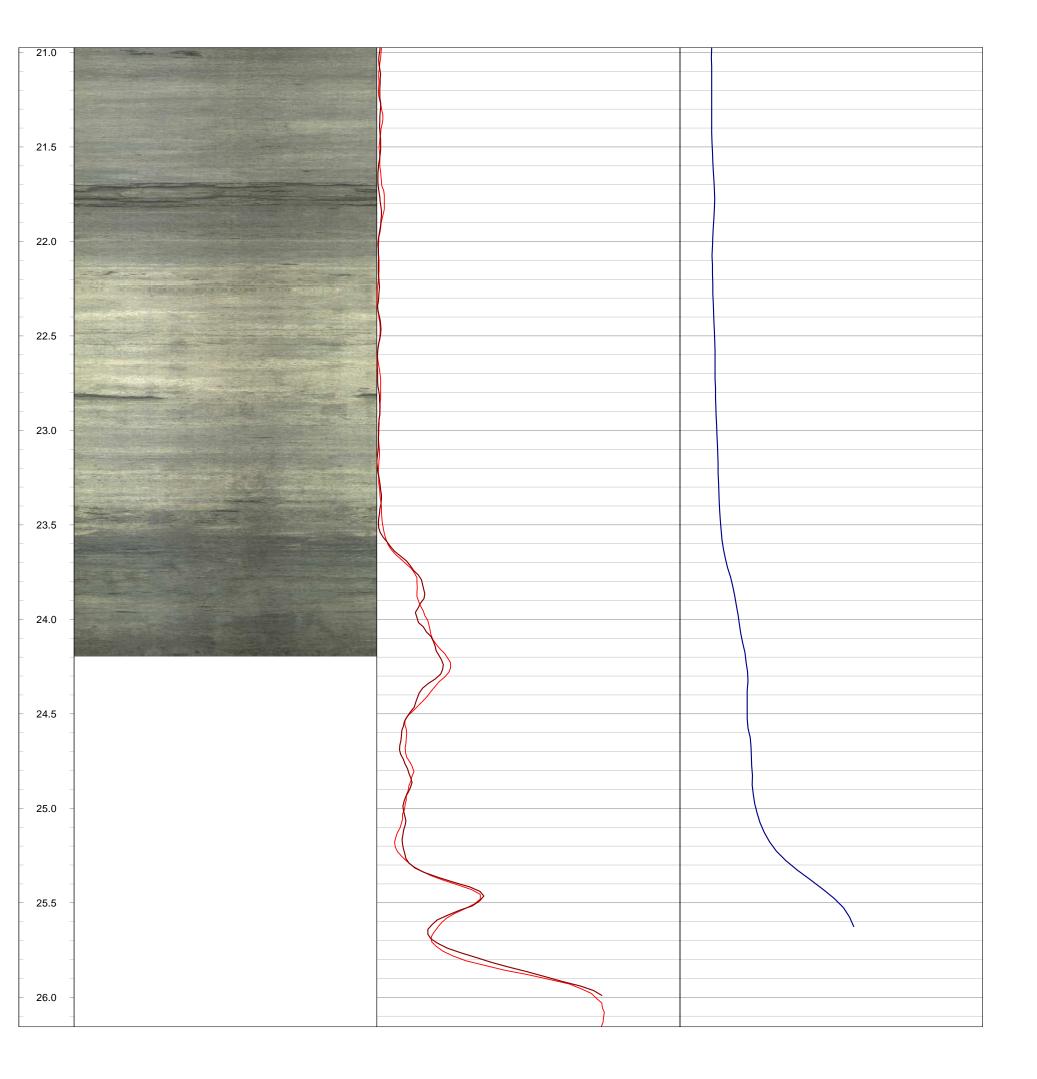
Geophysical Record of Borehole: MW20-24 (CAL)

Depth			OBI Image - MN			Natural Ga	amma - Down			Apparent Conductivity - Up	
	0°	90°	180°	270°	0°	0	cps	200	0	mS/m	50
1m:20m							Gamma - Up				
						0	cps	200			
						1					
0.5											
						<i></i>					
1.0											
1.5											
						· · · · · · · · · · · · · · · · · · ·					
2.0											
						1					
0.5											
2.5											
3.0											
3.5											
						X					
4.0											
4.5											
F.0											
5.0											
						\(\lambda\)					
)					
5.5						<u> </u>					
						V

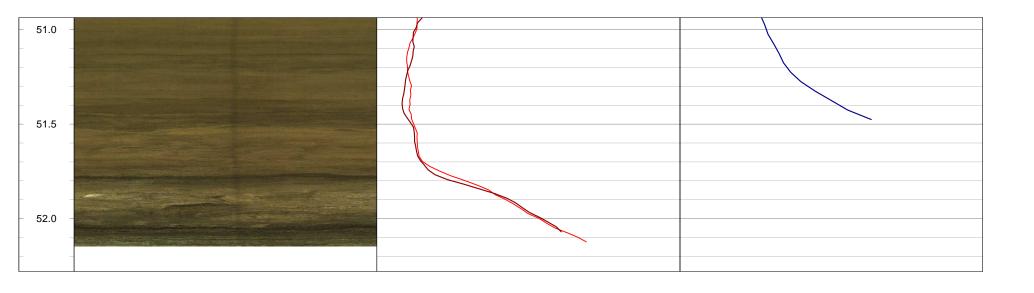
Geophysical Record of Borehole: MW20-28 (CAL)

OBI Image - MN				Natural Gamma - Down	Apparent Conductivity - Up		
Depth	0° 90°			0° (1	cps	200		mS/m 50
4 00	0 90	100	270	0 (Natural Gamma - Up	200	U	1113/111 50
1m:20m				()	cps	200		
					H				
1.0									
1.0									
1.5									
1111									
2.0									
2.5									
2.0									
3.0									
					1				
3.5									
4.0									
4.5									
5.0									
ე.U									
5.5									
					\				
6.0

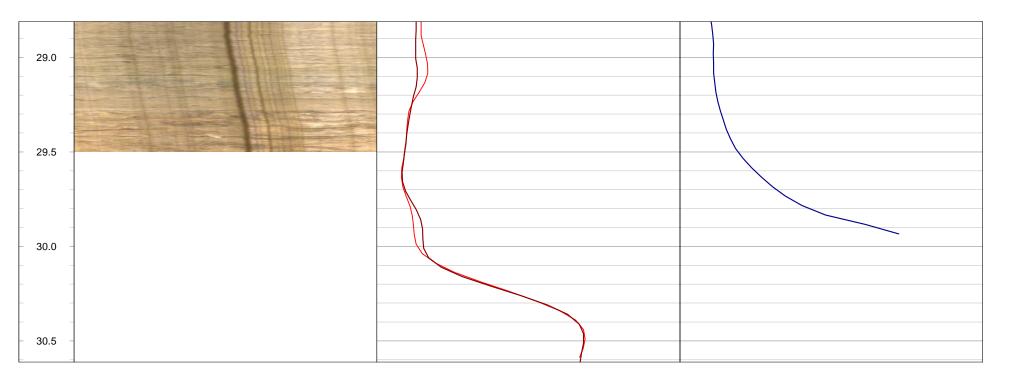
Geophysical Record of Borehole: MW21-1-1 (CAL)

OBI image blurry >30 m. Heat Pulse Flowmeter Dynamic pump at 10 m below top of collar. Pump rate approx. 2 L/min.

Depth		OBI Image - MN	_	Natural Gamma - Down		Apparent Conductivity - Up	
- r ·	0°	90° 180° 270° Heat Pulse Flowmeter - Dynamic	0° 0	Cps	200	0 mS/m	50
1m:20m	2			Natural Gamma - Up			
	-2	L/min	2 0	cps	200		
			V				
1.0							
1.5							
2.0							
2.5							
3.0							
			\ \ \ \ \ \ \ \ \ \ \ \ \ \ \ \ \ \ \				
3.5							
4.0							
7.0							
4.5							
4.0							
5.0							
5.5							
6.0

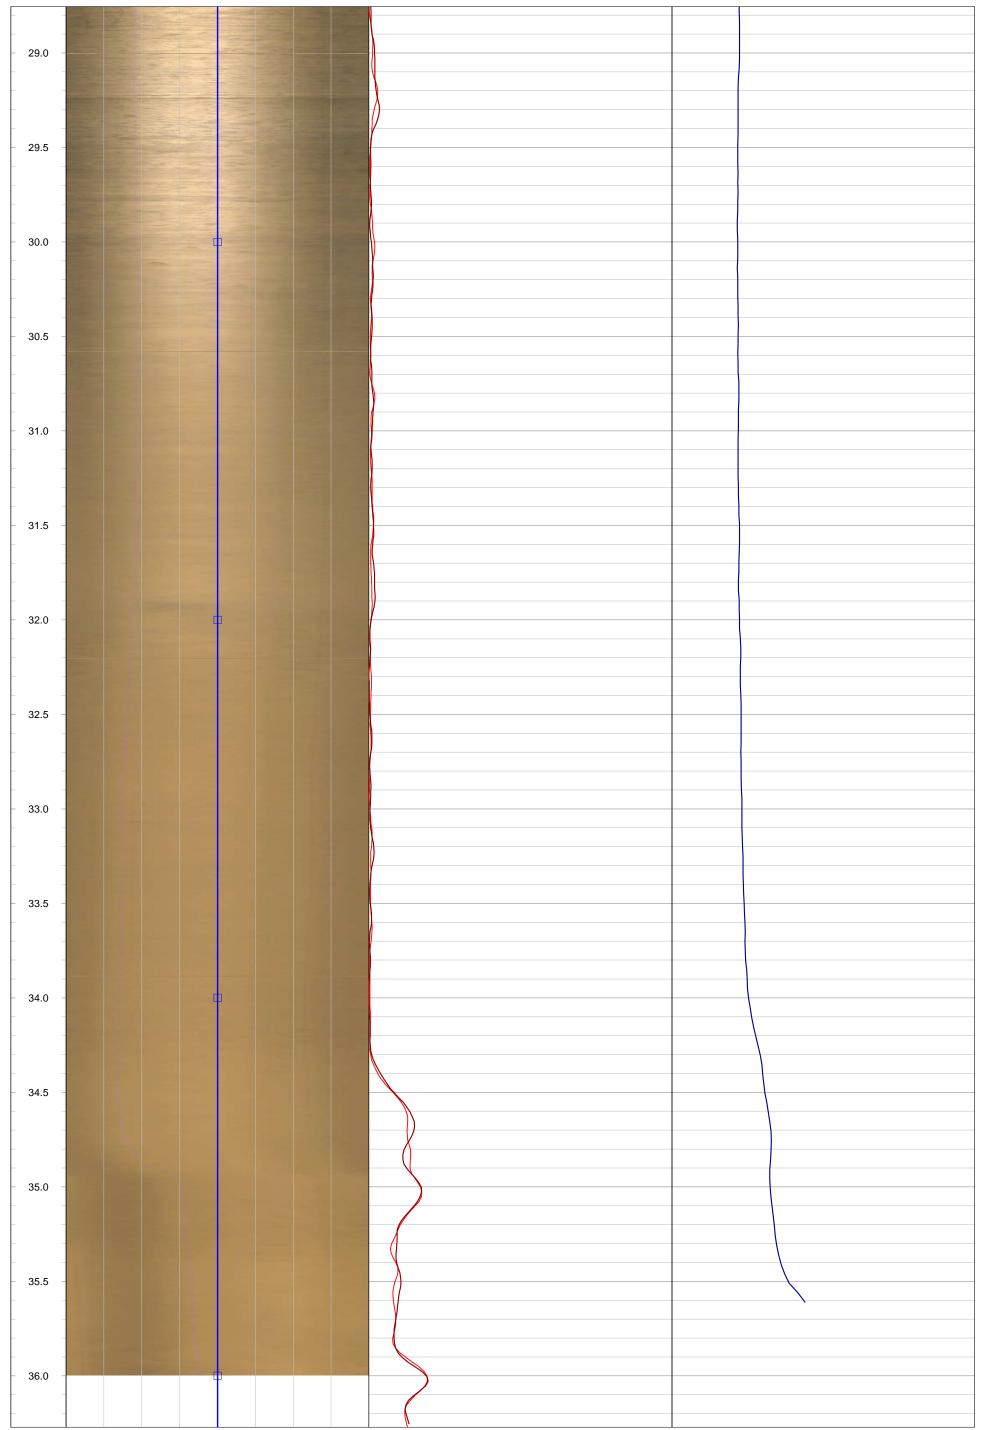
Geophysical Record of Borehole: MW21-1-2 (CAL)

Depth		Natural Gamma - Down		Apparent Conductivity - Up
Бериі	0	cps	200	0 mS/m 50
1m:20m	 0	Natural Gamma - Up cps	200	
	/	cps	200	
1.0				
1.5				
2.0				
2.0				
2.5				
3.0				
3.5				
4.0				
		$\sqrt{}$		
4.5				
5.0				
		/		
		igwedge		
5.5				
0.0				
6.0

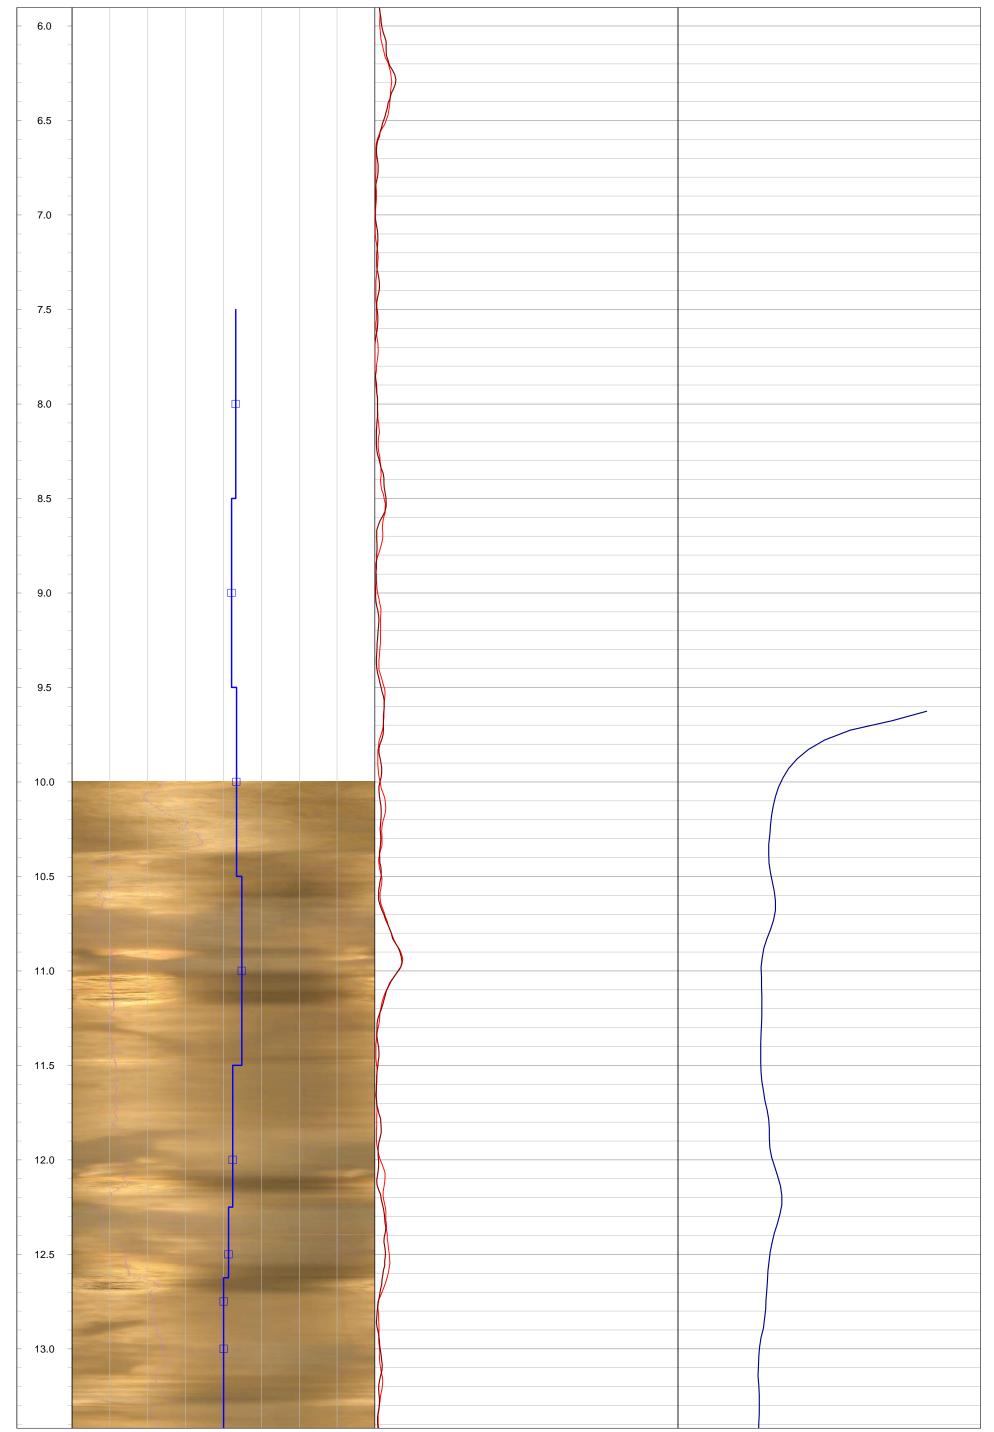
Notes: Very murky image. Tried 3 runs with same results. Heat Pulse Flowmeter Dynamic pump at 6.5 m below top of collar. Pump rate approx. 3 L/min. OBI Image - MN Natural Gamma - Down Apparent Conductivity - Up Depth 180° 0° 200 mS/m cps Natural Gamma - Up Heat Pulse Flowmeter - Dynamic 1m:20m -2 L/min 2 0 cps 200 0.5 1.0 1.5 2.0 3.0 3.5 4.0 4.5 5.0 5.5

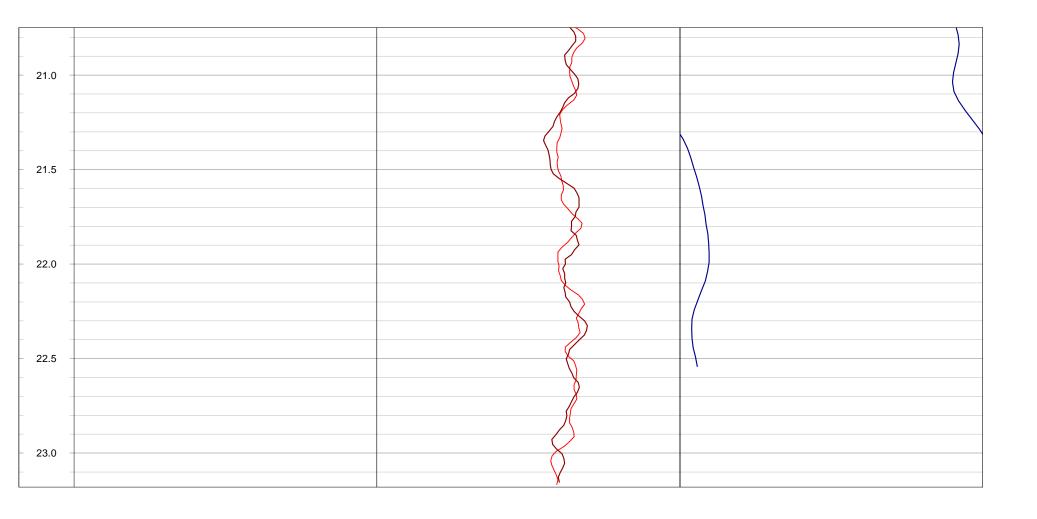
Geophysical Record of Borehole: MW21-2-4 (CAL)

Casing Stickup: 0.09 m ags Logged By: PL

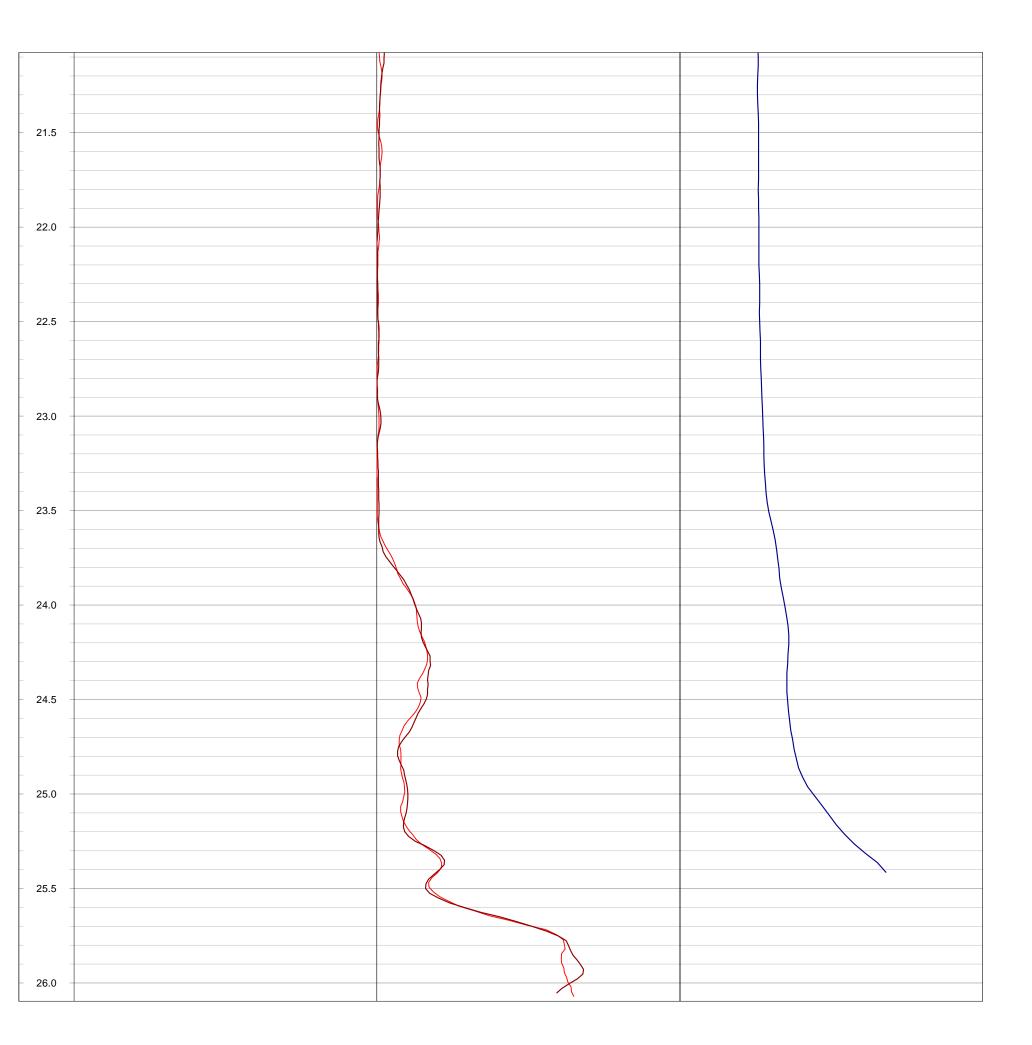
Geophysical Record of Borehole: MW21-3-1 (CAL)

Notes: Image orange (rust?) from 8.3 to 10.7 mbgs, opaque>10.8 m bgs. Heat Pulse Flowmeter Dynamic pump at 7.3 m below top of collar. Pump rate approx. 1 L

Image orange (rust?) from 8.3 to 10.7 mbgs, opaque>10.8 m bgs. Heat Pulse Flowmeter Dynamic pump at 7.3 m below top of collar. Pump rate approx. 1 L

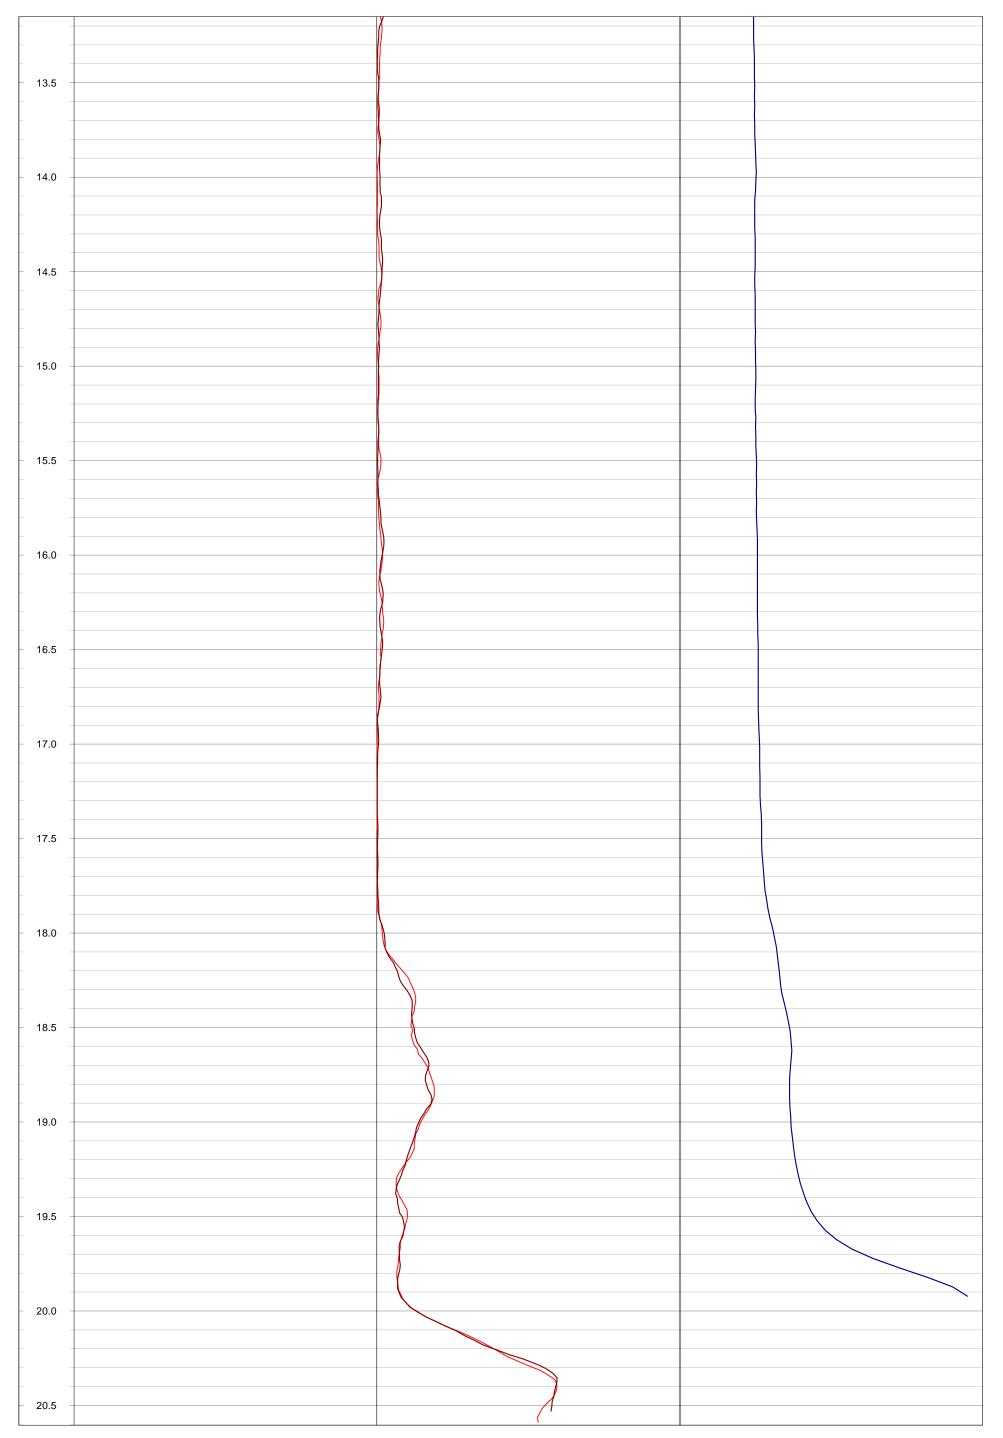
Geophysical Record of Borehole: MW21-3-3 (CAL)

Elevation: 405.12 m asl Casing Diameter: 152 mm Casing Stickup: 0.13 m ags Logged By: PG
