REPORT

Water Report Level 1/2

Proposed Caledon Pit / Quarry

CBM Aggregates, a division of St. Marys Cement Inc. (Canada)

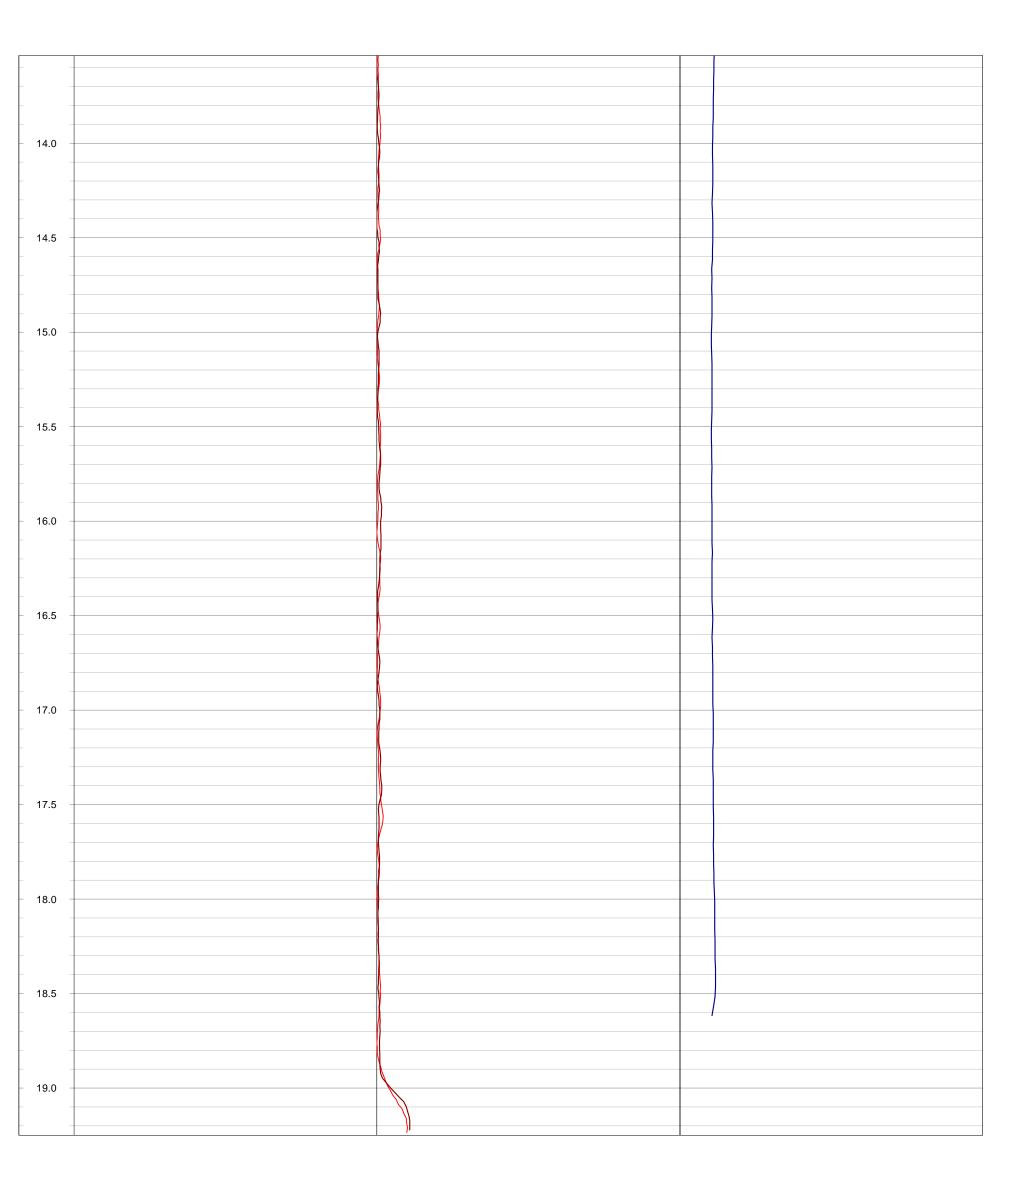
Geophysical Record of Borehole: MW21-3-4 (CAL)

Casing Stickup: 0.27 m ags Logged By: PG

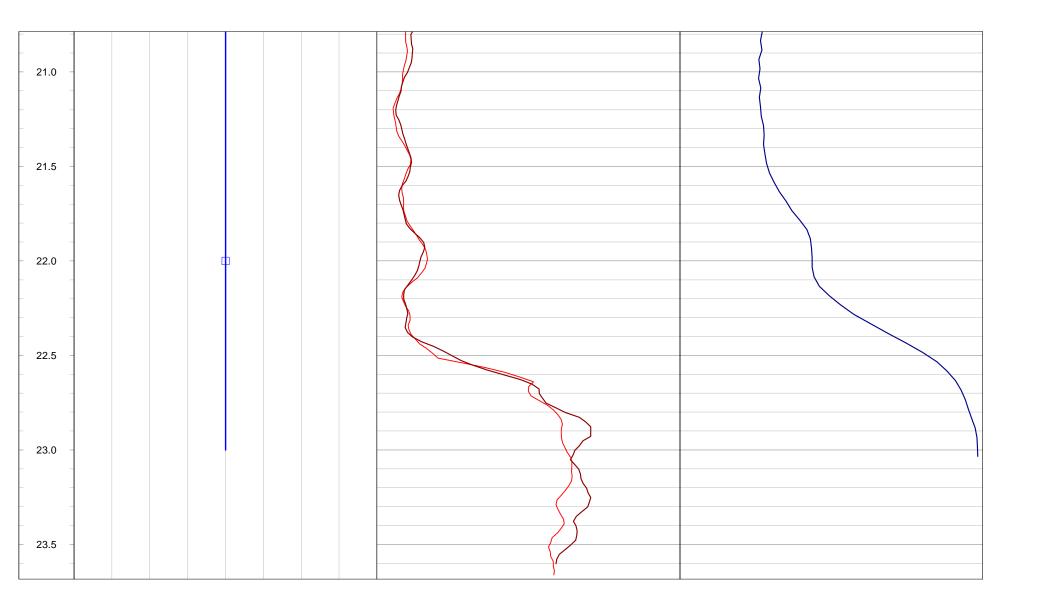
Geophysical Record of Borehole: MW21-4-2 (CAL)

Casing Stickup: 0.24 m ags Logged By: PG

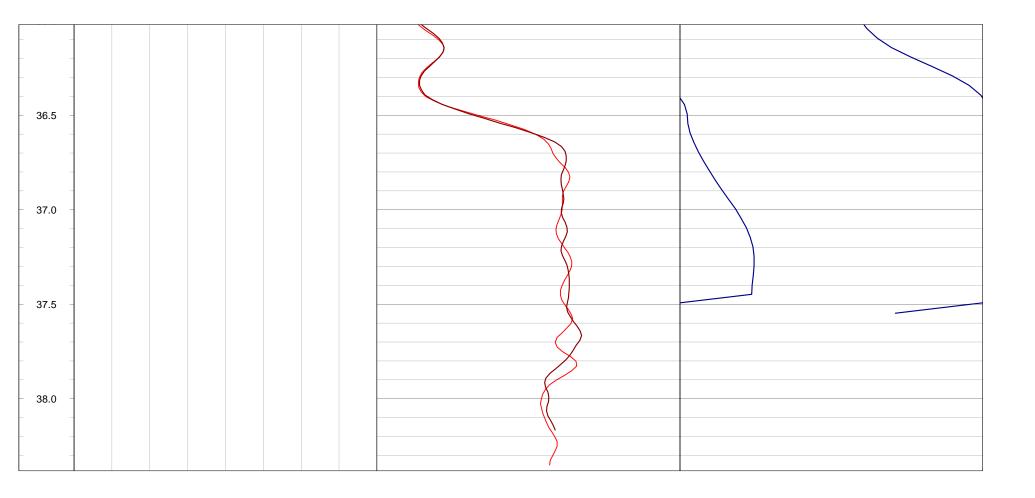
Geophysical Record of Borehole: PW21-2 (CAL)

Heat Pulse Flowmeter Dynamic pump at 6 m below top of collar. Pump rate approx. 4 L/min.

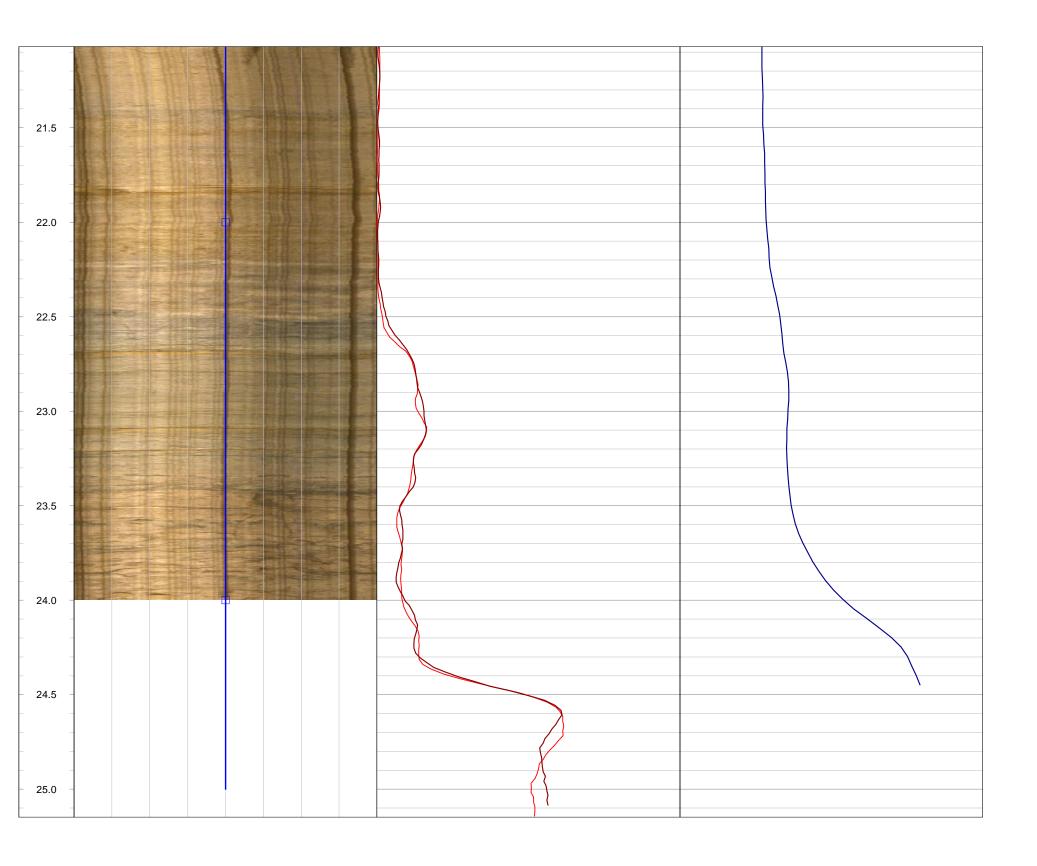
Geophysical Record of Borehole: PW21-3 (CAL)

Image orange (rust?) 10.7 to 19.5 m bgs, opaque>19.6 m bgs. Heat Pulse Flowmeter Dynamic pump at 11 m below top of collar. Pump rate approx. 1.7 L/min.

Notes: Image orange (rust?) 10.7 to 19.5 m bgs, opaque>19.6 m bgs. Heat Pulse Flowmeter Dynamic pump at 11 m below top of collar. Pump rate approx. 1.7 L/min.

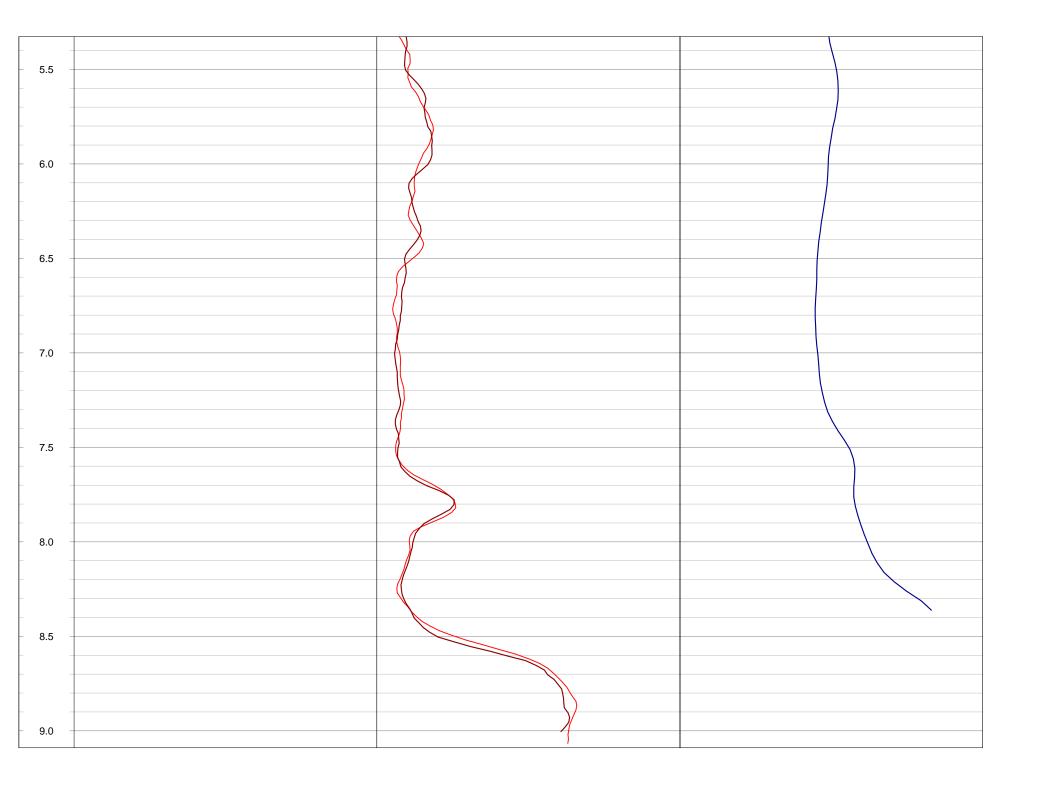
Geophysical Record of Borehole: JHL-BH19 (CAL)

Casing Stickup: 0.60 m ags Logged By: PG

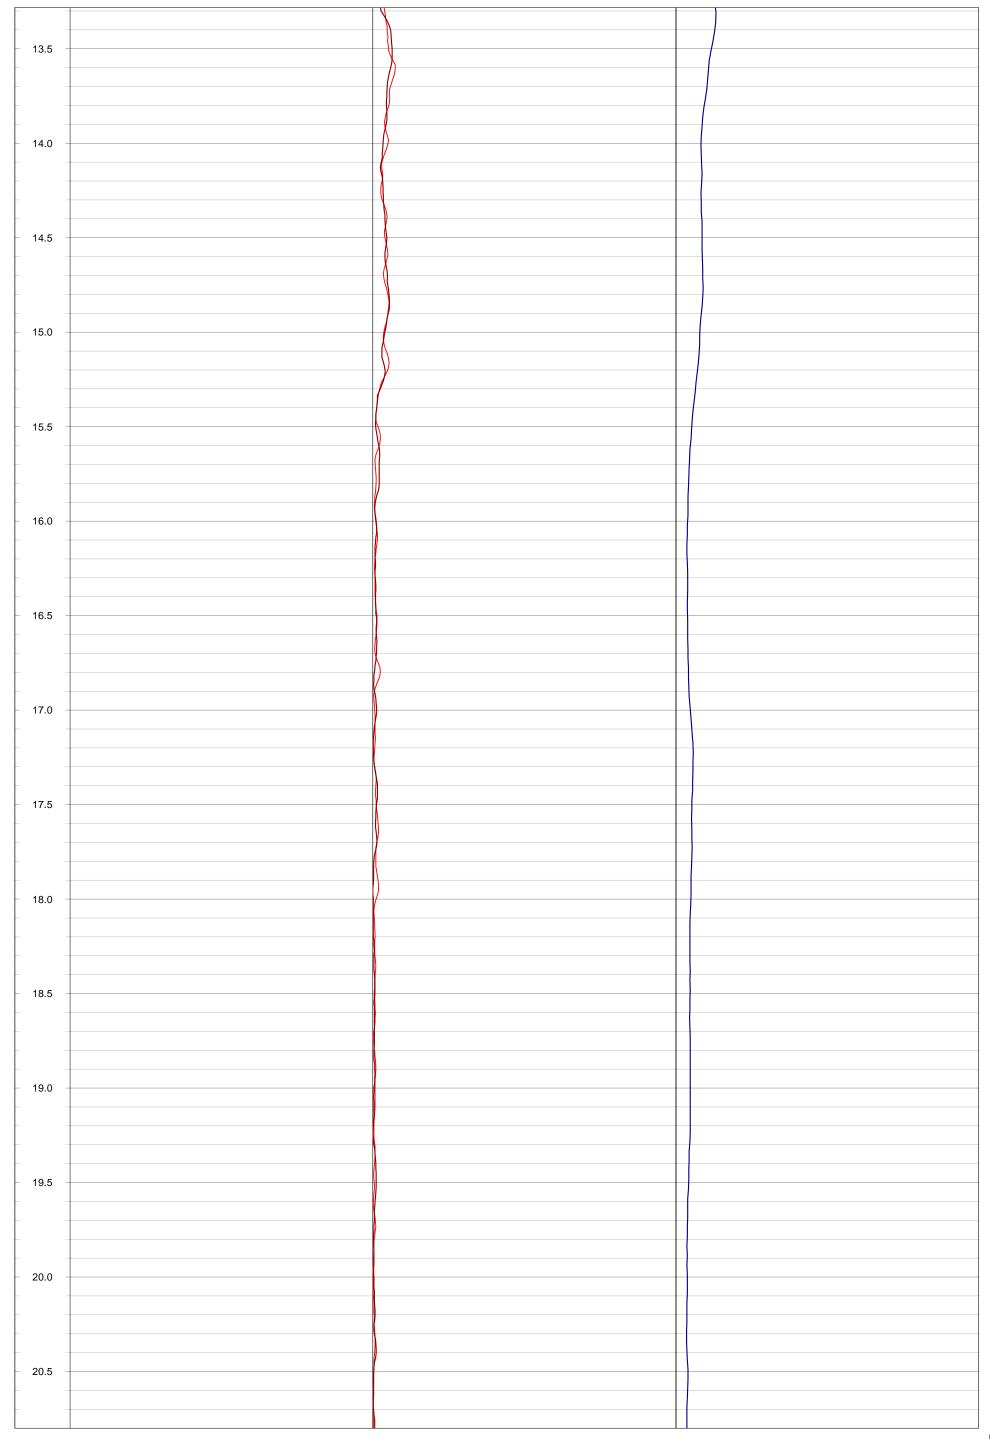
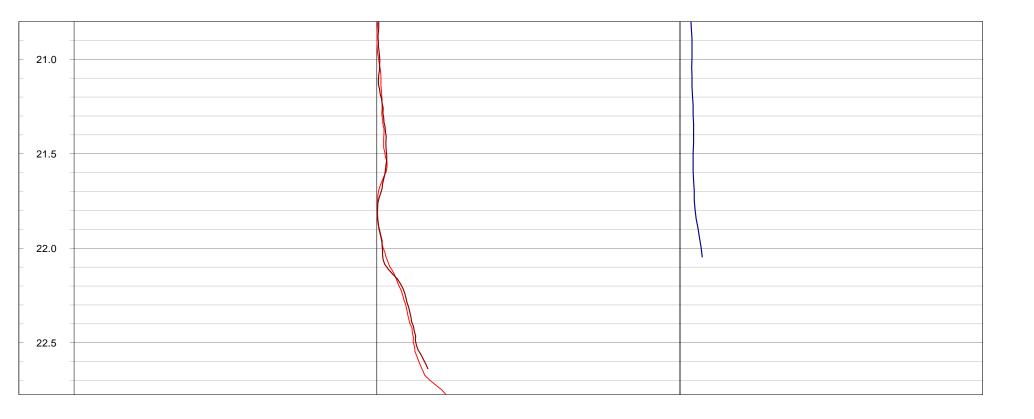
Geophysical Record of Borehole: BH20-01 (CAL)

Notes: OBI image is opaque > 21.60m

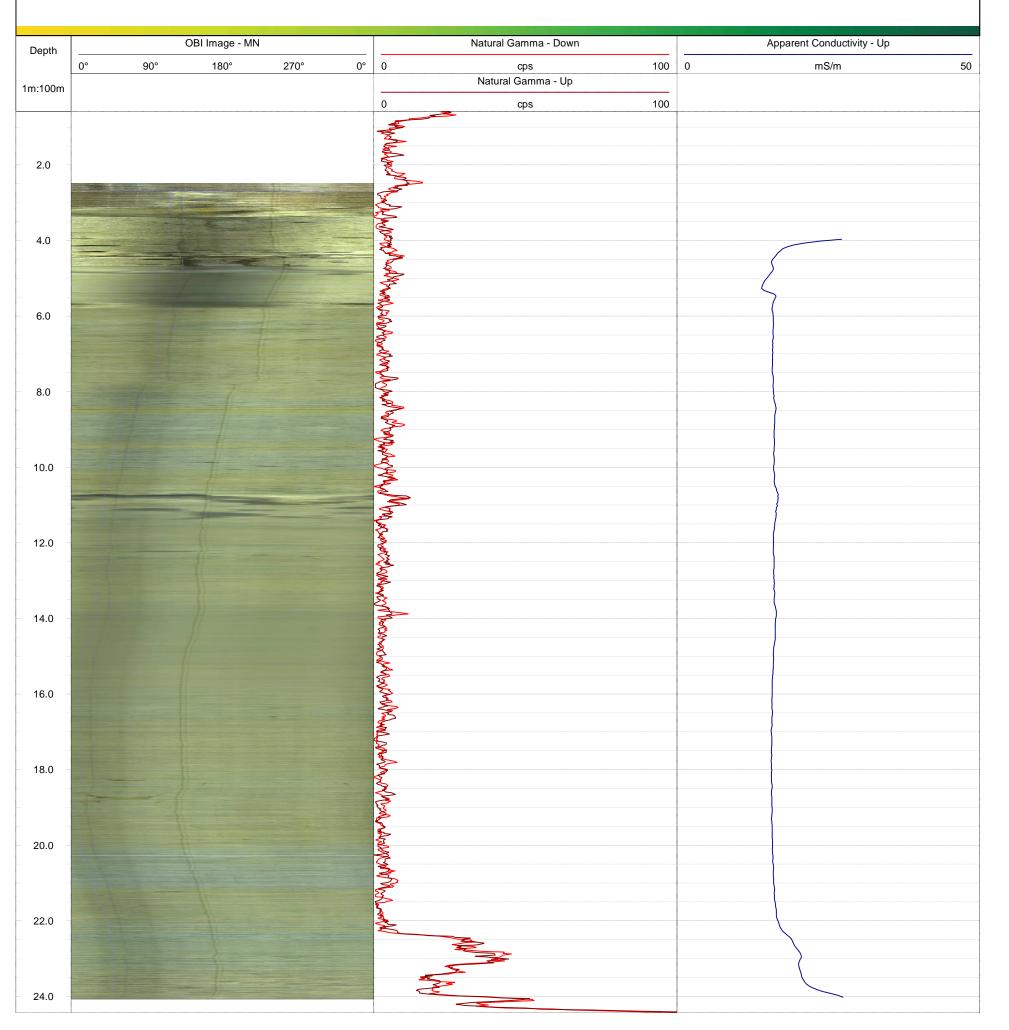
Geophysical Record of Borehole: BH20-20 (CAL)

Notes: OBI image opaque > 40.78 m bgs

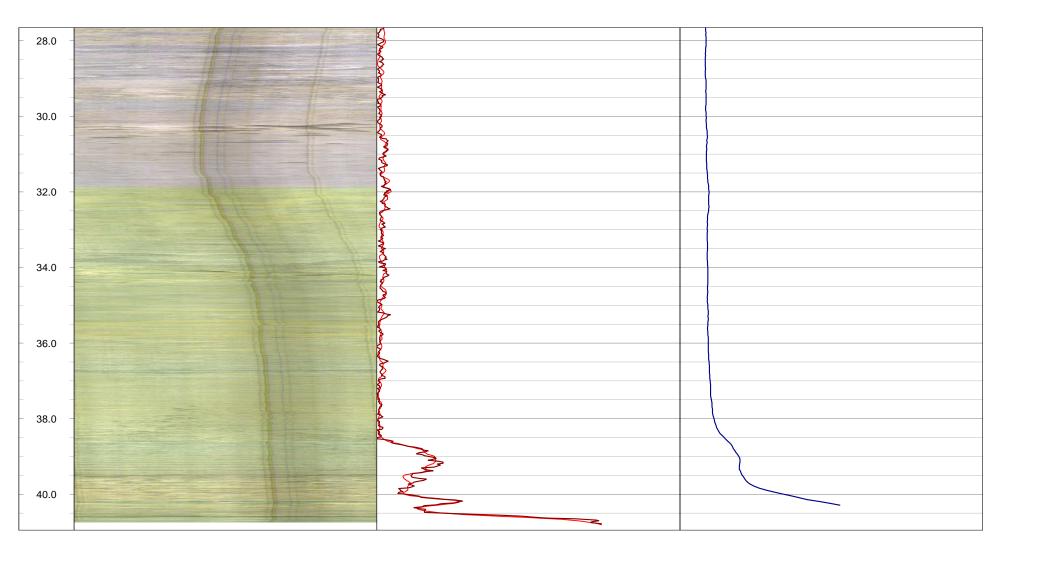
Geophysical Record of Borehole: BH20-21 (CAL)

Notes: OBI image opaque > 33.1 m bgs

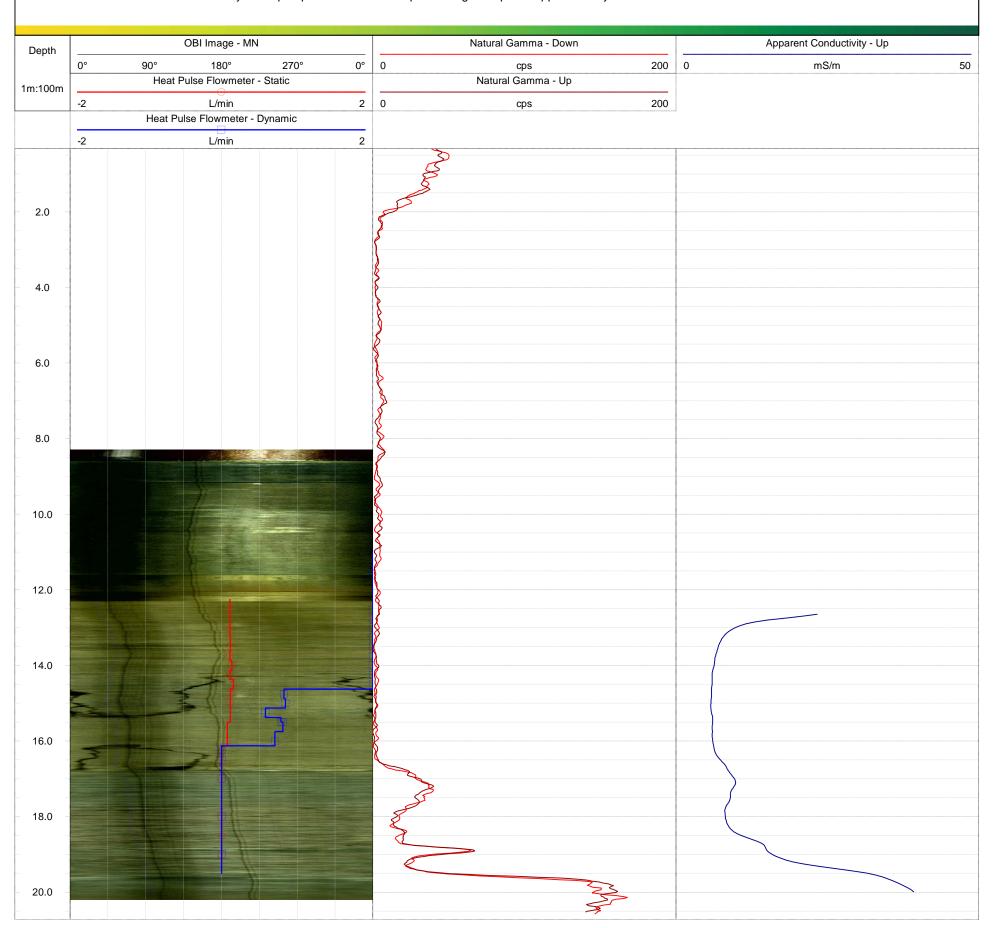
Geophysical Record of Borehole: MW20-11 (CAL)

Notes: OBI image opaque > 25.90. Heat Pulse Flowmeter Dynamic pump at 5.0 m below top of casing. Pump rate approximately 2.63 L/min.

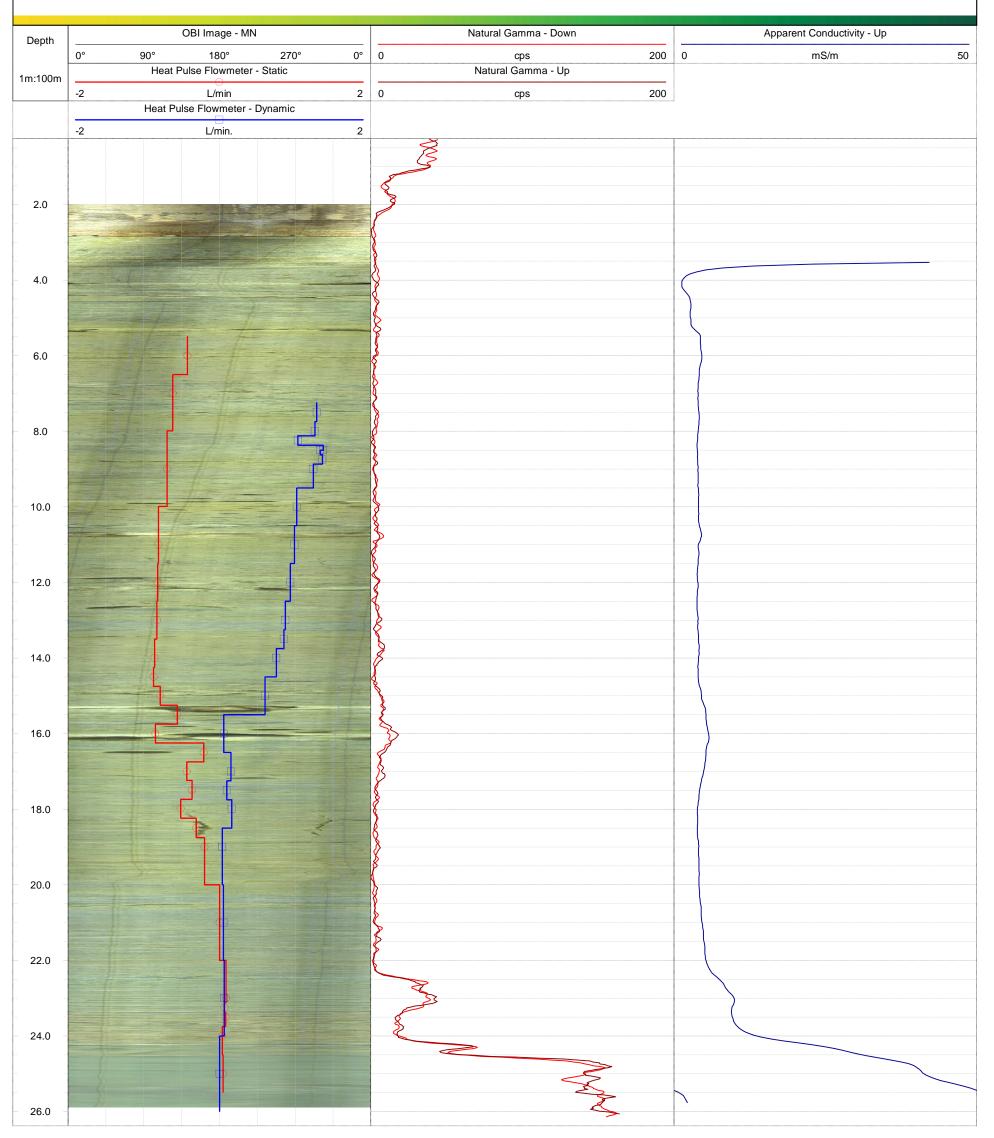
Geophysical Record of Borehole: MW20-15 (CAL)

Notes: OBI image opaque > 36.6 m bgs

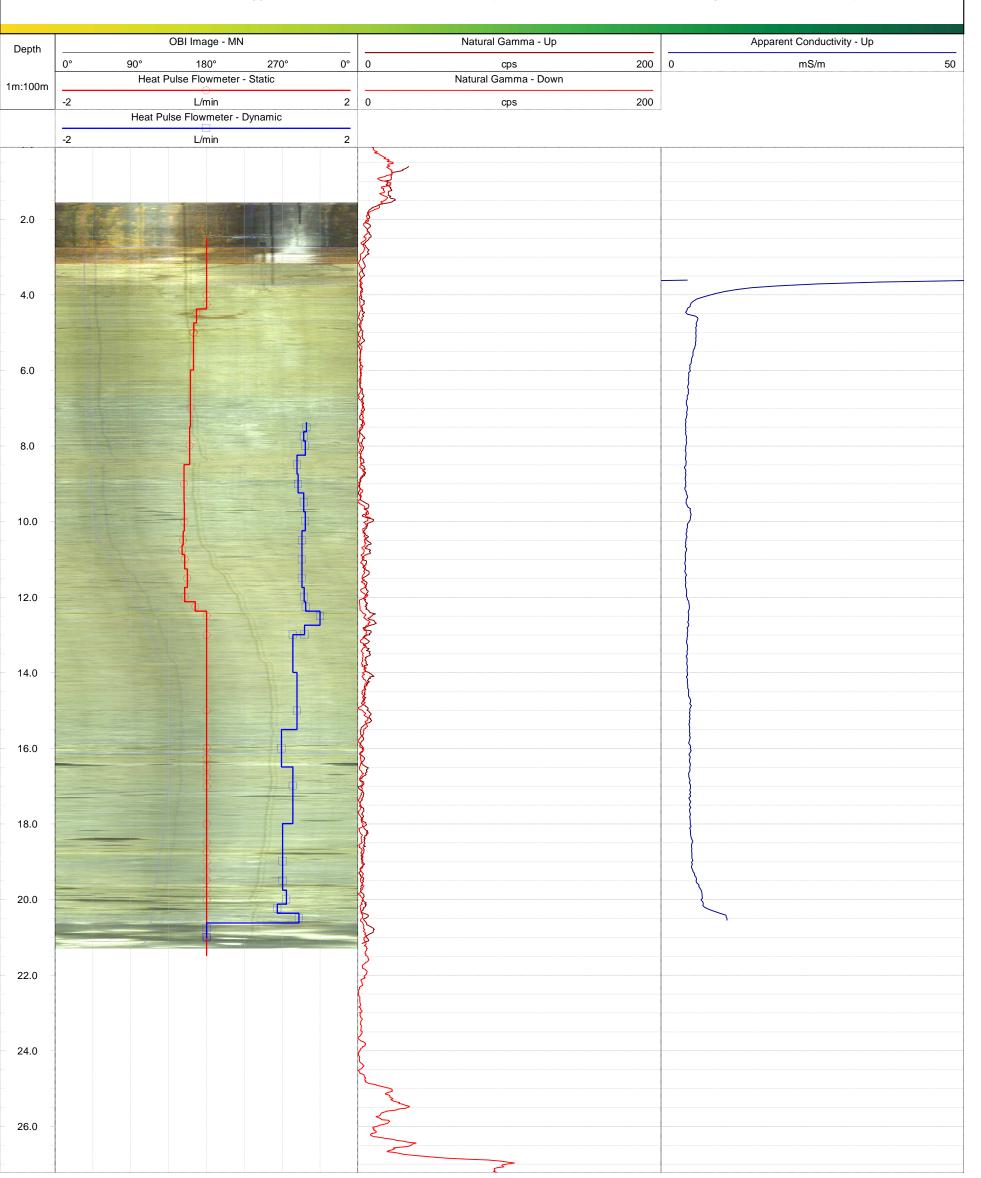
Geophysical Record of Borehole: MW20-18 (CAL)

Notes: Collapsed hole. Only Gamma logged inside the rods.

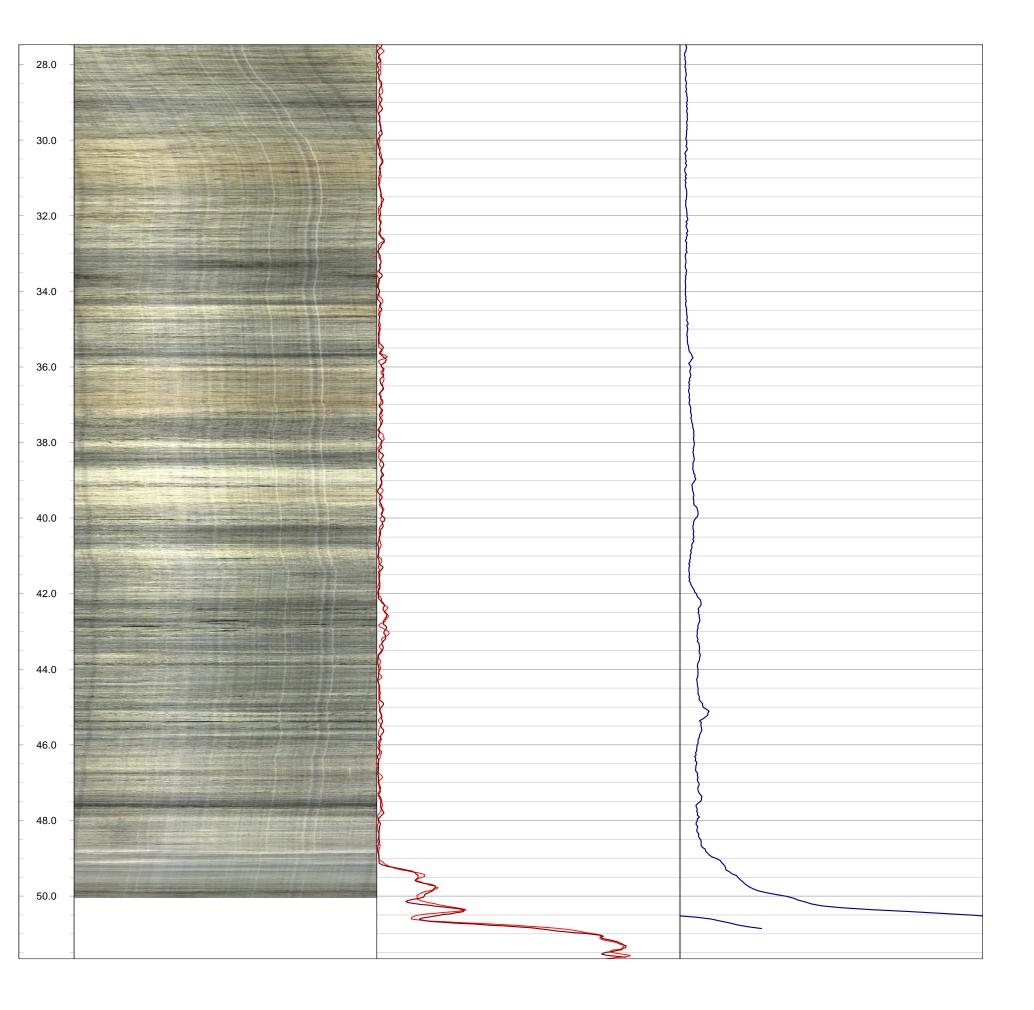
Geophysical Record of Borehole: MW20-26 (CAL)

Notes: Optical image blurred > 39 m bgs

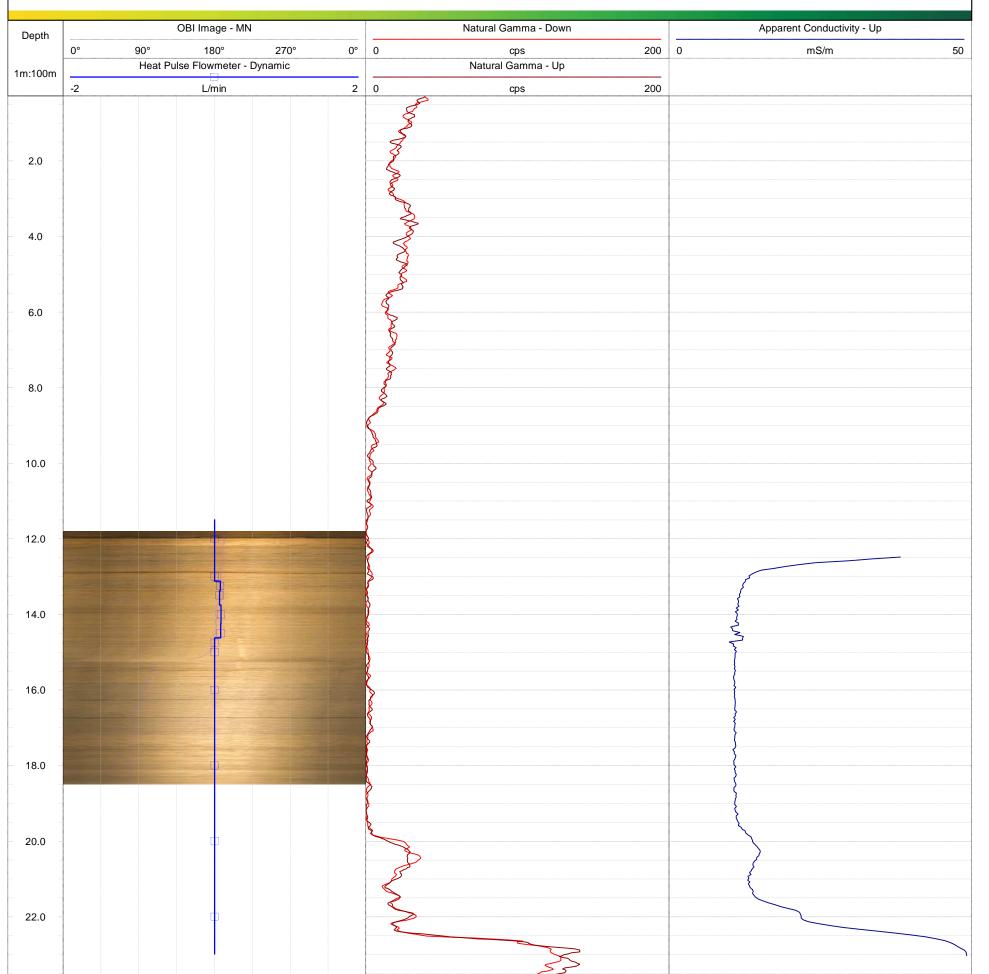
Geophysical Record of Borehole: MW21-4-2 (CAL)

Notes: OBI image opaque>32 m bgs. Heat Pulse Flowmeter Dynamic pump at 10 m below top of collar. Pump rate approx. 4 L/min.
